## Upper Suspension Balljoints in early Ford Falcons and Fairlanes

### Ford Falcon balljoint problem discovered:

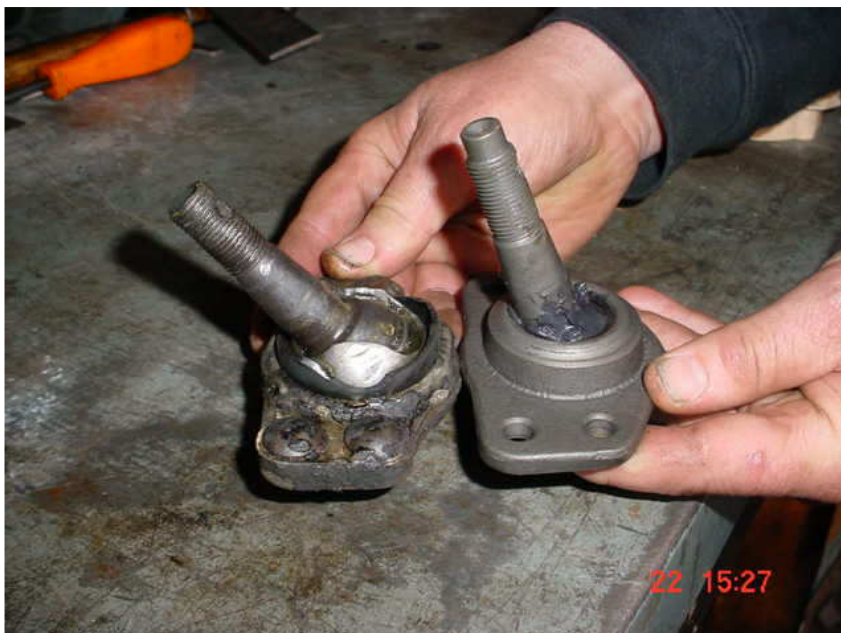
Two of the 4-bolt units are compared, at maximum angularity. The OE version (still with rivets attached) is on the left. The right hand unit is brand 'WJ Automotive'.

The result of the balljoint having insufficient angular movement is that the suspension cannot reach the upper bump-stop without the balljoint components traveling beyond their design limits.

LVV Certifiers that are certifying Ford Falcons or Fairlanes for any reason need to check the balljoints to identify the brand and condition. The proper means of assessing whether or not the balljoint is safe is by removal of the springs, and moving the suspension throughout its complete range of travel between the rubber bump stops, checking that the bumpstops are reached before

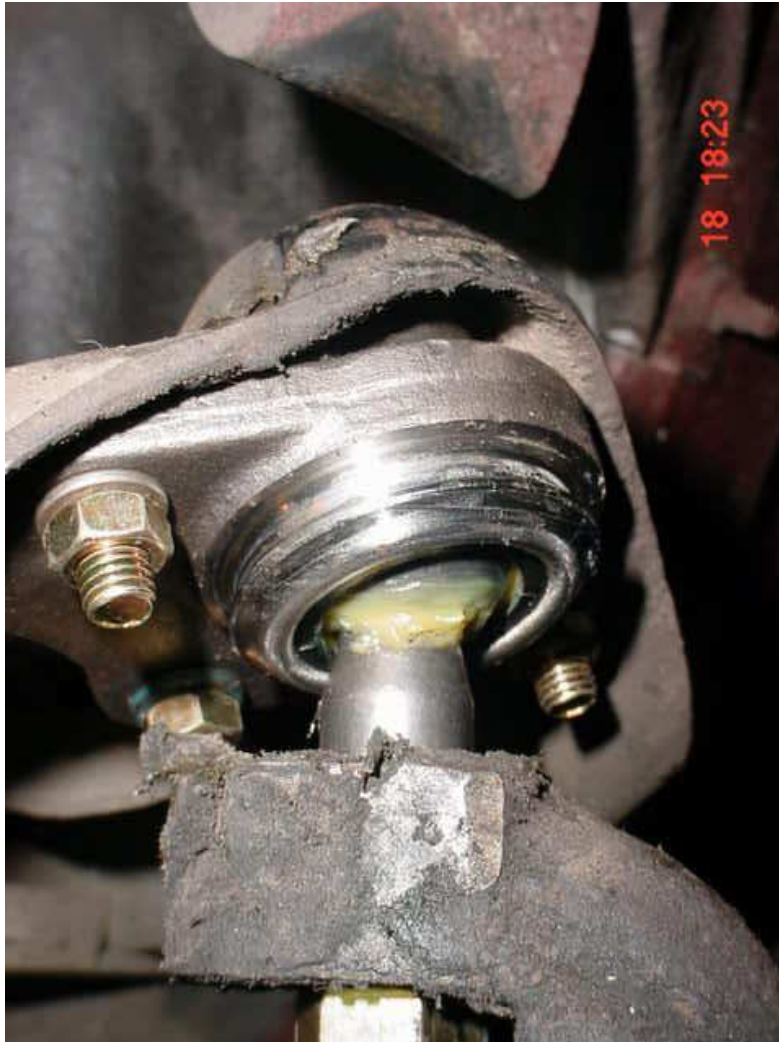
This photo of a 3-bolt 'WJ Automotive' balljoint shows the balljoint having reached its limit of angular movement with about 25mm of suspension travel still remaining before the bump-stop would be reached.

When the balljoint 'binds' like this but is forced to travel further, very high loadings occur. The following photo shows the result, as the edge of the balljoint housing causes damage to the shaft while trying to break it.

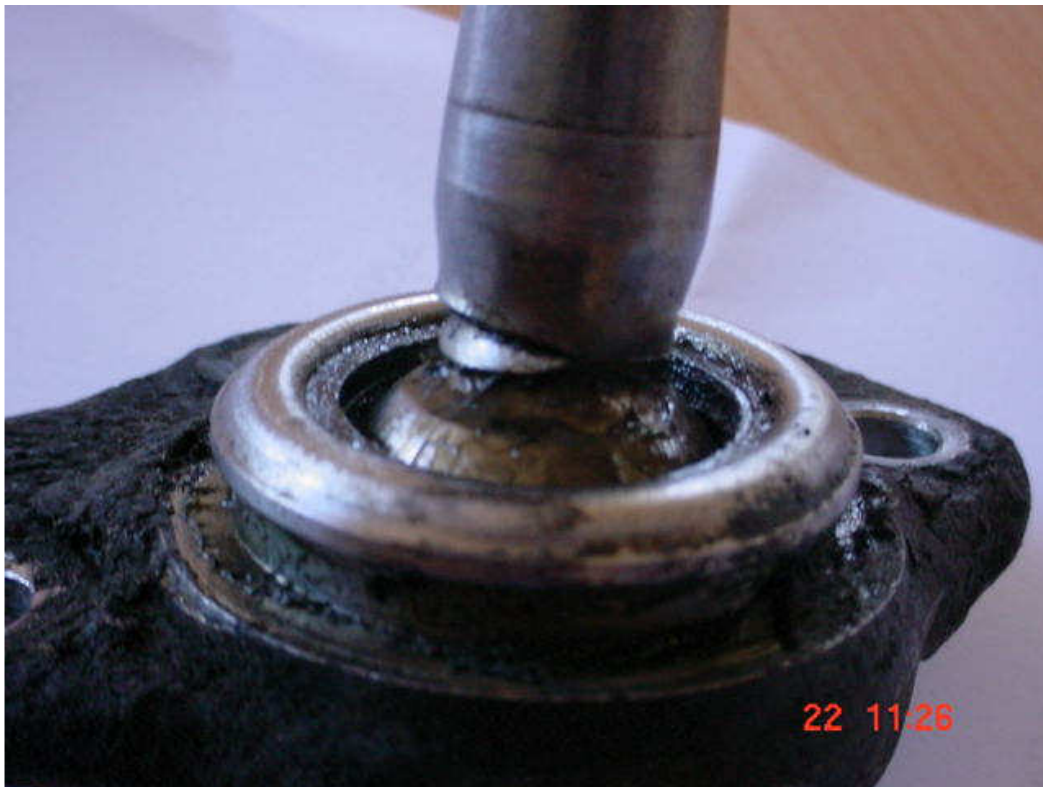
The deep groove in the 'Camelot' brand balljoint shaft has been caused by the high loads.

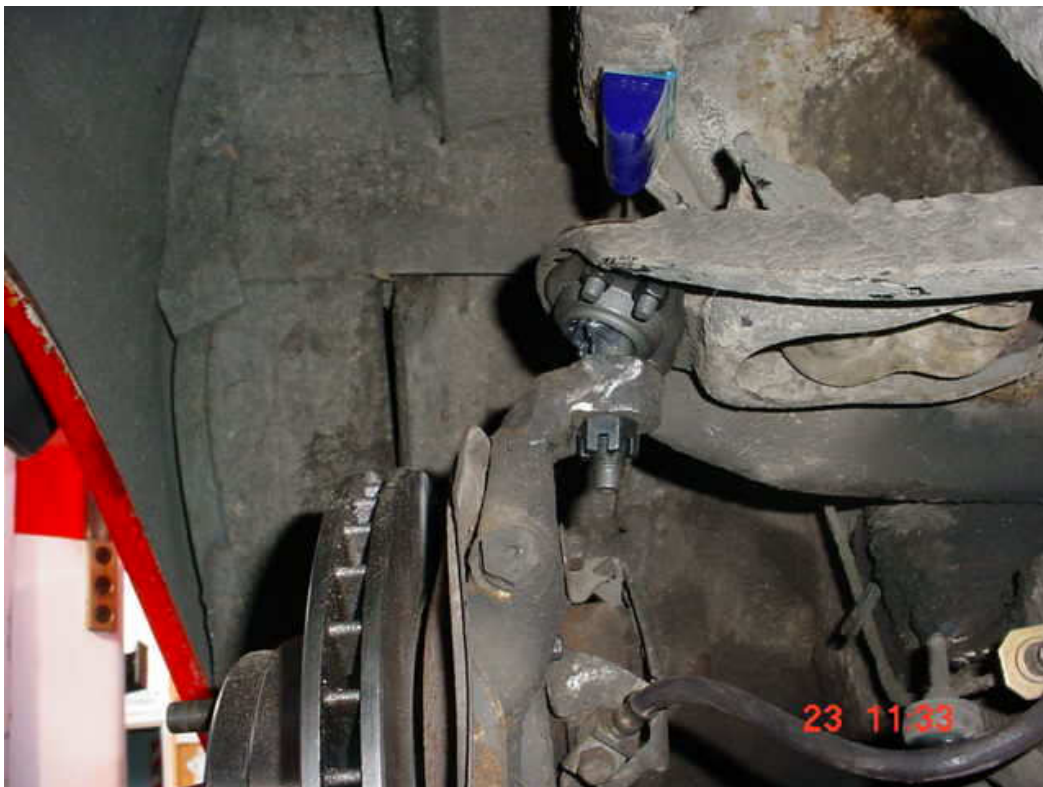
This picture of an XY Falcon with the 4-bolt 'WJ Automotive' balljoint is at the limit of suspension travel due to the balljoint reaching its maximum angular movement. About 25 mm more suspension travel is required to contact the bump-stop.
