## Upper Suspension Balljoints in early Ford Falcons and Fairlanes

### Ford Falcon balljoint problem discovered:

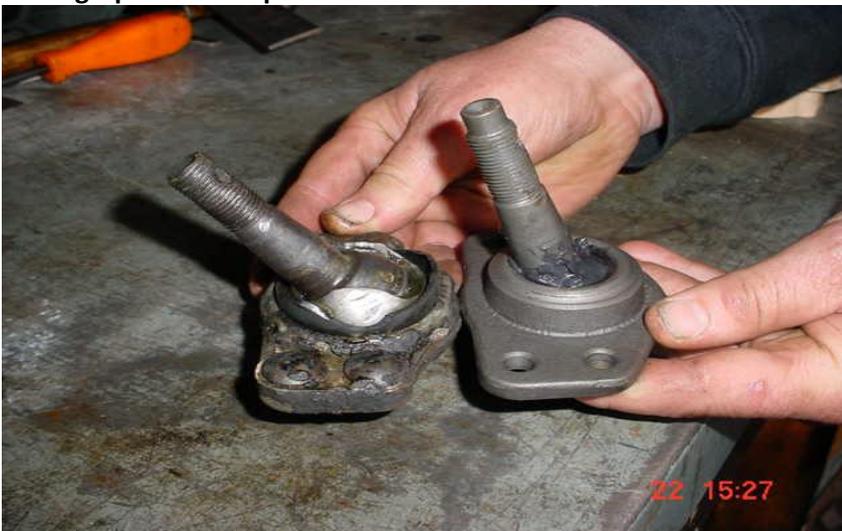
Two of the 4-bolt units are compared, at maximum angularity. The OE version (still with rivets attached) is on the left. The right hand unit is brand 'WJ Automotive'.

The result of the balljoint having insufficient angular movement is that the suspension cannot reach the upper bump-stop without the balljoint components traveling beyond their design limits.

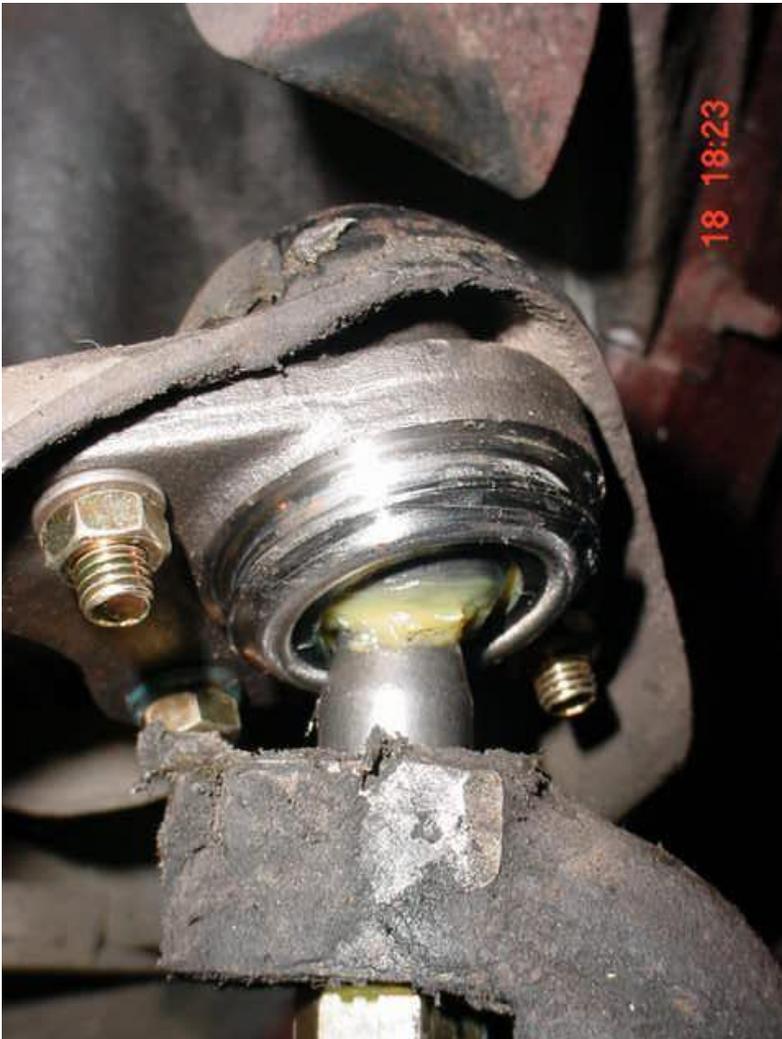
This photo of a 3-bolt 'WJ Automotive' balljoint shows the balljoint having reached its limit of angular movement with about 25mm of suspension travel still remaining before the bump-stop would be reached.

When the balljoint 'binds' like this but is forced to travel further, very high loadings occur. The following photo shows the result, as the edge of the balljoint housing causes damage to the shaft while trying to break it.

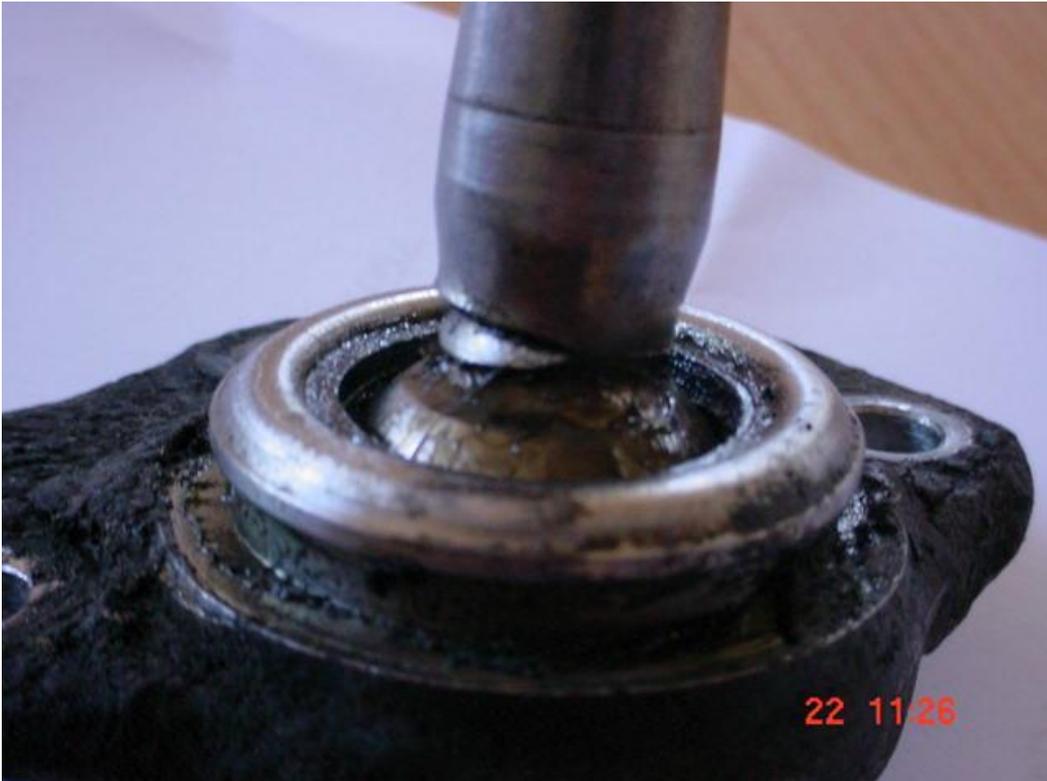
The deep groove in the 'Camelot' brand balljoint shaft has been caused by the high loads.

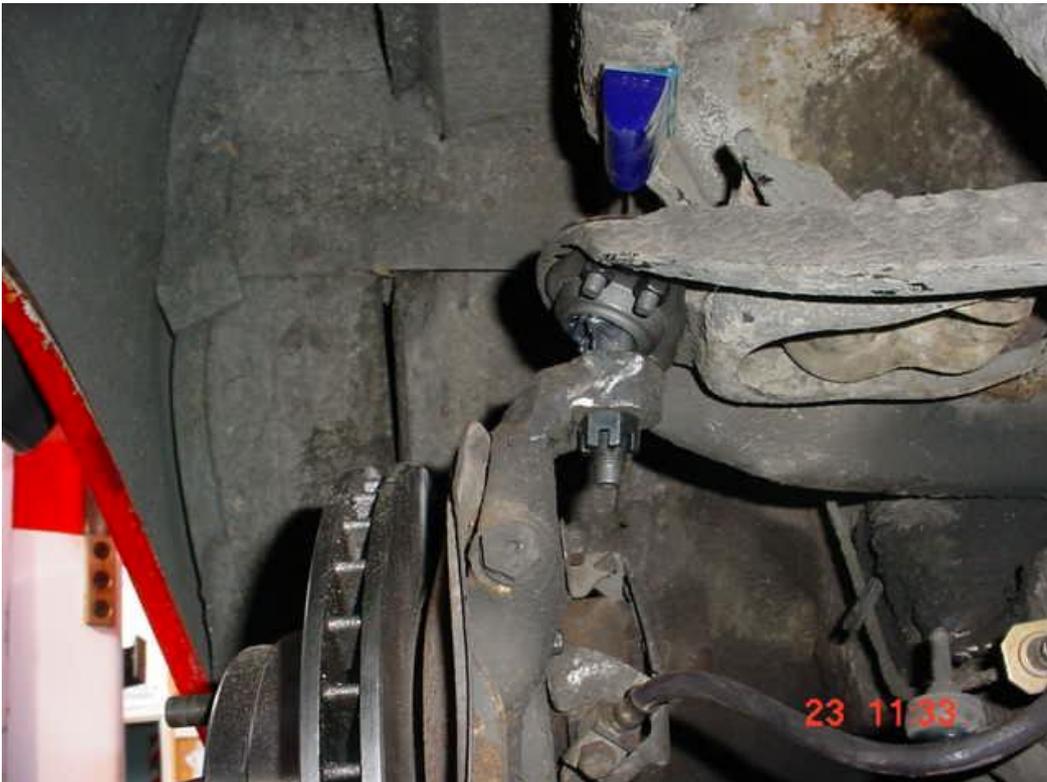
This picture of an XY Falcon with the 4-bolt 'WJ Automotive' balljoint is at the limit of suspension travel due to the balljoint reaching its maximum angular movement. About 25 mm more suspension travel is required to contact the bump-stop.

LVV Certifiers that are certifying Ford Falcons or Fairlanes for any reason need to check the balljoints to identify the brand and condition. The proper means of assessing whether or not the balljoint is safe is by removal of the springs, and moving the suspension throughout its complete range of travel between the rubber bump stops, checking that the bumpstops are reached before the balljoint binds against its housing. Obviously this takes time, and you should alert any potential owner that this situation may exist, and offer them the opportunity to have you carry out the inspection for them, at an additional charge for your time.
