Unsafe Aftermarket Steering Columns

Introduction:

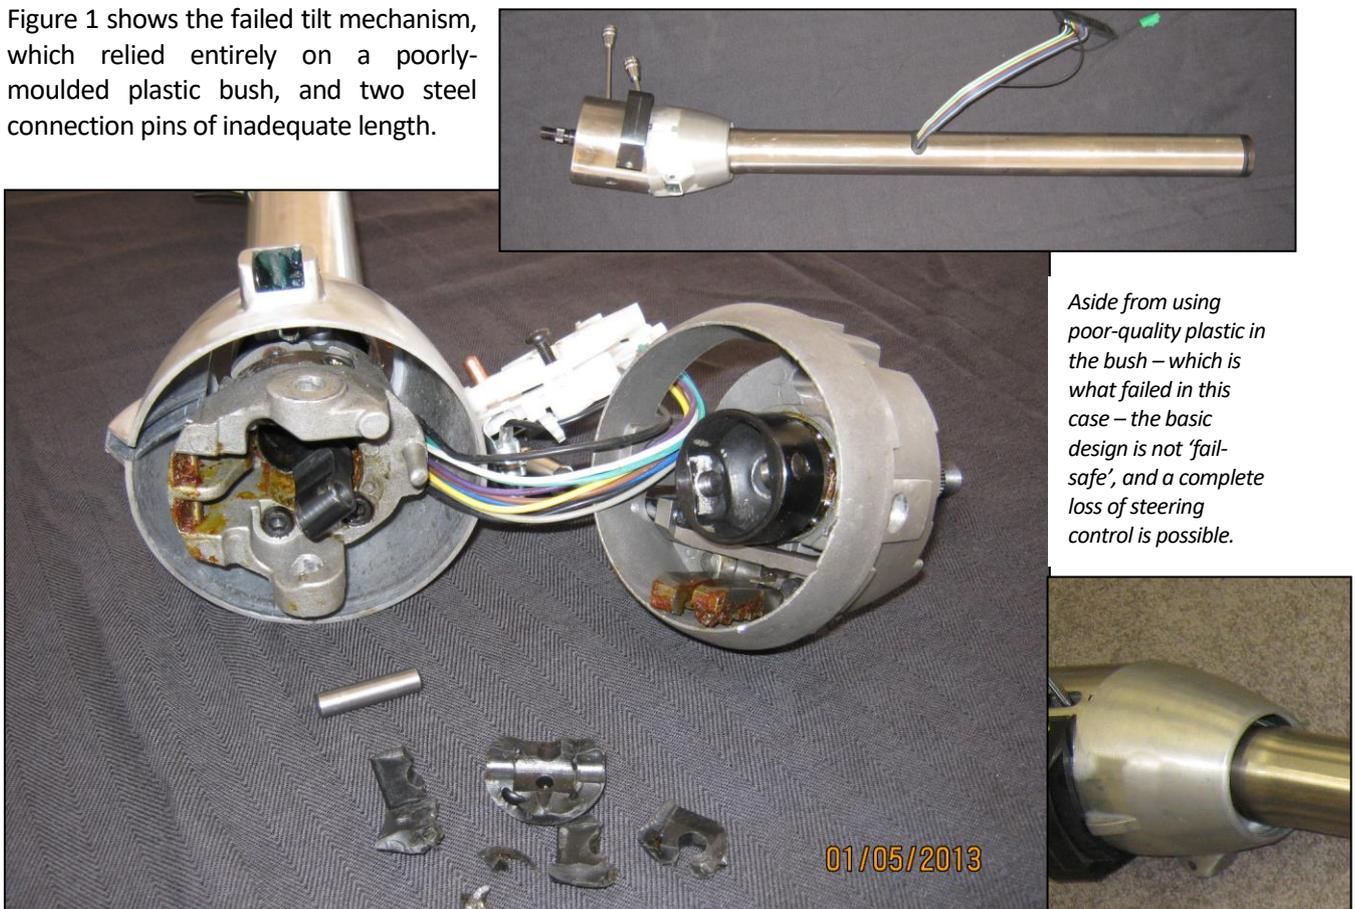
Figure 1: 'Helix' brand column, with collapsed plastic tilt mechanism

Figure 1 shows the failed tilt mechanism, which relied entirely on a poorly-moulded plastic bush, and two steel connection pins of inadequate length.

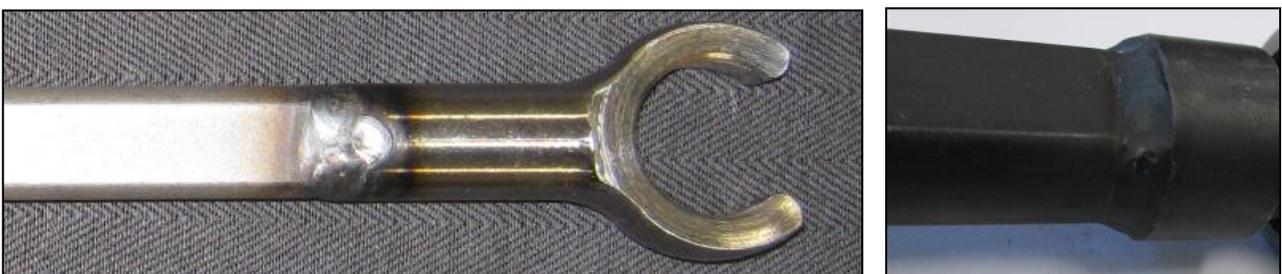
Figure 4: Non-OEM welds within tilt mechanisms in aftermarket steering columns

Any such welds in any aftermarket steering column (other than within one of the three recognised manufacturers' columns which include welding within their manufacturing process) must never be accepted for LVV certification.

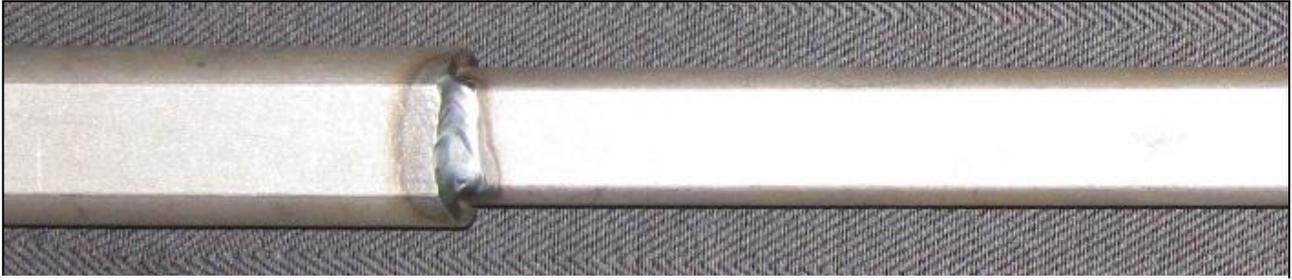
Figure 5: Welding holding two 'double-D' sections together within aftermarket steering column

This welding can be accepted on any column regardless of brand, as the vehicles' directional control does not rely on the weld.

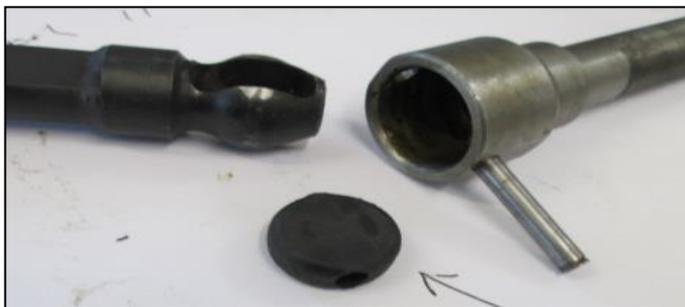
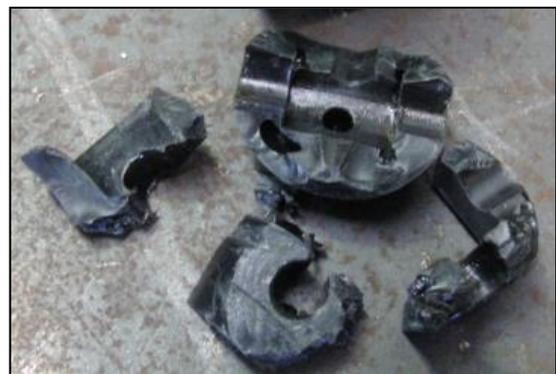
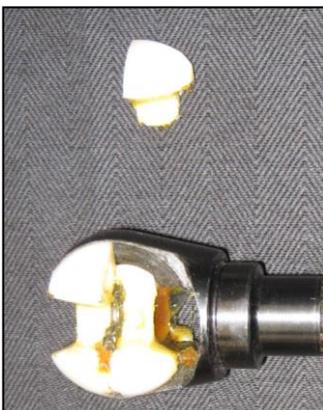
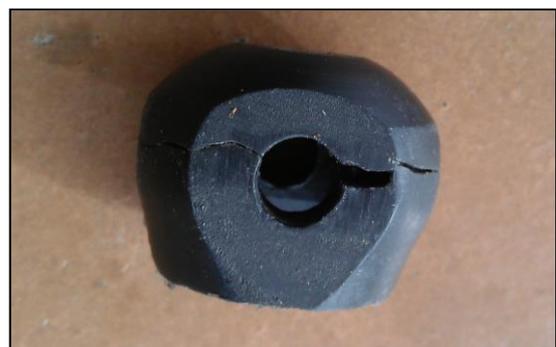
Figure 6: Various failed or excessively loose plastic bushes & balls within brand new aftermarket steering columns

Figure 6 shows some examples of plastic components that have broken, or have free-play when still brand new.

Above: Plastic swivel-joint bush with excessive play in brand new column.
Above right: Failed plastic bush & pin system in brand new column.
Right: Poorly-made injection-moulded plastic bush in brand new column.
Left: Low-grade plastic tilt ball that fell apart during disassembly of tilt mechanism in brand new aftermarket GM-style column.

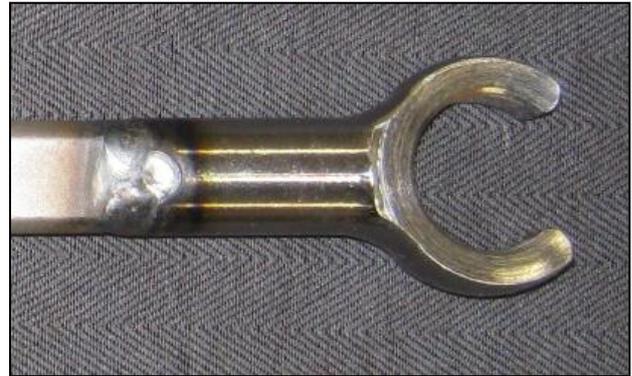
Figure 17: Welded 'CPP' yoke-to-shaft connection

The 'CPP' brand column incorporates a welded connection to join the lower yoke of the tilt mechanism to the main steering column shaft. Figure 17 shows a typical welded section from a 'CPP' brand tilt steering column, with a poor-quality weld. On other 'CPP' columns that LVVTA has inspected, this weld appears to simply butt-weld the two sections together (without the plug-weld that appears to exist in the example shown in Figure 16).

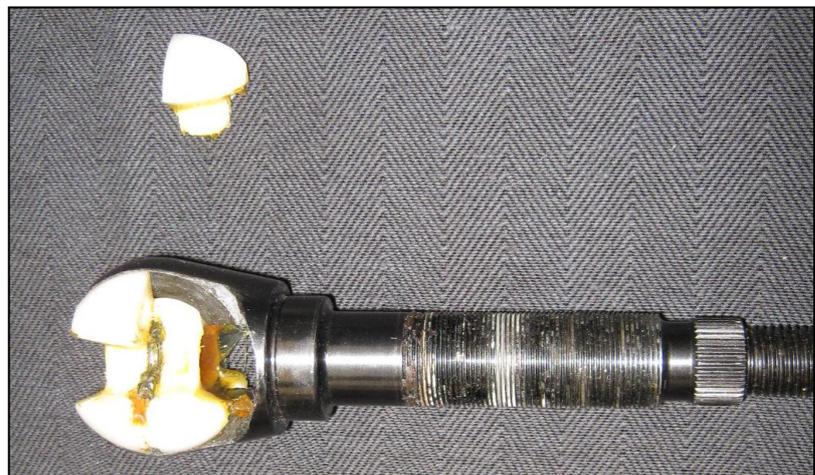
Figure 18: Plastic ball in unused 'CPP' column as found during disassembly

The tilt ball shown in Figure 18 with the corner piece broken away (shown as a separate piece at the top of photograph) was fractured in brand new unused condition, and fell apart during the disassembly process. No force was used to dismantle the mechanism.

Column is to be rejected by LVV Certifier as unsafe. Upon vehicle owner's request, column may be disassembled and assessed by LVV Certifier for the purpose of visual comparison to that shown above. If verified as that shown above, column must be rejected. If internal components and systems fundamentally differ to that shown above, LVV Certifier should contact LVVTA technical staff for advice.

No approved repair process exists for this brand of steering column on a one-off basis.

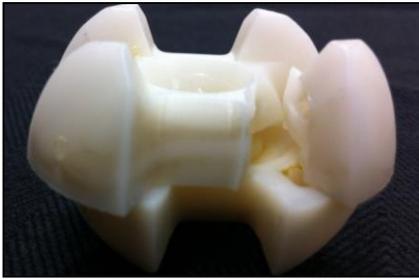
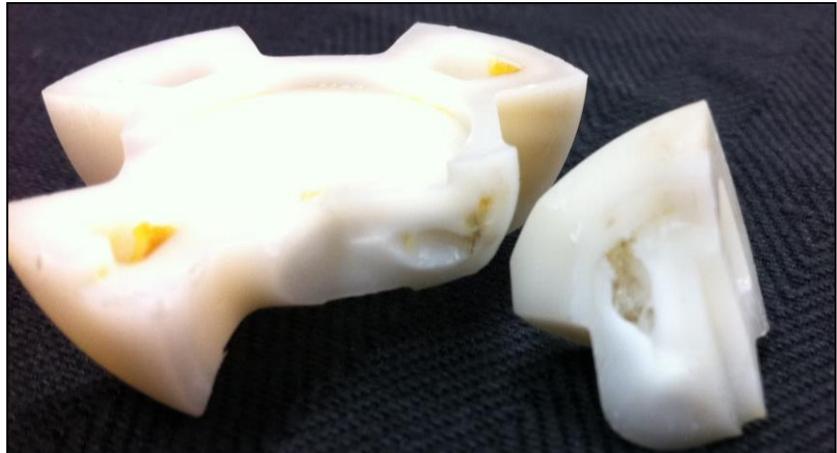
A further problem with the plastic tilt ball is that it has been manufactured via a very poor injection-moulding process that has left the tilt ball riddled with cavities and air pockets, as shown in Figure 19, which will assist in the collapse of the low-grade plastic ball under load. There is little likelihood that this tilt mechanism will be sufficiently strong and durable to withstand the high torque loads that will be imposed on it throughout its life, particularly in a vehicle without power steering.

When in position the ball looks normal, but where the ball has collapsed, cavities caused by a very poor moulding process which have massively weakened this critical plastic component are evident.

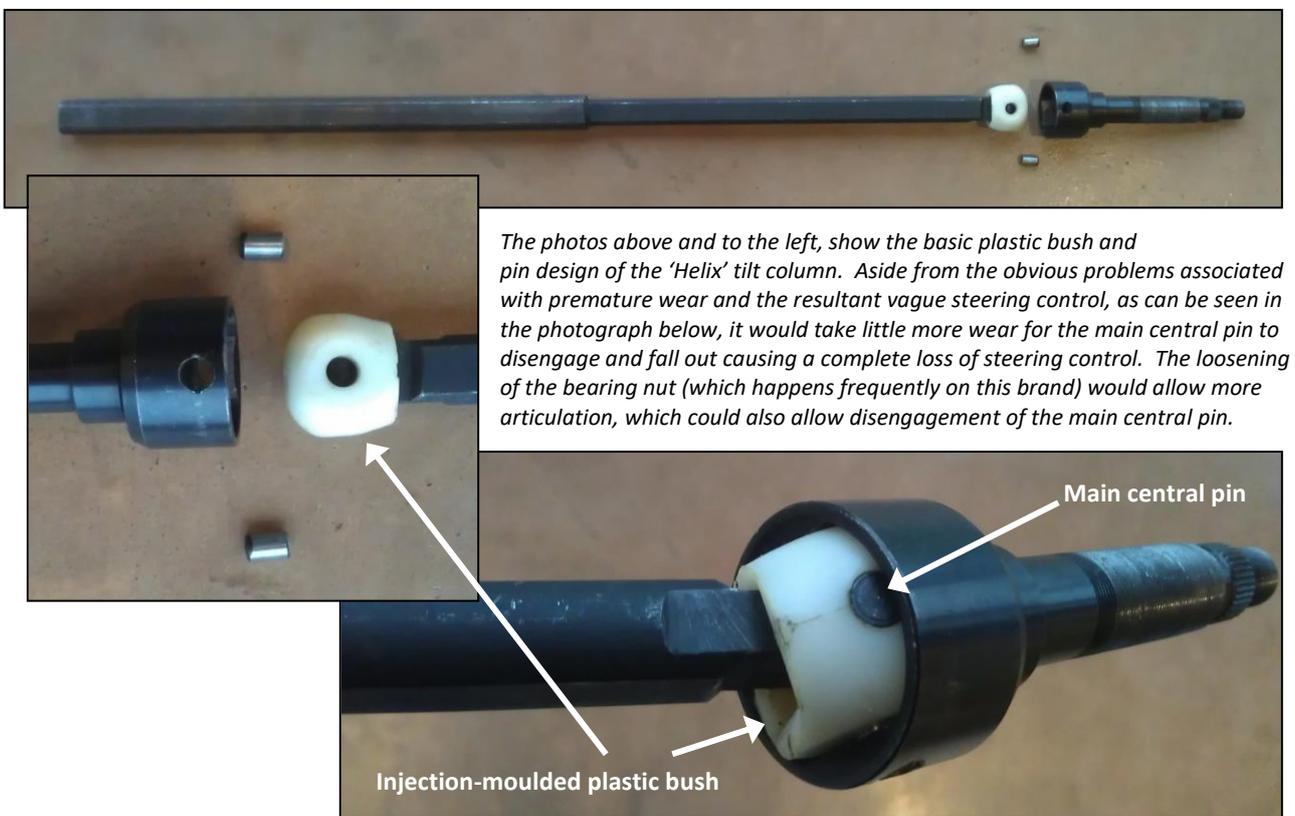
Figure 22: Plastic bush and pin design of the 'Helix' brand steering column tilt mechanism assembly

The group of photographs shown in Figure 22 below illustrate the plastic bush and pin system used in the 'Helix' brand as sold by the Hoffman Group. The 'Helix' system is a very rudimentary system, which is not 'fail-safe'. Due to the design of the tilt mechanism system and the poor quality of the components used, the 'Helix' system is considered by LVVTA to be of very poor design and quality, and the most dangerous system seen to date.

The tilt mechanism of the Chinese-made 'Helix' column shown in Figure 22 had so much play (without ever having been fitted to a vehicle) that it would have failed a warrant of fitness inspection.

Column is to be rejected by LVV Certifier as unsafe. Upon vehicle owner's request, column may be disassembled and assessed by LVV Certifier for the purpose of visual comparison to that shown above. If verified as that shown above, column must be rejected. If internal components and systems fundamentally differ to that shown above, LVV Certifier should contact LVVTA technical staff for advice.

No approved repair process exists for this brand of steering column on a one-off basis*.

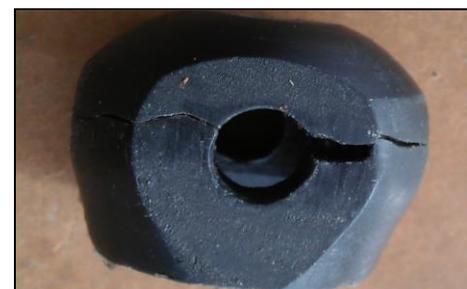
Figure 23: Poor-quality moulded bush with cavities & cracks

A further problem with this system, is that, aside from the overall poor design, one plastic bush (as shown in Figure 23) from this type of column that LVVTA inspected is so poorly moulded that – in brand new unused condition – was so full of casting flaws and cavities that it is likely to collapse with very little use. The column in which this bush was fitted, was reportedly sold as a 'Helix' brand but may in fact be of a different brand; - this identification problem is symptomatic of brand-copying and a lack of visual identifiers.

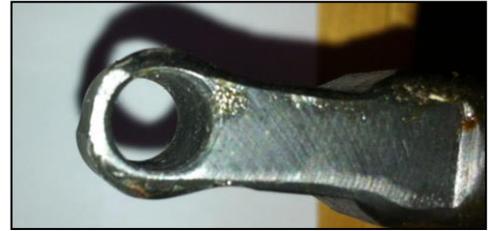
Figure 24: 'Helix' plastic bush pin-eye

The top end of the lower steering shaft is made from solid D-shape bar, which has been machined to create a pin-eye for the plastic bush to swivel from, as shown in Figure 24. Poor machining tolerances of that pin-eye lead to an inconsistent shape around the pin-eye opening, which in turn leads to a lack of uniformity and wall thickness in some areas of the pin-eye area. It is unlikely that sufficient quality control processes exist in order to ensure that the machining process involved is consistent and repeatable.

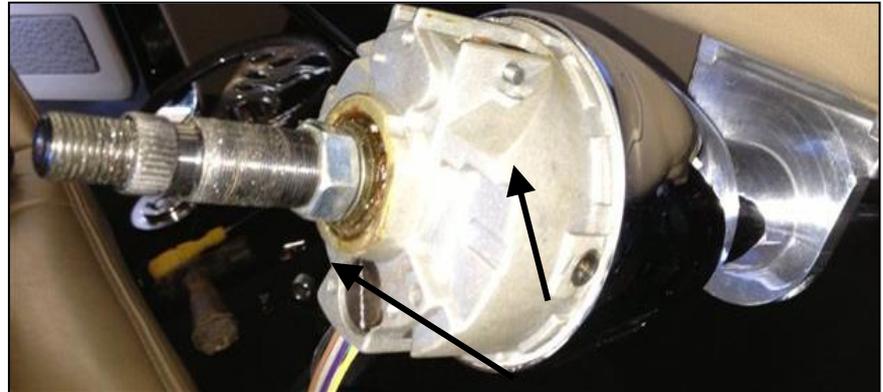
Figure 25: Main retaining nut with no locking system in 'Helix' column

Some 'Helix' columns have, from brand new, a huge amount of free-play, both up and down, and side-to-side. The reason for the play is that the main nut used to retain the upper steering shaft into the upper bearing housing (see Figure 25) had completely loosened itself off. This occurs because there is no locking mechanism to prevent it from undoing, which is poor design, and process control.

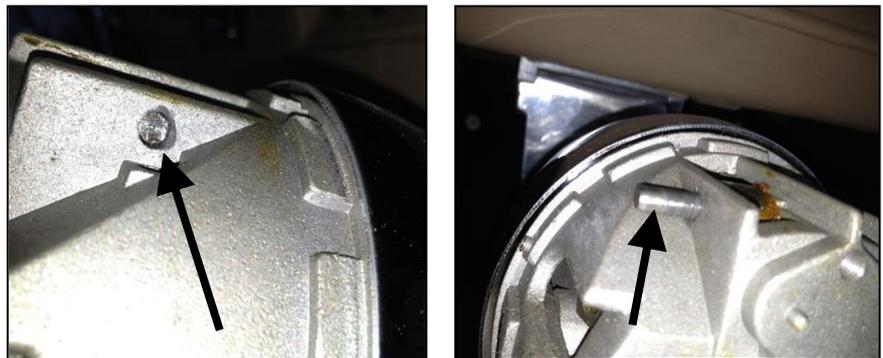
Figure 26: Tilt mechanism pivot lock pin falling out of 'Helix' upper housing

Additionally, the removal of the steering wheel and upper steering column components to enable the inspection for the play at the upper housing also showed that the tilt mechanism pivot lock pin (see arrows in Figure 26) for the tilt mechanism had almost completely fallen out. Again, there was no locking mechanism to prevent it from doing so.

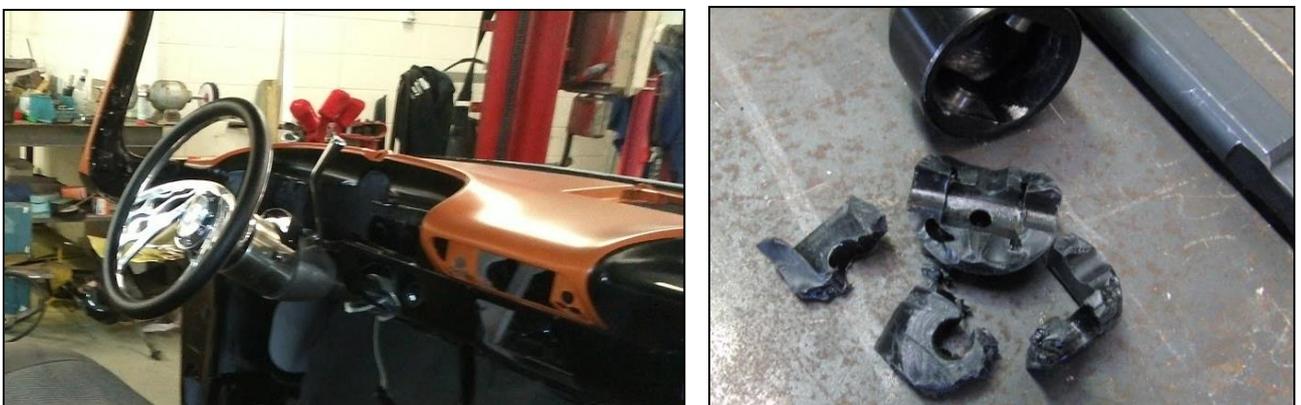
Figure 27: 'Helix' column in vehicle at left; collapsed remains of the plastic bush which caused steering failure at right

Underlining how poorly-designed and unsafe the 'Helix' steering column is, one such column completely failed leaving the driver totally without any directional control of his vehicle. The principal failure was the poor-quality plastic bush described previously, however, the fact that the basic system is not 'fail-safe' turned a tilt mechanism component failure into a complete steering system failure. See Figure 27.

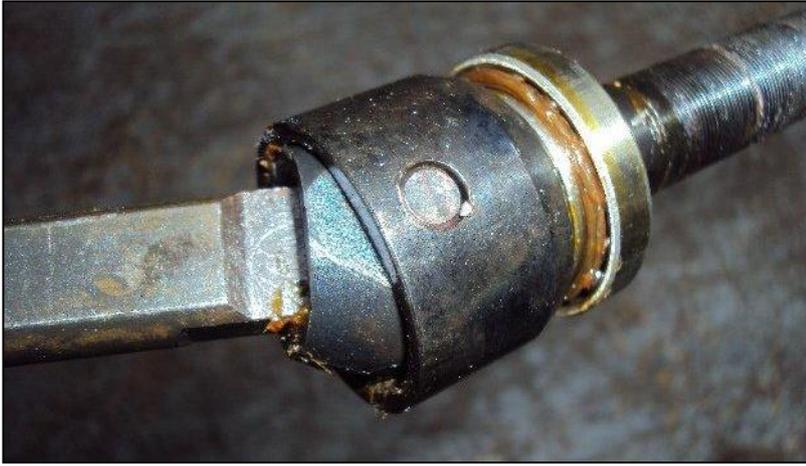
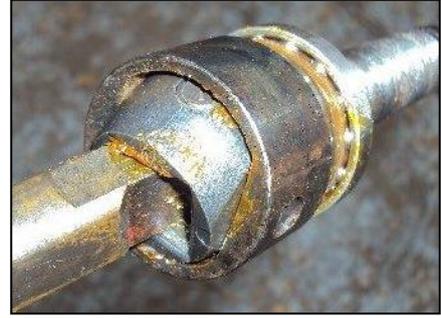
Figure 29: Tilt mechanism with plastic bush & pin system in 'Procomp' brand steering column

The photographs shown in Figure 29 below illustrate the same plastic bush and pin system as used in the 'Helix' brand, which failed and caused a complete loss of steering control. The 'Procomp' system is, like the 'Helix' column, a very rudimentary system, which is not 'fail-safe'. Due to the design of the tilt mechanism system and the poor quality of the components used, in particular the injection-moulded plastic bush (upon which the entire directional control of the vehicle relies), the 'Procomp' system is considered by LVVTA to be of extremely poor design and quality, and may be just as dangerous as the 'Helix' brand steering columns.

Below: as with the 'Helix' column, it would take very little wear for the main central pin to disengage and fall out causing a complete loss of steering control.

Particularly because of the plastic bush and pin system within the tilt mechanism, there is nothing that LVVTA is aware of to prevent a 'Procomp' brand column having the same complete and catastrophic failure as experienced by the owner of the 'Helix' brand column depicted earlier in this Information Sheet.

Column is to be rejected by LVV Certifier as unsafe. Upon vehicle owner's request, column may be disassembled and assessed by LVV Certifier for the purpose of visual comparison to that shown above. If verified as that shown above, column must be rejected. If internal components and systems fundamentally differ to that shown above, LVV Certifier should contact LVVTA technical staff for advice.

No approved repair process exists for this brand of steering column on a one-off basis*.

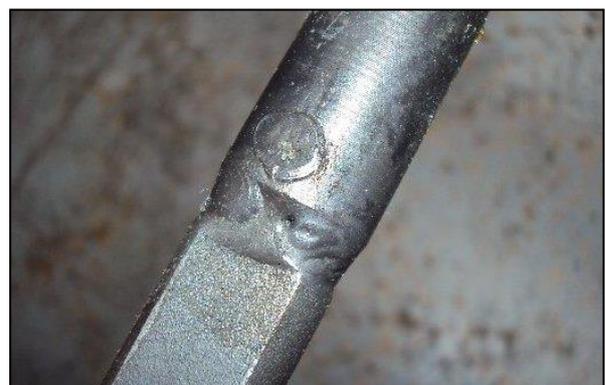
Figure 32: Welded connection in 'RPC' steering shaft

As can be seen in Figure 31 above, the 'RPC' brand column incorporates a welded connection to join the lower yoke of the tilt mechanism to the lower steering column shaft. Figure 32 shows a close-up image of the welded section from an 'RPC' brand tilt steering column, with an obvious defect visible within the photograph of the poor-quality weld. Despite the presence of a plug-weld, LVVTA cannot have any confidence in the quality controls of the welding, or the suitability in either the parent or filler materials used in the manufacturing and welding processes, particularly given that the entire directional control of the vehicle relies upon this weld.

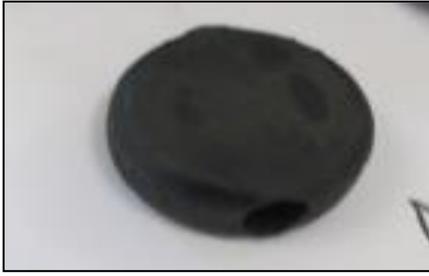
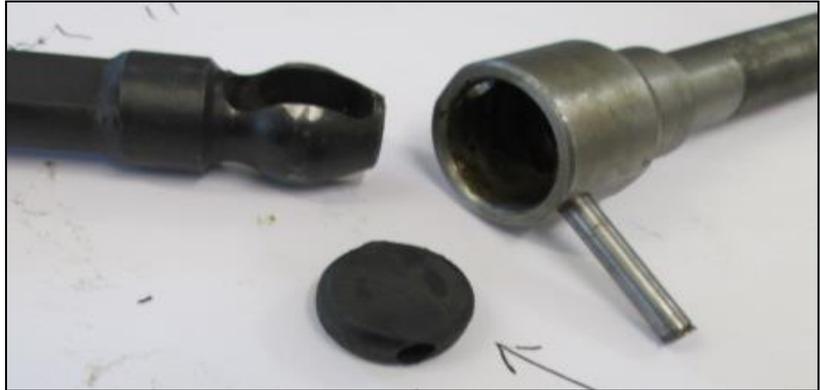
Figure 34: Poor-quality injection-moulded plastic tilt-disc on 'Wysco' column

'Wysco' brand steering columns use a swivel joint system (as shown in Figure 34) which appears to be a poorly-designed copy of the 'Flaming River' system, but instead of using a brass tilt-disc to allow rotation between the two shaft sections, it incorporates a poor-quality plastic bush which, in brand new unused condition, during LVVTA's inspection of one such unit, had so much play that it would have failed a warrant of fitness inspection.

Although difficult to tell in the photos, the plastic bush was full of cavities as a result of a poor injection-moulding process.

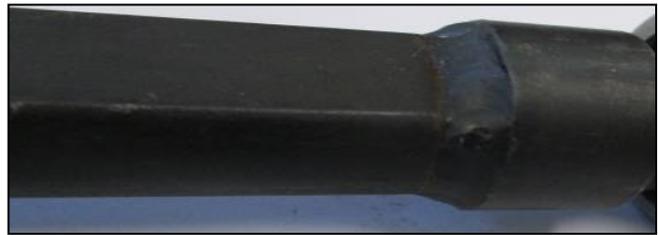
Figure 35: Welded shaft connection on 'Wysco' column

The 'Wysco' brand aftermarket steering column incorporates a welded connection of unknown and unverified quality to join the tilt-ball housing of the tilt mechanism to the main lower steering column shaft. Figure 35 shows a welded connection, joining the swivel-joint housing to the lower shaft within a 'Wysco' brand tilt steering column – upon which the entire directional control of the vehicle relies.

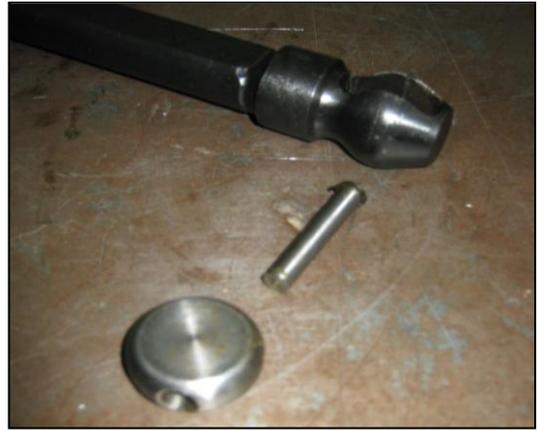
Figure 36: 'Unknown brand A' swivel-joint

As shown in Figure 36, unlike the 'Wysco' brand steering column which featured an injection-moulded plastic tilt-ball, the tilt-ball within the 'Unknown brand A' swivel joint housing is made from steel. While this will have the required strength properties, there will, over time be binding and wearing problems that result from the steel tilt-ball's inability to self-lubricate.

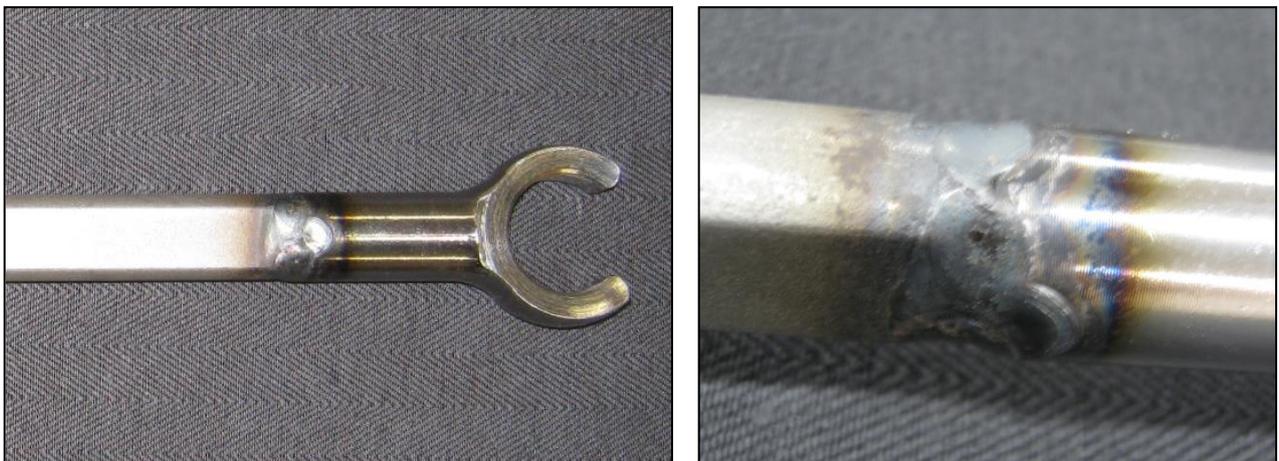
The New Zealand purchaser, when buying this column from the website-based company, was assured the column was made in America, but upon arrival, the steering column was in a plain white box with no branding, and the column was wrapped up in Chinese newspapers.

Figure 37: 'Unknown brand B' with GM-style 'double yoke' tilt mechanism, and poor-quality welded connection

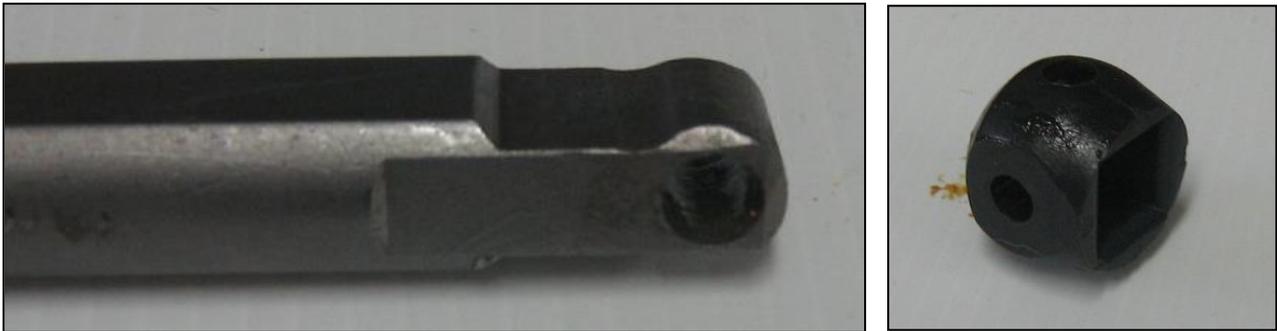
The whole steering system of the vehicle is reliant on the thickness of the material from which the bush pin-eye is formed at the top end of the lower steering shaft, as shown in Figure 38. Poor machining tolerances of that pin-eye can lead to an inconsistent shape around the pin-eye opening, which in turn leads to a lack of uniformity and wall thickness in some areas of the pin-eye area. It is unlikely that sufficient quality control processes exist in order to ensure that the machining process involved is consistent and repeatable.

Figure 38: 'Unknown brand C' with unsafe plastic bush and pin system, & inconsistent forming of bush pin-eye
