Total Cost Involved (TCI) Independent Front Suspension System Failure

The purpose of this LVVTA Information Sheet is to advise LVV certifiers and potentially-affected vehicle owners, suppliers, and distributors of a safety risk associated with a range of Total Cost Involved (TCI) independent front suspension (IFS) systems.

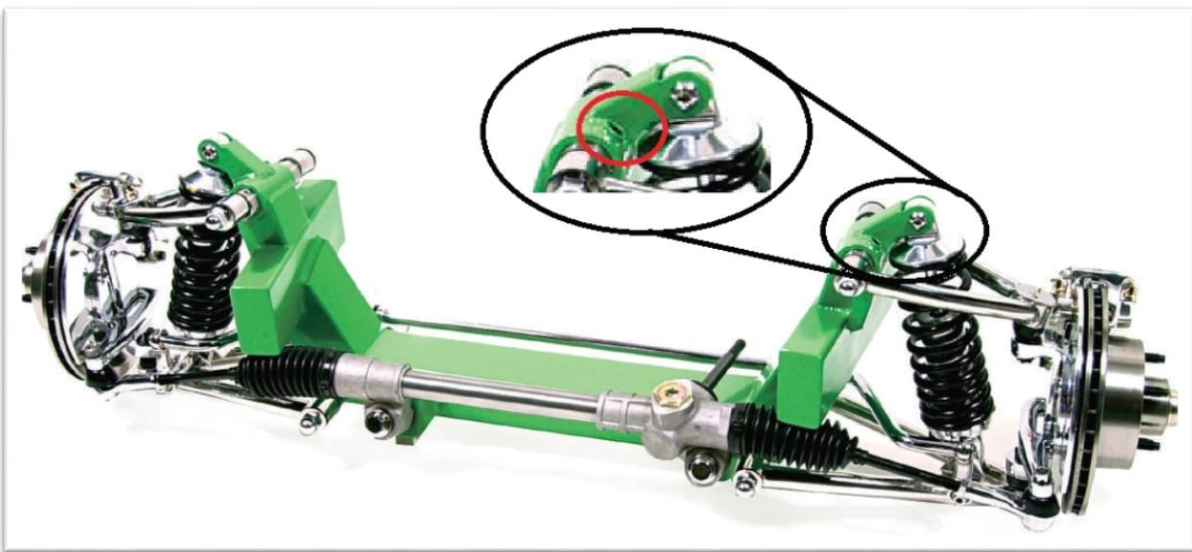
During 2017 there was a catastrophic failure of a welded upper coil-over shock absorber mount on a newly installed and LVV certified TCI IFS. That failure directly resulted in a serious motor vehicle accident due to the complete collapse of one side of the front suspension, and the integral bump-stop which also became disconnected as a result of the failure. Fortunately, no-one was injured.

TCI make several styles of IFS. The design which is affected is the coil-over IFS which has an upper coil-over mount welded to the upper a-arm pivot tube, as shown — along with the area of failure — below. A similar design is offered by TCI for a variety of IFS systems which utilise coil-over shocks.

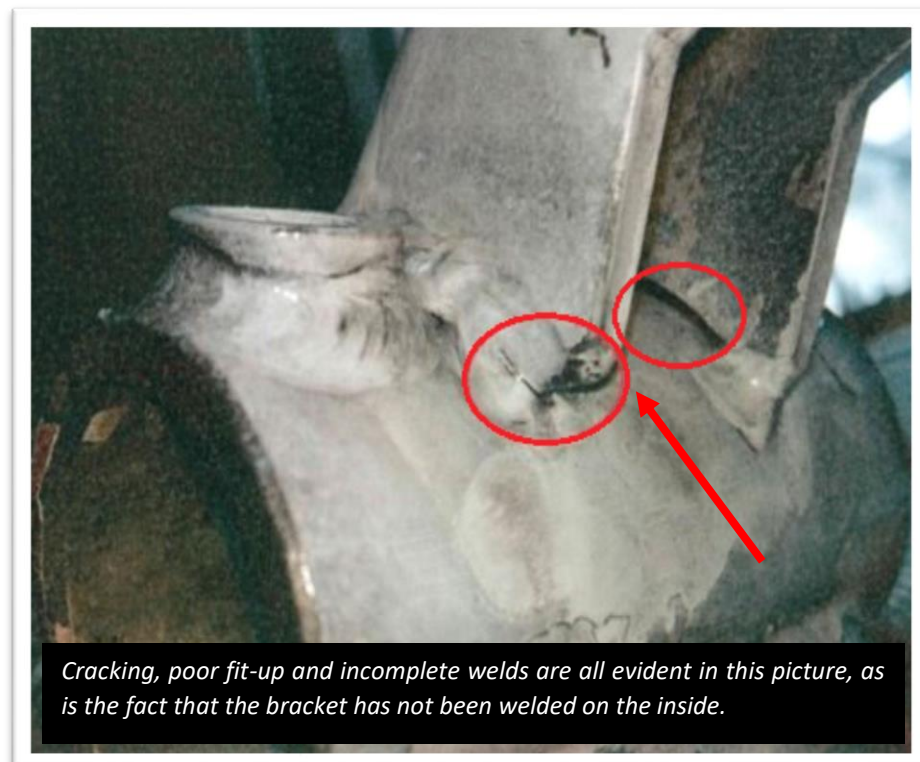
Fit-up:

The coil-over mounting bracket was poorly fitted-up to the tube prior to welding, which left a gap of up to 3 mm between the underside of the bracket and the tube to which it is welded.

This resulted in a lack of fusion, and in the weld essentially becoming a 'bridge' between the two parts, which provided inadequate strength.

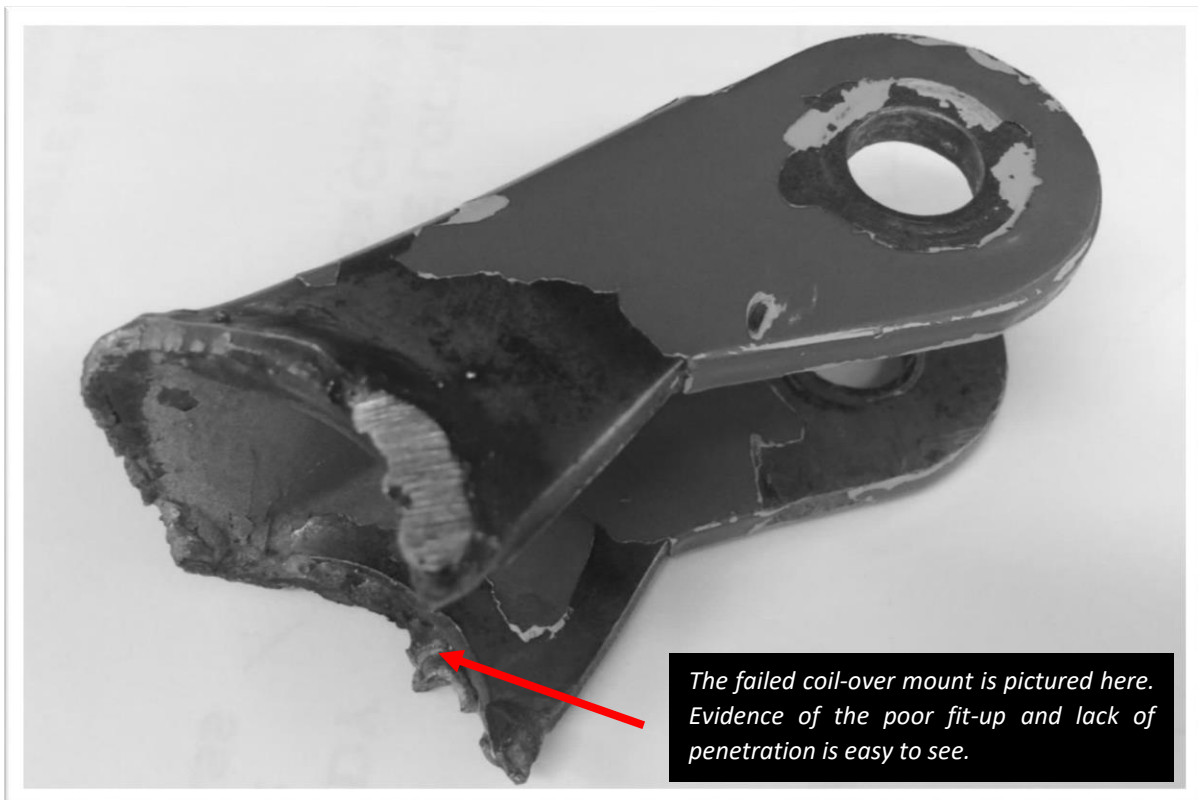
Bracket design:

TAC members are of the opinion that with only (approximately) 90 mm of weld area in total, the design of the coil-over mounting bracket does not allow sufficient weld area to provide an adequate safety factor. Additionally, the highest loads are applied to the very end of the weld, at the edge of the bracket. That means the main load-bearing welds (on each side of the bracket) are only around 60 mm in total.

To achieve an increase in weld area, the bracket should extend further down the outside of the 'beam', which has the added advantage of adding material and weld area in tension; — the direction of highest loading. There are numerous other ways that weld area can also be achieved whilst maintaining aesthetic appearances. TAC members have recommended to TCI that the bracket is redesigned to provide an increased safety factor.

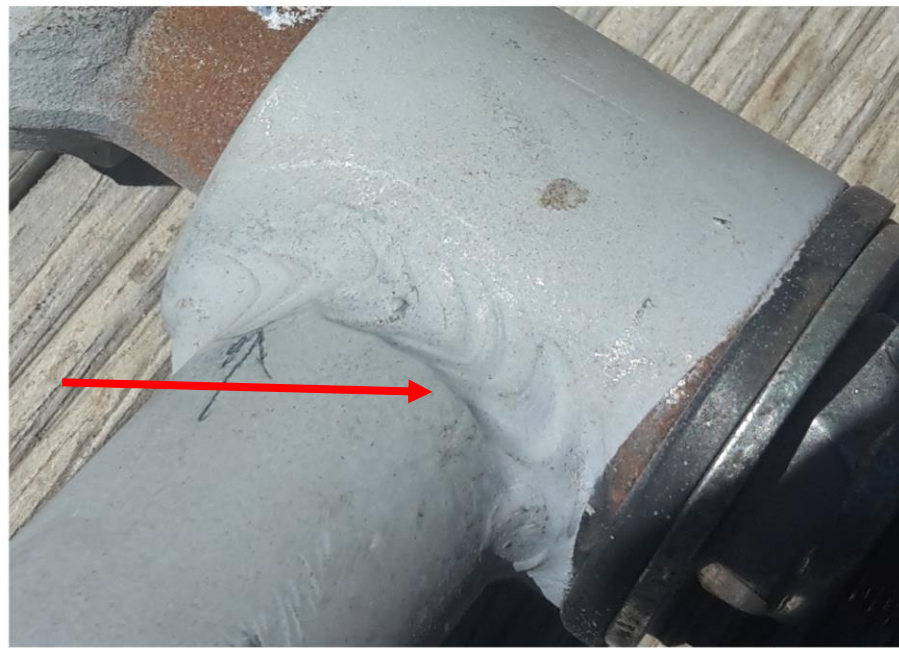
A weld defect called 'undercut' is visible in this picture. Undercut can result in a significant reduction in weld strength, and also reduction in the material cross-sectional area of the parent metal. This is usually a result of poor fit-up of sections, excessive gaps, and lack of sufficient filler metal in the weld. These issues combine to indicate poor

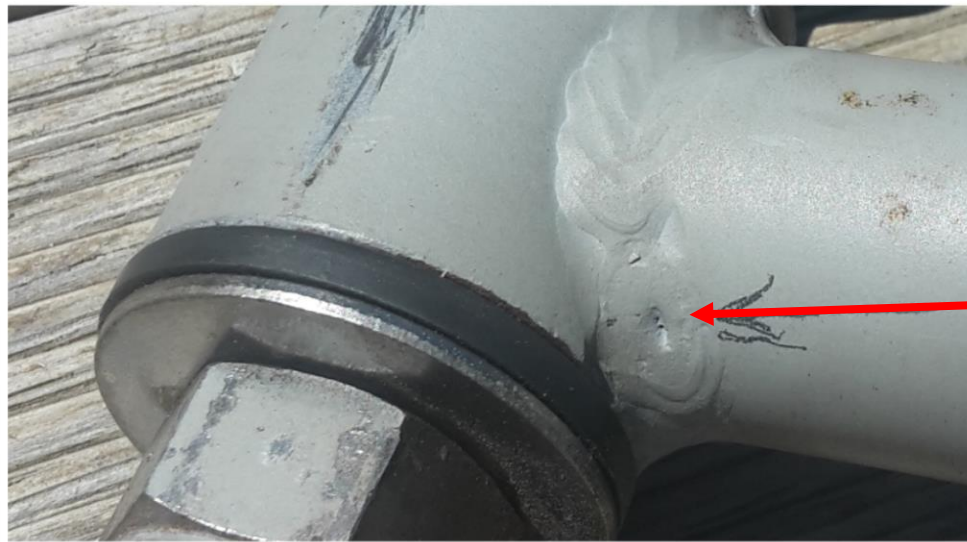
An undesirable 'crater' can be clearly seen in this photograph. Such an imperfection can cause weakness in the weld, and is caused by poor operator techniques in the start/stop regions of

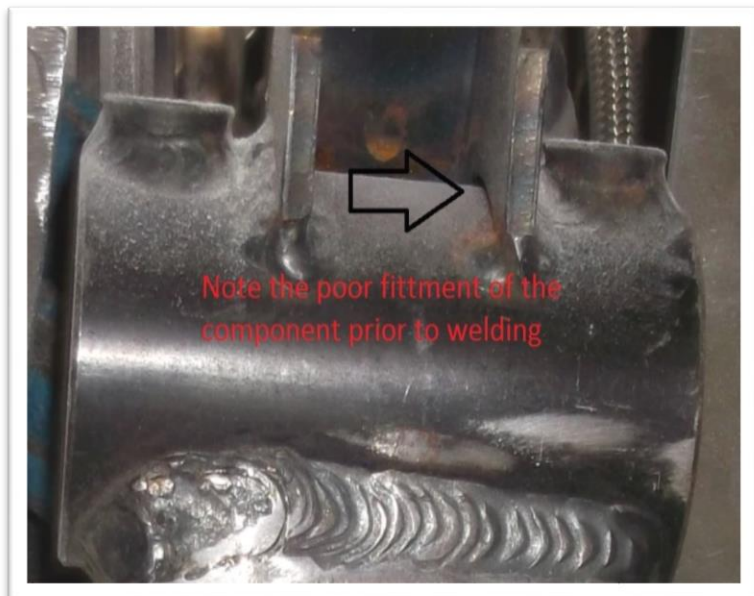
2. Fit-up Inspection:

The area inside the coil-over mount must be carefully inspected for any signs of a poor fit-up* between the bracket and the pivot-tube it is welded to. If any evidence of poor fit-up is evident, the vehicle owner should be advised in writing, on an F004 - LVVTA Rectification Sheet, with a copy retained by the LVV certifier.

* Poor fit-up in this context is defined as any gap which exists between the two welded sections. When inspecting a vehicle, an LVV Certifier must look for is how well the shock absorber mounting bracket attaches. While the front suspension assembly in most of these vehicles are likely painted, an LVV Certifier should still be able to get an indication of the quality of the fit up of components.

If any poor fit-up between the upper coil-over and the upper A-arm pivot tube is identified, refer to paragraph # 4. The vehicle owner must be advised that rectification work is required, and they should not operate the vehicle until such time as the rectifications have taken place.

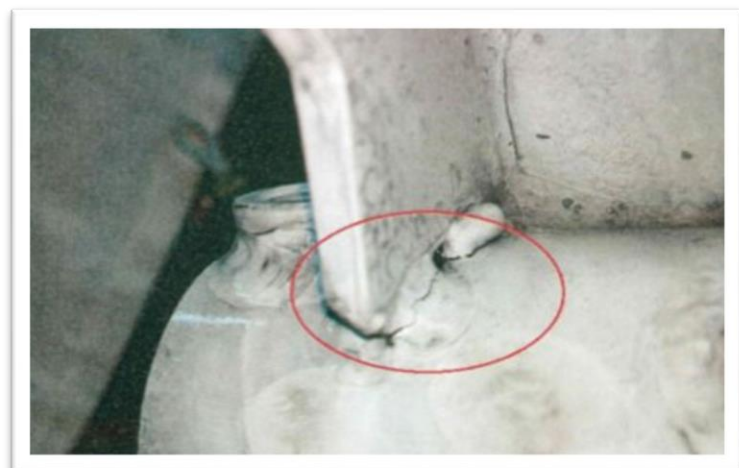
3. Welding Inspection:

If *any* visible cracking or other significant weld defects are evident, the vehicle owner must be advised that rectification work is required, and they should not continue to operate the vehicle until such time as the rectifications have taken place.
