'Magnum'-brand I-beam Axle Safety Warning

The purpose of this LVVTA Information Sheet is to advise LVV Certifiers, and potentially-affected vehicle owners, suppliers, and distributors of a significant potential safety risk associated with 'Magnum'-brand dropped I-beam axles. This is an interim notification only, published in urgency to provide awareness of the current situation to the hobby and the industry.

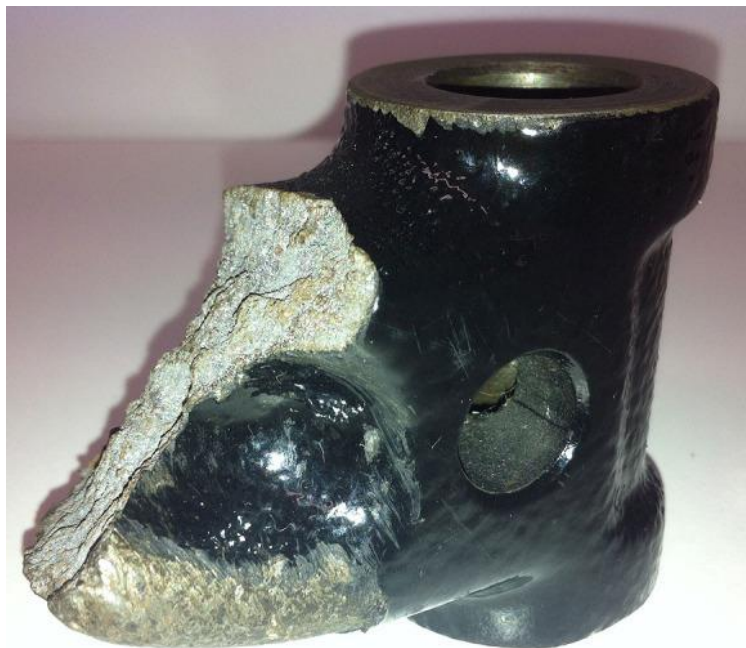
LVVTA has recently been made aware of two instances of catastrophic failures of Magnum brand cast I-beam axles, one in Australia, and one in New Zealand. Other failures have also been reported in the USA. In both of the failures that LVVTA has become aware of, the failure has taken the form of a complete and sudden breakage which has caused a total loss of steering and braking control to the vehicle, due to the collapse of one side of the axle beam.

The investigation has shown thus far that a major manufacturing problem exists within the casting process used in the production of the batch of Magnum-brand axles that included the (New Zealand) failed axle. The full technical findings of this investigation, including details of the molecular structure of the material, and the reasons for its failure, will be provided in detail within a further LVVTA Information Sheet, which will be published in due course.

Where any doubt or question exists, LVVTA strongly recommends that owners of vehicles fitted with an axle which may be one of the affected axles, immediately cease using the vehicle until such time as the axle can be inspected and verified as safe.
