Modified Kia Carnival LWB Safety Inspection Request

Purpose of this LVVTA Information Sheet:

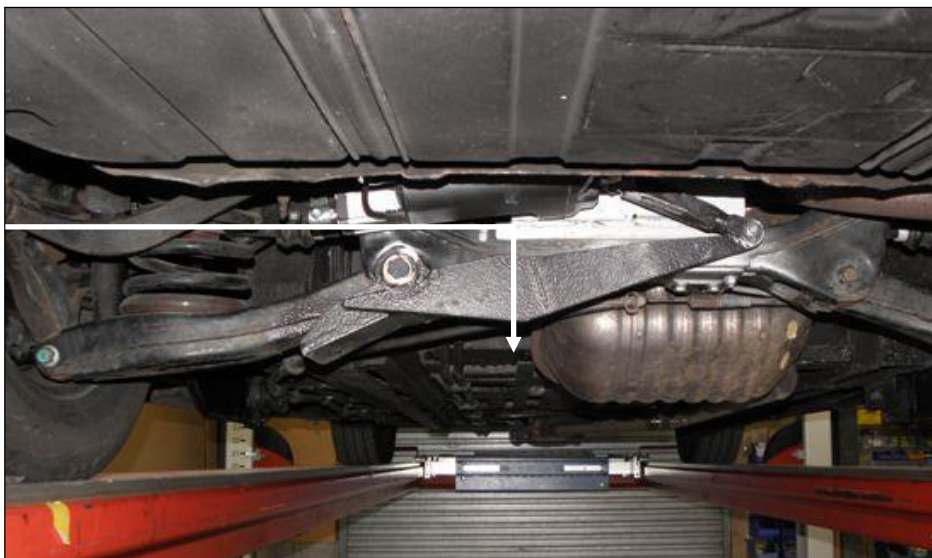
The left rear corner of the vehicle is lowered to aid wheelchair access by an electro-mechanically-actuated lever arm (see photo at right) which compresses the left rear coil spring. Approximately 50 of these vehicles have been imported into New Zealand by the ACC for their clients, who are highly-dependent on these vehicles for their continued mobility and independence.

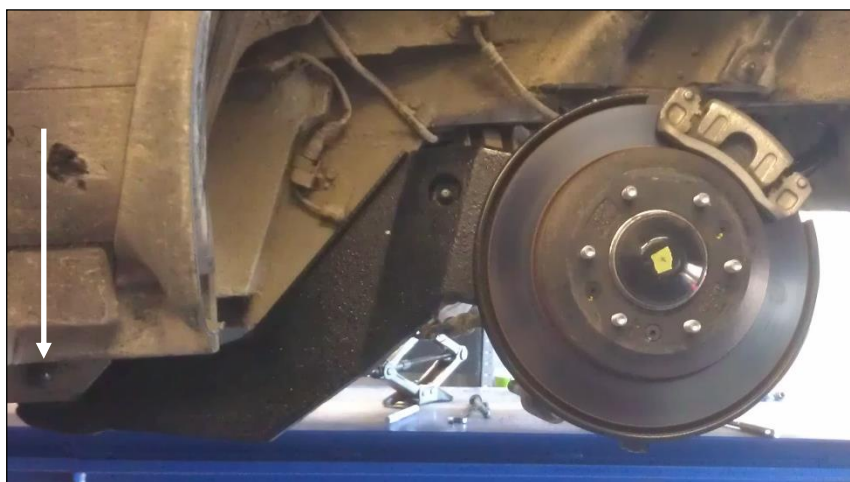
Fractured rear lower trailing arms:

Fracturing of the rear lower trailing arms have been discovered on four vehicles, which LVVTA believes is caused by incorrect suspension geometry and poor workmanship involved in the trailing arm modification process. The problems with the rear lower trailing arm is a result of the lower positioning of the forward pick-up points of the lower trailing arms, and shorter arm length, carried out in order to make room for the lowered floor.

As a result of the shortened and repositioned trailing arms, the suspension travel arc no longer pivots about the axle centerline, causing a geometry disturbance which has manifested itself in a number of ways as the suspension goes through its range of travel; including decreasing the wheelbase much further than it should (particularly as the suspension goes into compression), incorrect suspension upright angle (or king-pin inclination), and a misalignment between the top and bottom spring seats.

Elongation of the pivots in the original Kia cradle that the control arms attach to have been noticed on some vehicles, and although initially thought to have been caused by the ram pressure (1 ½ tons) exerted by the lever arm applied at the control arm pivot, LVVTA now believes that the pivots were deliberately slotted as part of the assembly process, found to be necessary at the European modification factory because of the misalignment caused by the incorrect trailing arm geometry.

New one-piece trailing arms have been designed which will move the original Kia Carnival suspension geometry much closer to its correct OE specifications, and the entire 'kneeling' system will be discarded, and replaced by a locally-designed chain and sprocket system that does not apply any increased mechanical disadvantage or loading to any part of the vehicle's suspension system.

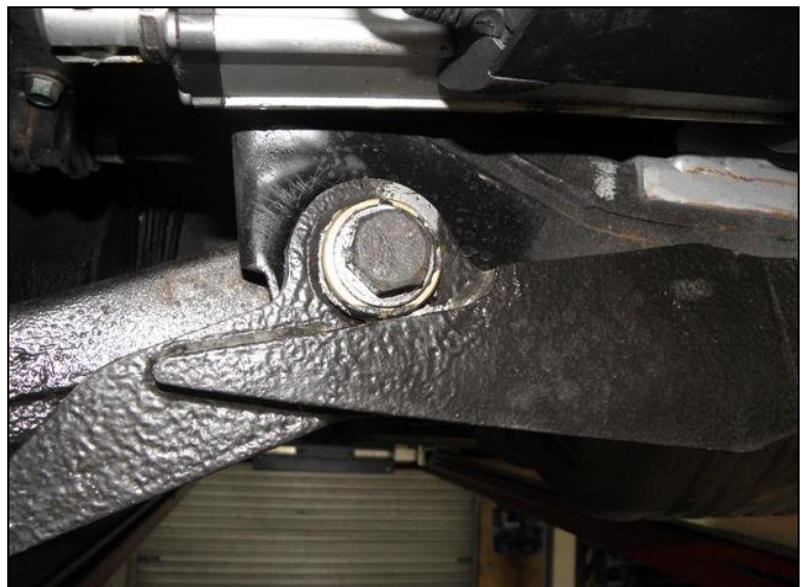
Fractured lever arm:

Fracturing has also been found around the pivot boss area of the electro-mechanically-actuated lever arm used to lower the rear left corner of the vehicle (to assist disabled occupant entry and exit by reducing the wheelchair ramp angle) on four vehicles.

The overseas modification process incorporates a lever arm system that compresses the left-side rear spring.

LVVTA believes that the fracturing of the lever arm is caused by the 3:1 mechanical disadvantage in the system which applies unnecessarily high loads and overloads the lever arm and other components within the Kia's suspension system.

It should be noted that any damage to or failure of this arm will not affect the vehicle's on-road safety, as the lever arm is only in use when the vehicle is stationary.

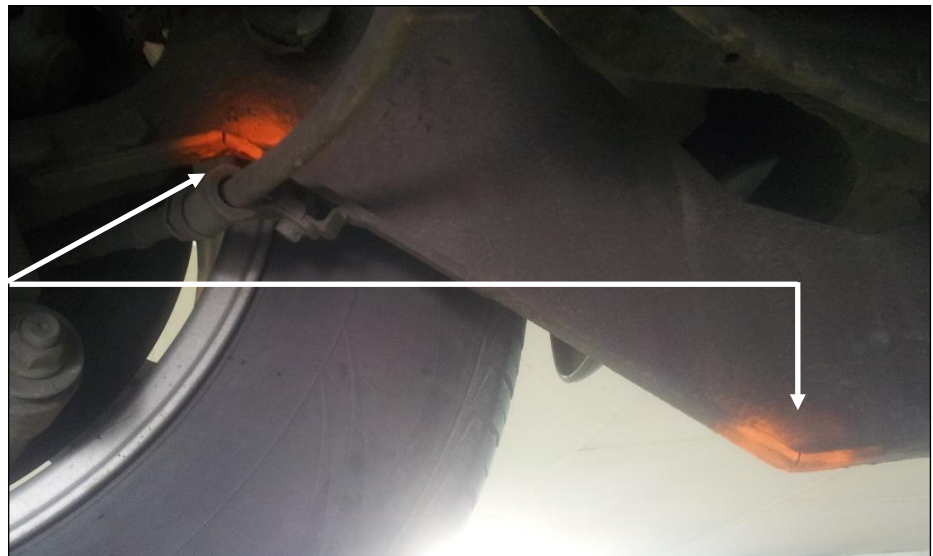
Rear lower trailing arm:

Each rear lower trailing arm (or radius rod) must be thoroughly inspected for cracking or fracturing throughout its length.

Particular attention should be paid to the welded areas where the flange sections have been joined.

See the orange-sprayed areas in the photograph at right for the typical areas where fracturing or cracking may occur.

If cracking is found on the lower trailing arms (or radius rod) where the flange sections have been joined, this may be ground out and re-welded by a specialist welder. The trailing arms are made from normal mild steel so no special or unusual welding processes need to be employed, however suitable welding equipment and methods (MIG or TIG) should be applied.

This is provided however that the cracking does not extend up into the web (vertical face) of the arm – if any cracking or fracturing is found on the trailing arm web, please do not proceed with localised repairs. Refer instead to the technical support point of contact provided below.

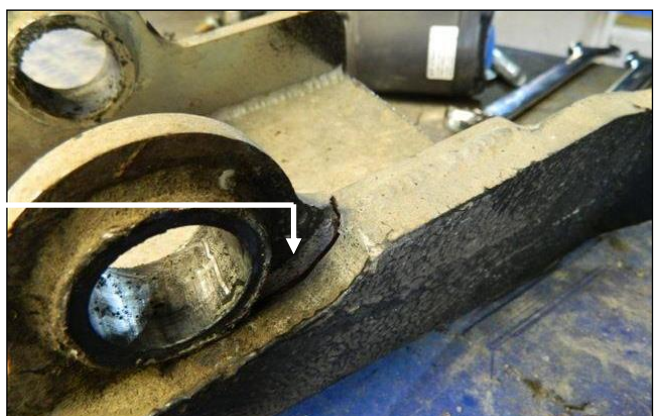
Rear lever arm:

The rear electro-mechanically-actuated lever arm that applies the leverage force to compress the coil spring must be thoroughly inspected for cracking or fracturing. Particular attention should be paid around the lever arm pivot points. From examples viewed, the cracking has occurred where insufficient or poor weld quality is present.

See the area pointed out by the arrow in the photograph at right for the typical areas where fracturing or cracking of the rear lever arm may occur.

If any cracking is found on the electro-mechanically-actuated lever arm, this may be ground out and re-welded by a specialist welder. The lever arm is made from normal mild steel so no special or unusual welding processes need to be employed, however suitable welding equipment and methods (MIG or TIG) should be applied, and particular consideration should be given to the output capabilities of the welding equipment being used, given the thickness of the material being welded.
