## Nissan Mistral Rear Seatbelt Anchorage/Floor Rust Problem and LVV Modification Solution

As a follow on to the LVV Loadbar solution to the Nissan Terrano, Land Transport NZ has asked LVVTA to provide a similar solution under LVV Seatbelt Anchorage Standard 175-00(01) for the rust problem that the Nissan Mistral has. Like the Terrano, the Mistral has been required to have a full rear floor replacement carried out if any rust is evident at WoF or entry inspection. This has been achieved, and an alternative cost effective solution is now available for these vehicles under the Low Volume Vehicle Code. This Information Sheet outlines the problem, the solution and the procedures involved.

## **Nissan Mistral Load-bar Modification & LVV Certification Procedure:**

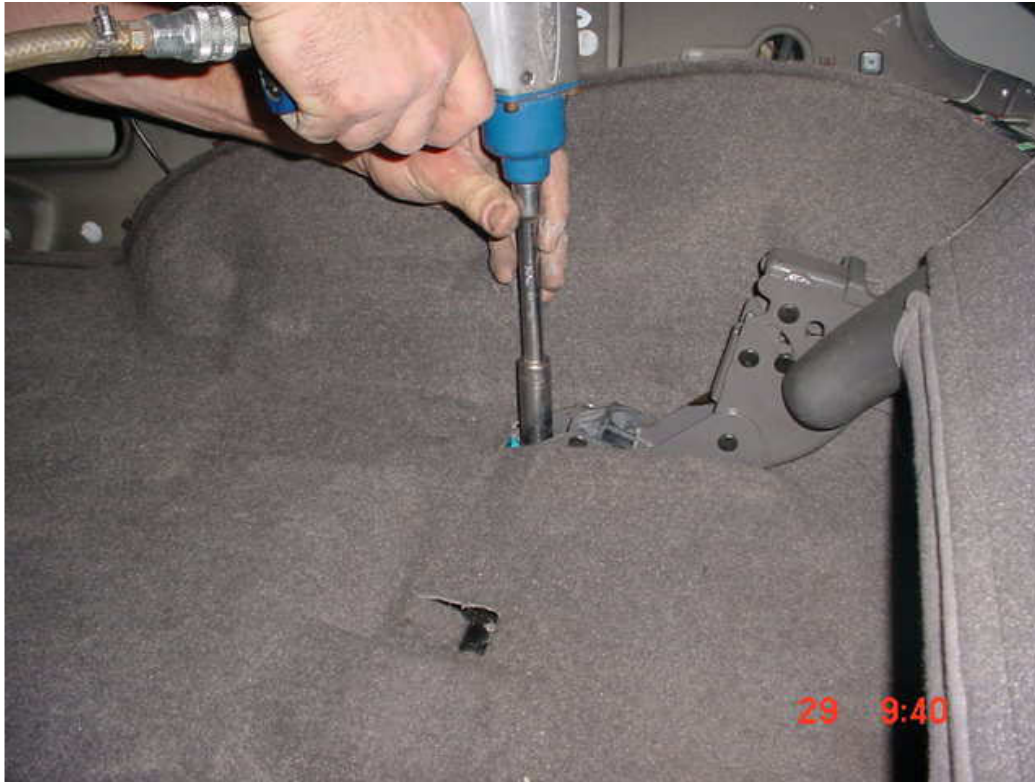
**A**

Mistral floor, inside vehicle, remove two bolts from each seat mount.

- 1) Remove the rear seats, seatbelts, trim, and carpet from the central floor C section of the vehicle. Two bolts are removed from each of the stressed seat mountings (*Photo A*).

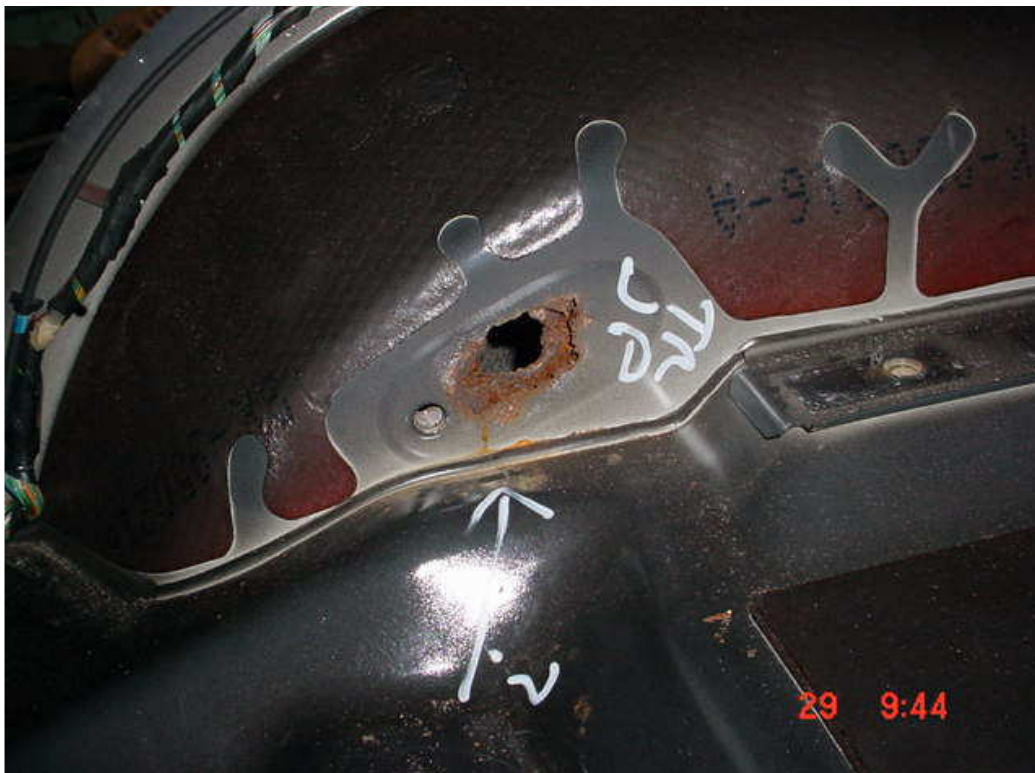
**B**

View of the seatbelt anchorage in the wheel arch, from inside the vehicle

- 2) Identify the two seatbelt mounts in the wheel-arch area (*Photo B*).
- 3) Undo all body mount bolts holding the body to the chassis and remove the rear six bolts completely. Lift the back of the body away from the chassis by about 60 mm, and support the rear of the body in the raised position with some timber blocks or other appropriate material. (This is to provide enough room to remove the reinforcing plate through the wheel-arch opening) (*Photo C*). Note the clip holding the chassis-mounted rear bumper will pop out when the body is raised.

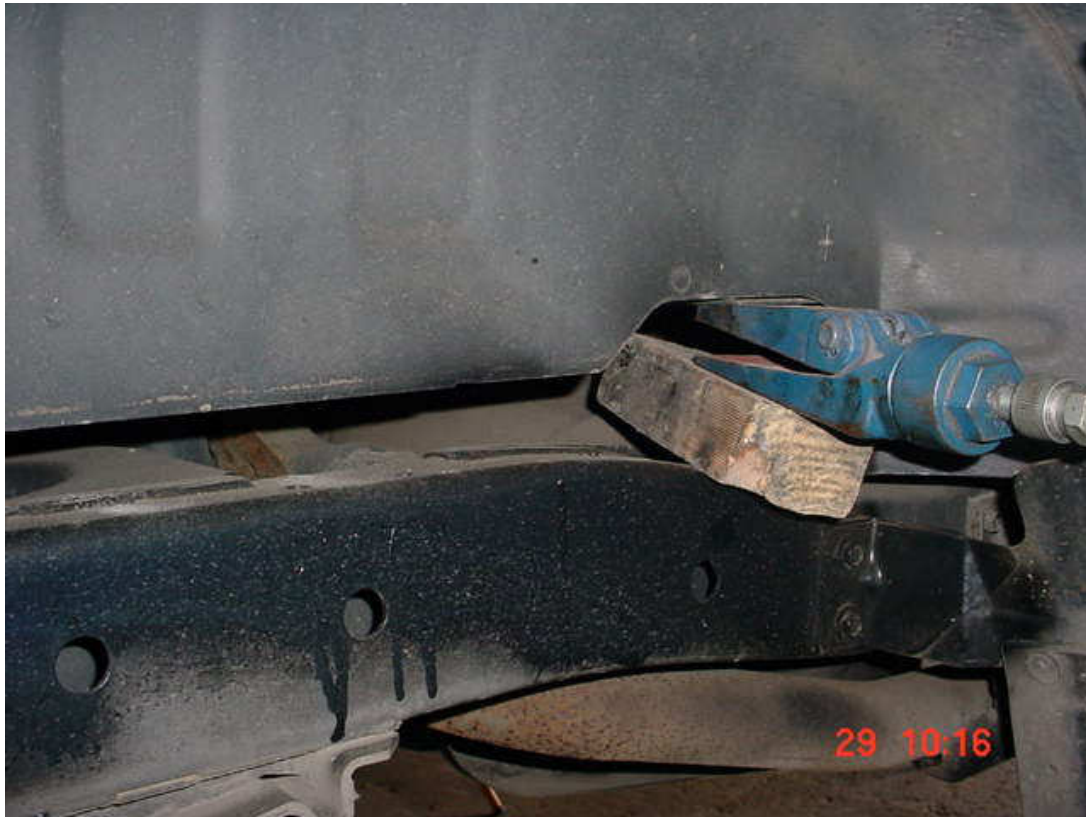
**C**

Lift the body from the chassis after removal of the 6 body mounting bolts. Note the rear bumper clip will pop out as the bumper is chassis mounted.

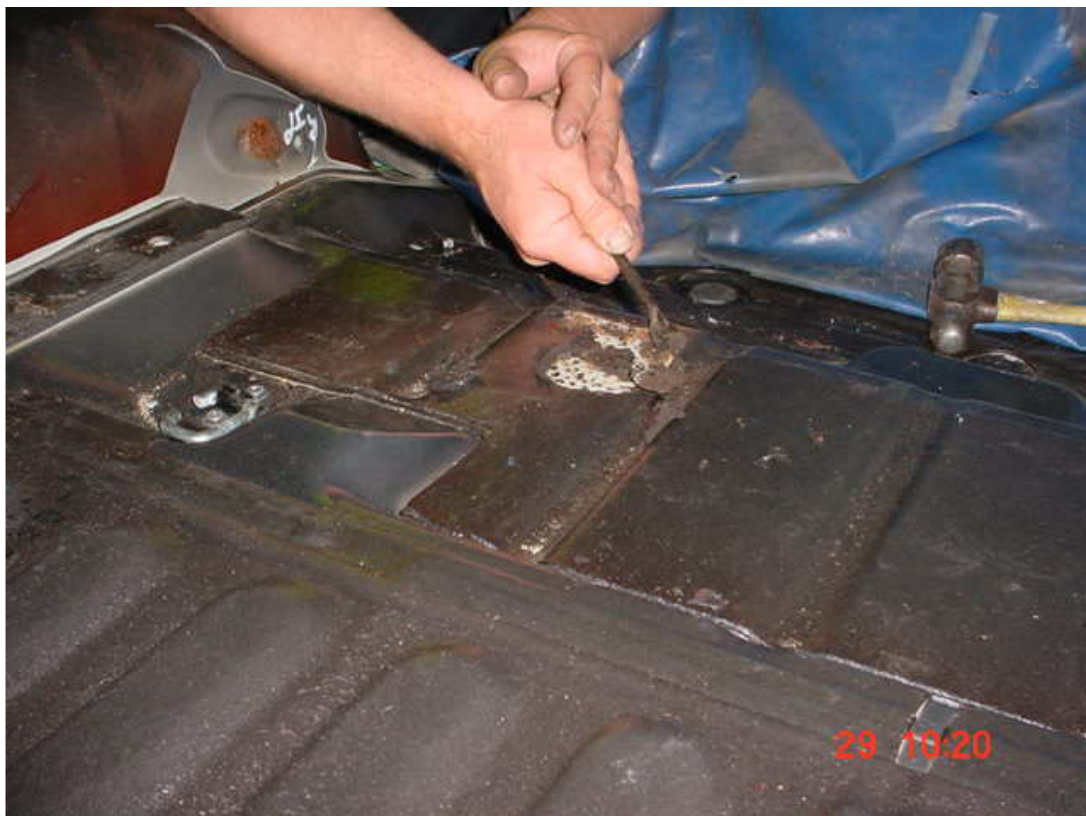
**D**

Remove the interior floor coating from underneath the rear seat area.

- 4) From inside the vehicle, remove all the interior floor coating from underneath the seat area (*Photo D*), back to the floor join seam just behind the cargo hooks (*visible in photo S*).

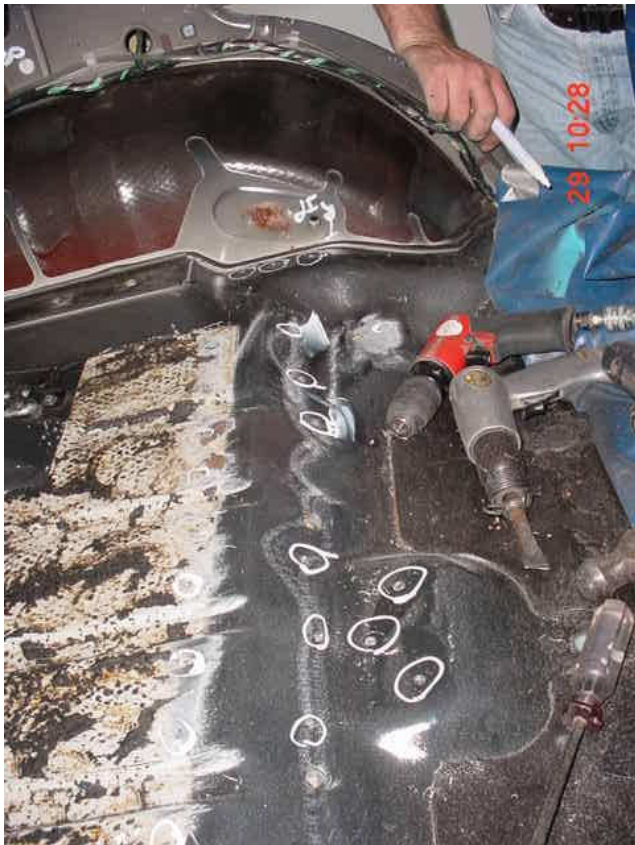
**E**

The spot-welds have been marked, there are a total of about 30 including 3 each side beside the wheel arches.

- 5) Using a wire-wheel, strip to bare metal the area underneath the seat area to reveal the spotwelds.
- 6) From inside the vehicle, identify 30 spot-welds in the rear floor section that attach the reinforcing plate to the central floor section. (*Photo E*) Drill all spot-welds through the centre of the spot-weld, through both the rear floor section and the reinforcing panel using (approximately) a 2 mm (1/8") drill-bit. This is followed by an 8 mm or 8.5 mm (5/16") drill through the central floor section (1 layer only) to remove the spot-welds. (*Photos F, G*). (These holes are now prepared and ready for plug-welding the complete reinforcing-plate and load-bar assembly back together at the end of the process). Note the three spot-welds

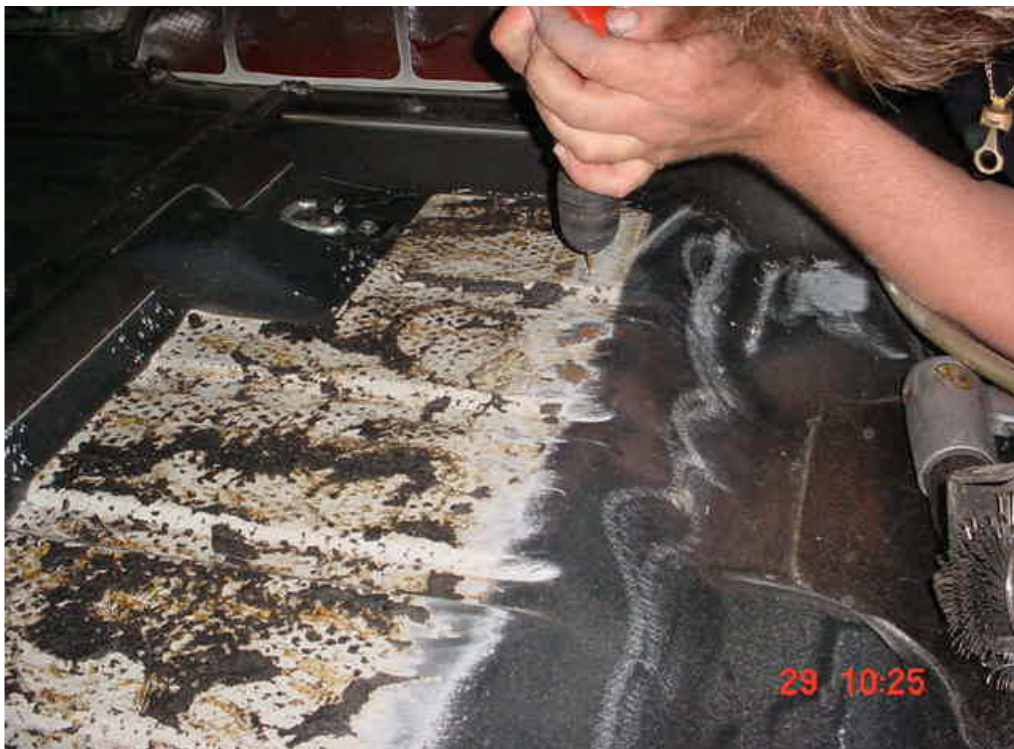
**F**

Interior of vehicle floor after wire-wheel cleanup, spot-welds are drilled 2 mm through the central floor section and reinforcing plate, (2 layers).

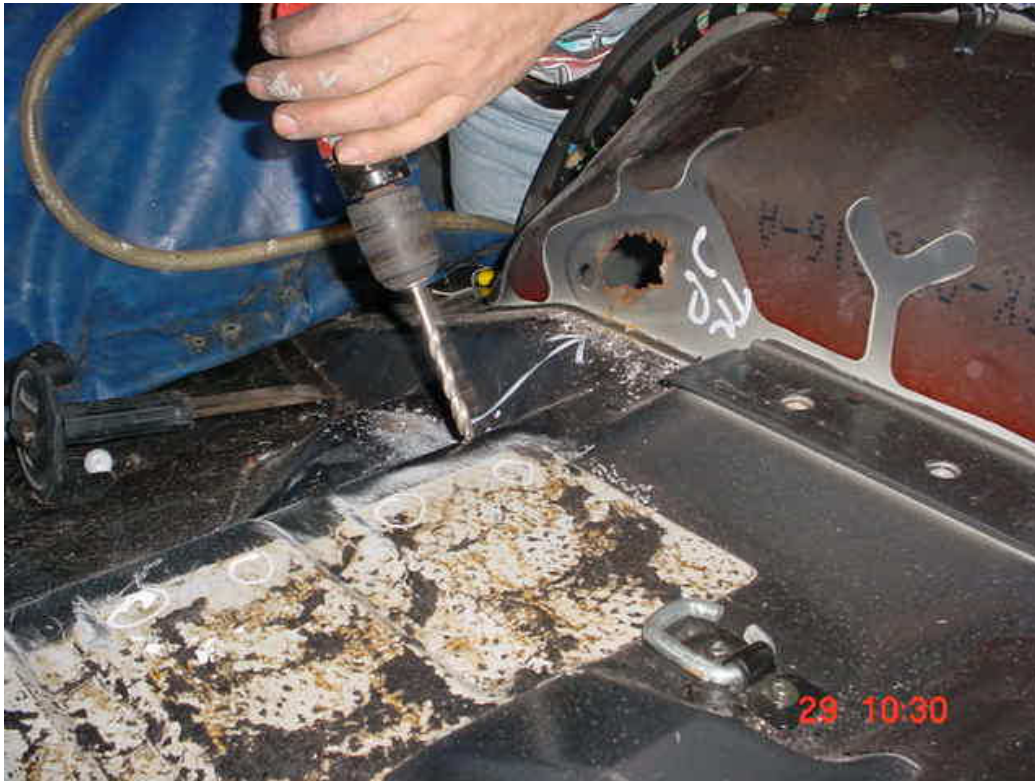
**G**

Drill each spot-weld with an 8 mm drill bit (5/16") through the floor only (1 layer). The holes are now prepared and ready for later plug-welding.

beside each wheel-arch (*visible by the arrow to the right of the drill in photo G*), these are used in step 36.

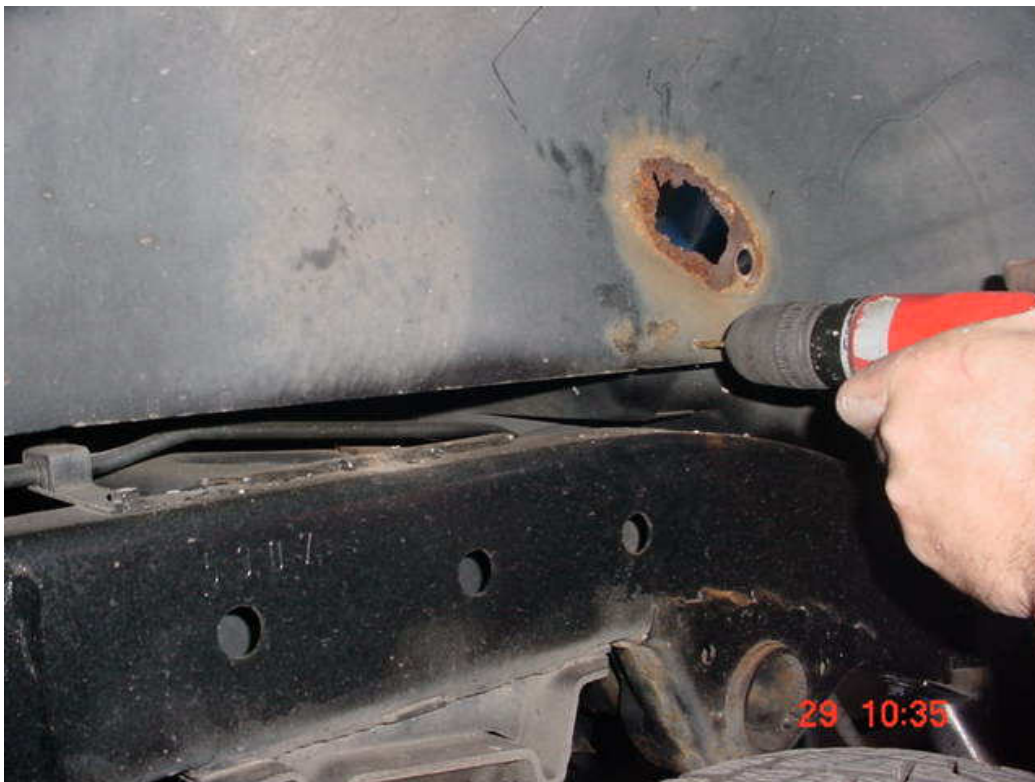
**H**

From inside the wheel arch, drill a 2 mm hole through each of three spot-welds below the seatbelt anchorage, through the wheel-arch panel and the reinforcing plate (2 layers), followed by 8 mm through the wheel-arch panel only (1 layer). Note: the seatbelt anchorage plate would normally still be present (see next picture I).

- 7) From the outside of the vehicle, in the wheel-arch area, clean the area under the seatbelt anchorage plate back to bare metal using a wire-wheel, then drill through the three spot-welds attaching each end of the reinforcing plate to each wheel-arch panel. Drill right through the bodywork and reinforcing plate (2 layers) using a 2 mm drill bit (1/8"). (*Photo H*).

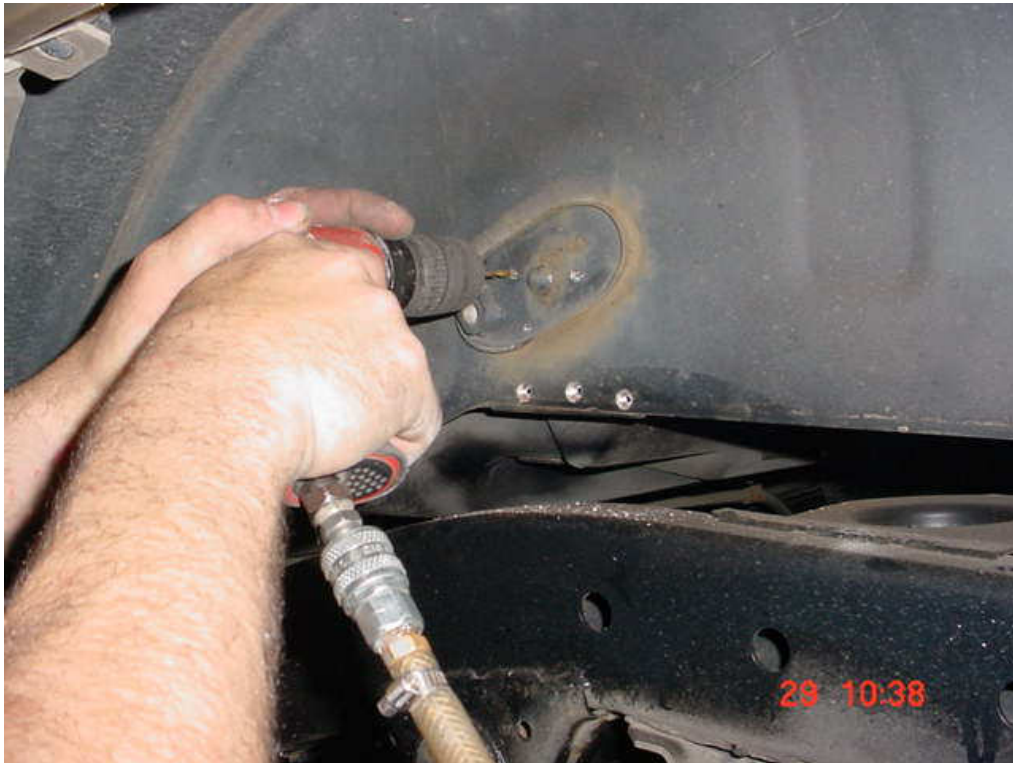
Three spot welds hold the seatbelt anchorage plate to the wheel-arch panel. Drill 2 mm through the seatbelt anchorage plate and the wheel-arch panel (2 layers) followed by 8 mm through the seatbelt anchorage plate (1 layer). Remove the seatbelt anchorage plate.

- 8) From the outside of the vehicle, in the wheel-arch area, using a 2 mm drill bit (1/8"), drill through the three spot-welds attaching each seatbelt anchorage plate to the wheel-arch panel. Drill right through the anchorage plate and the bodywork (2 layers) (*Photo I*).

- 10) Complete the removal of the three spot-welds in the seatbelt anchorage plate by using an 8 mm drill (5/16") through one layer only. Remove the seatbelt anchorage plate. (*Photo I*).

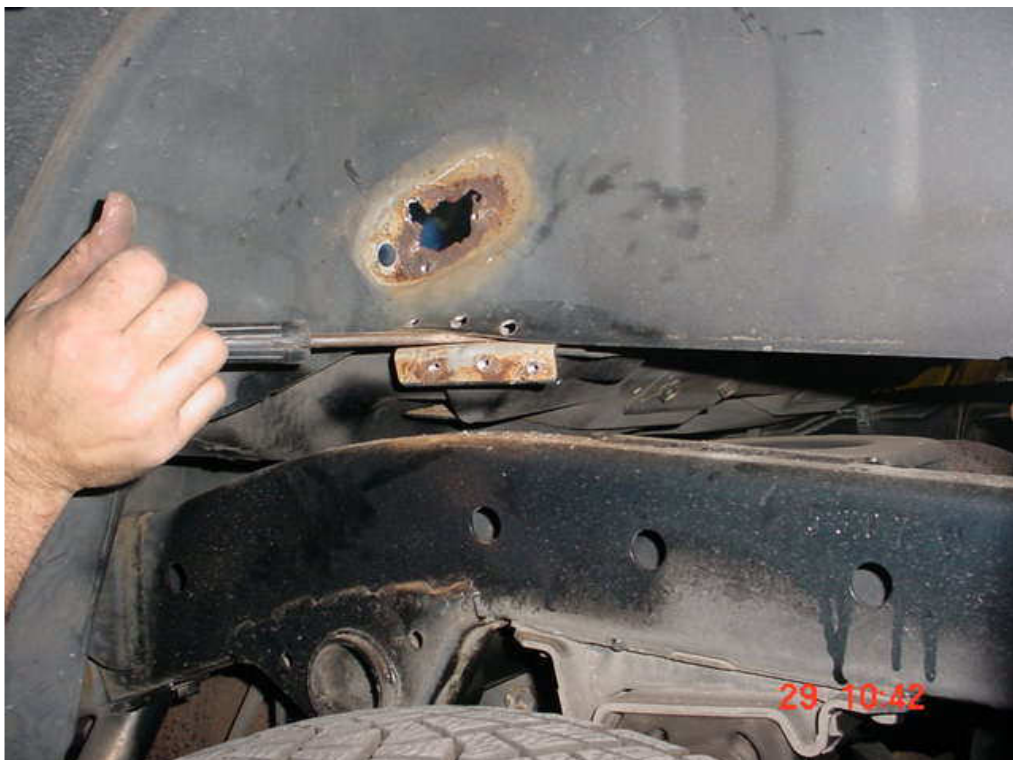
**J**

The reinforcing plate is now able to be levered free from the central floor section.

- 11) Use a lever to ensure all spot-welds have been removed, and manoeuvre the reinforcing plate out from under the vehicle, through the vehicle's left-side wheel-arch. (*Photos J & K*).

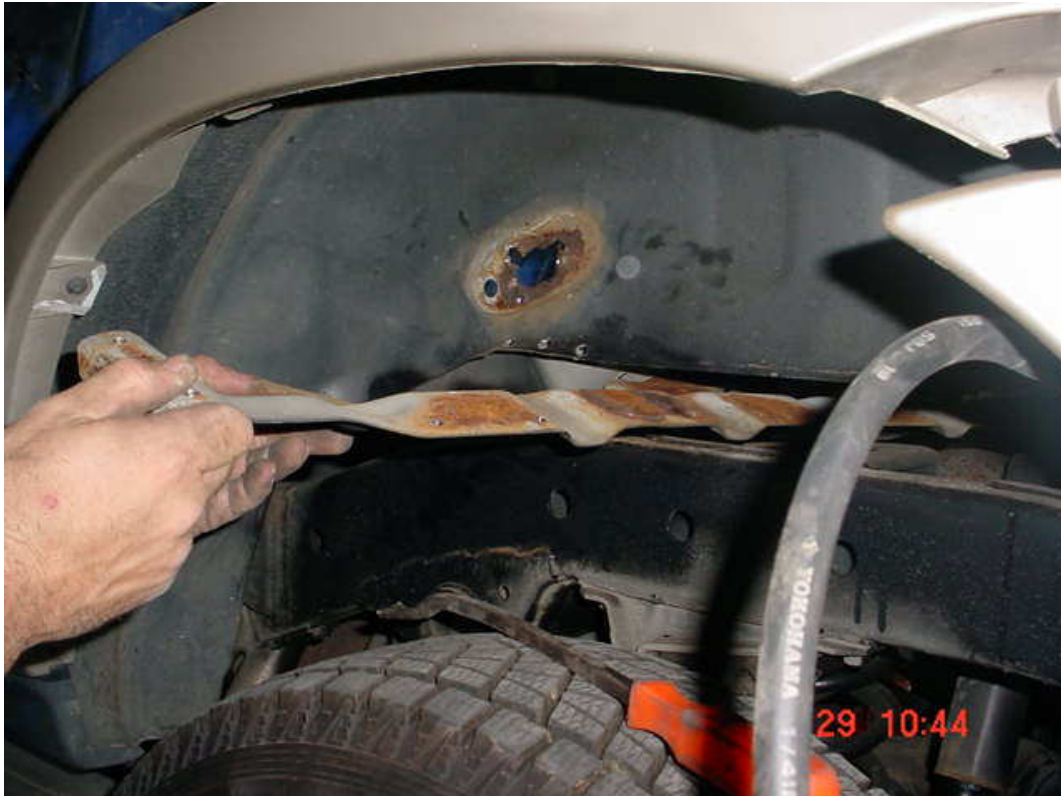
**K**

Withdraw the reinforcing plate out the left side of the vehicle.

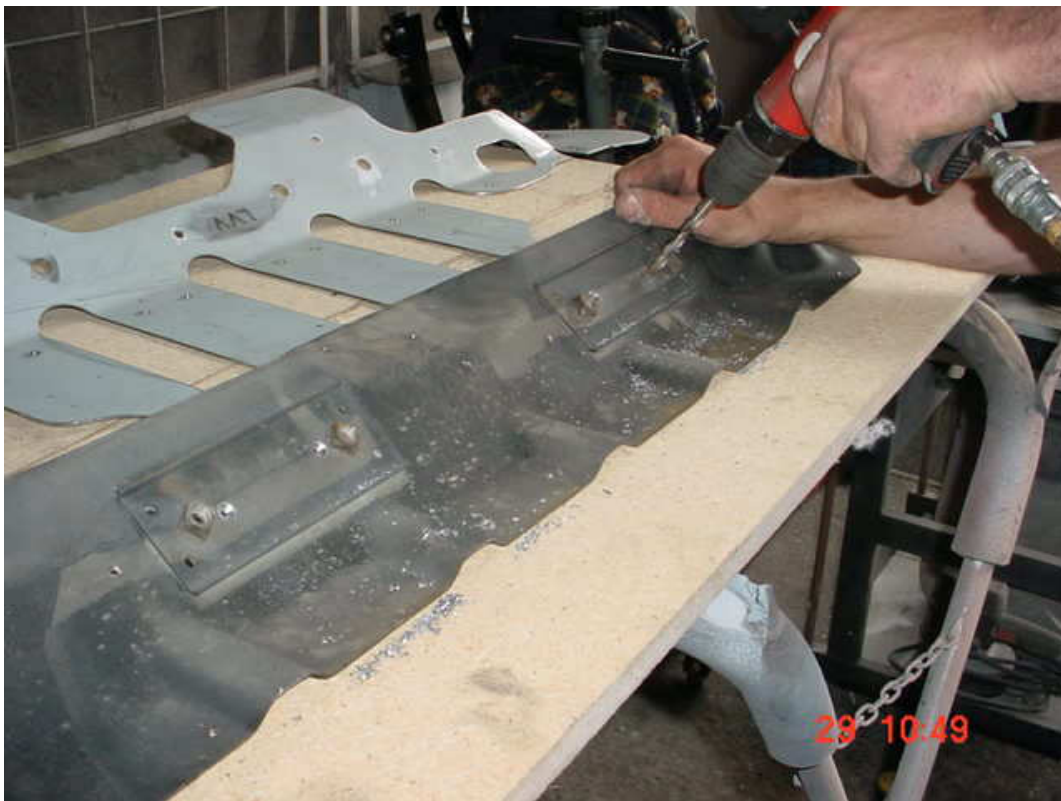
**L**

The spot-welds holding the two seat anchorages to the reinforcing plate are drilled through 2mm (both layers) then 8 mm through the seat anchorage plate only (1 layer). Remove the two plates.

- 14) The spot-welds holding each of the two seat anchorage plates (*Photo L*) on the underside of the reinforcing plate are drilled through 2mm (both layers) then 8 mm through the seat anchorage plate only (1 layer). Remove, and clean-up by wire-wheel, grinding, disc-sanding or sandblasting to a bright steel condition.
- 15) If rust holes or heavy pitting are present on the seat anchorage plates, discard and make similar plates from 30 mm x 3 mm flat-bar or other suitable material that meets all applicable requirements of LVVTA Seat Anchorage Standard 185-00{00}.

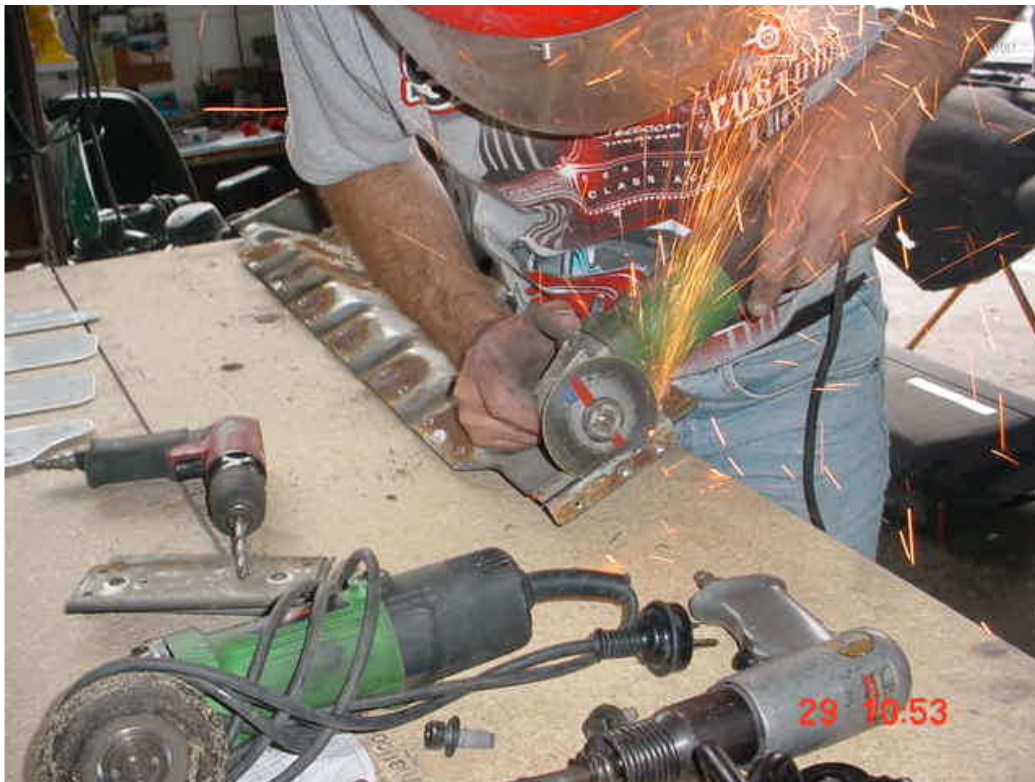
**M**

Grind off the two downturned ends on the reinforcing plate. Keep them for use as templates (see photo N).

- 16) Using a cut-off wheel, remove the two downturned ends on the reinforcing plate that were attached to the wheel-arch panel, retaining the cut off pieces (*Photo M*).

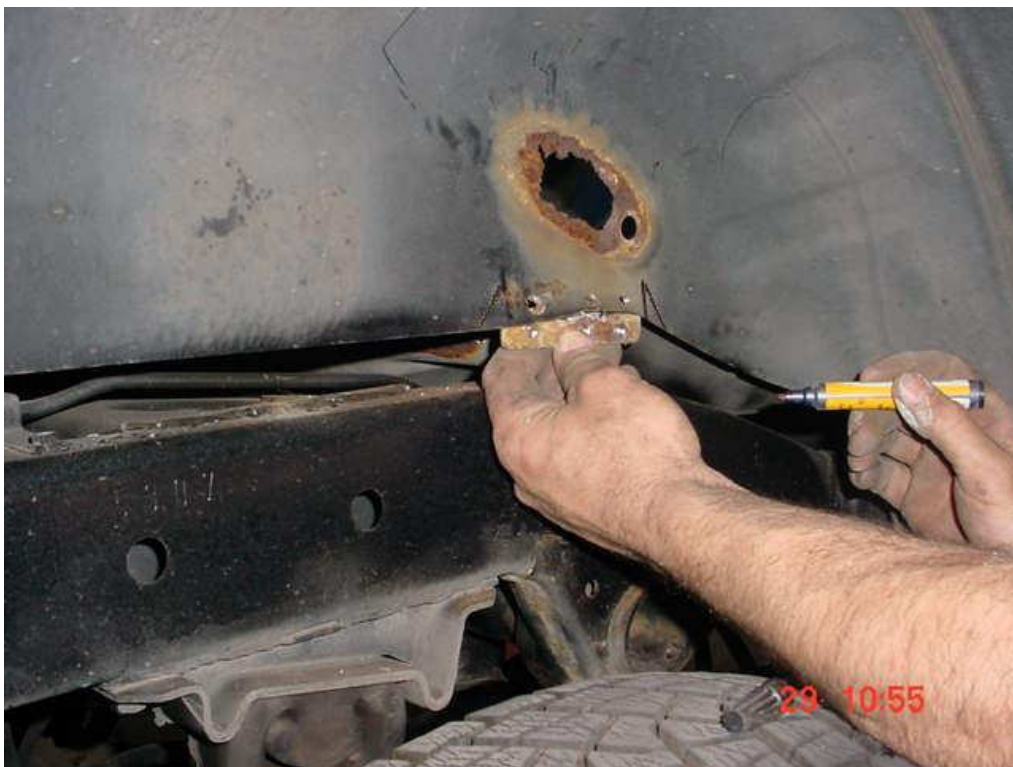
**N**

Using the cutoff ends as templates, mark the shape to cut out of the wheel arch lip, to bring it flush with the floor.

- 17) Using the ends cut off in step 16, mark out the shape to be cut out of the wheel arch lip, where this extends below floor level (*Photo N*).
- 18) Using a cut-off wheel, cut out the marked section in the wheel-arch, flush with the floor. Angle the cuts at about 45 degrees to avoid any sharp edges remaining (*Photo O*).

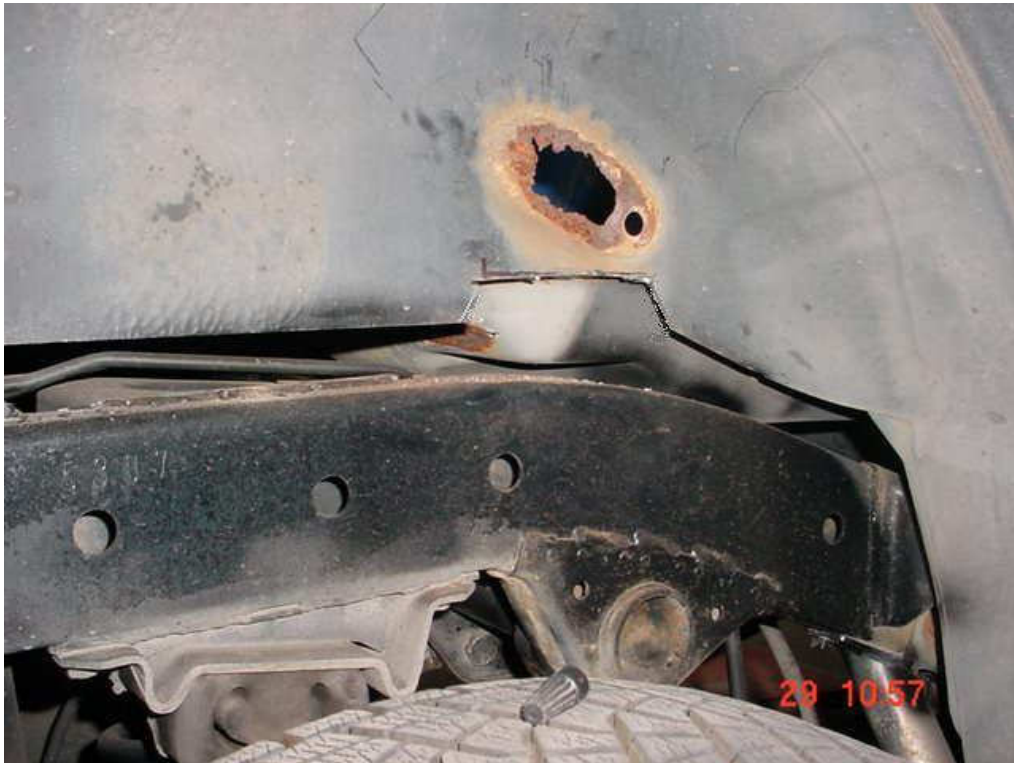
**O**

The wheel arch panel has been cut flush with the floor.

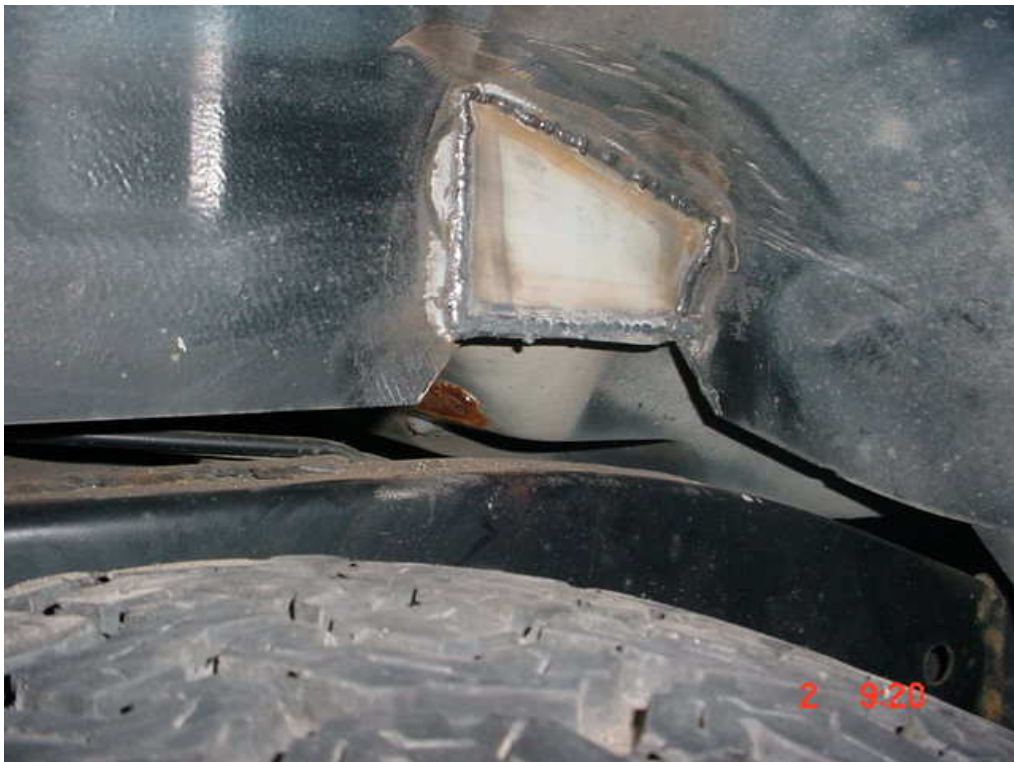
**P**

Cut out and patch repair (if necessary), the wheel arch seatbelt anchorage area.

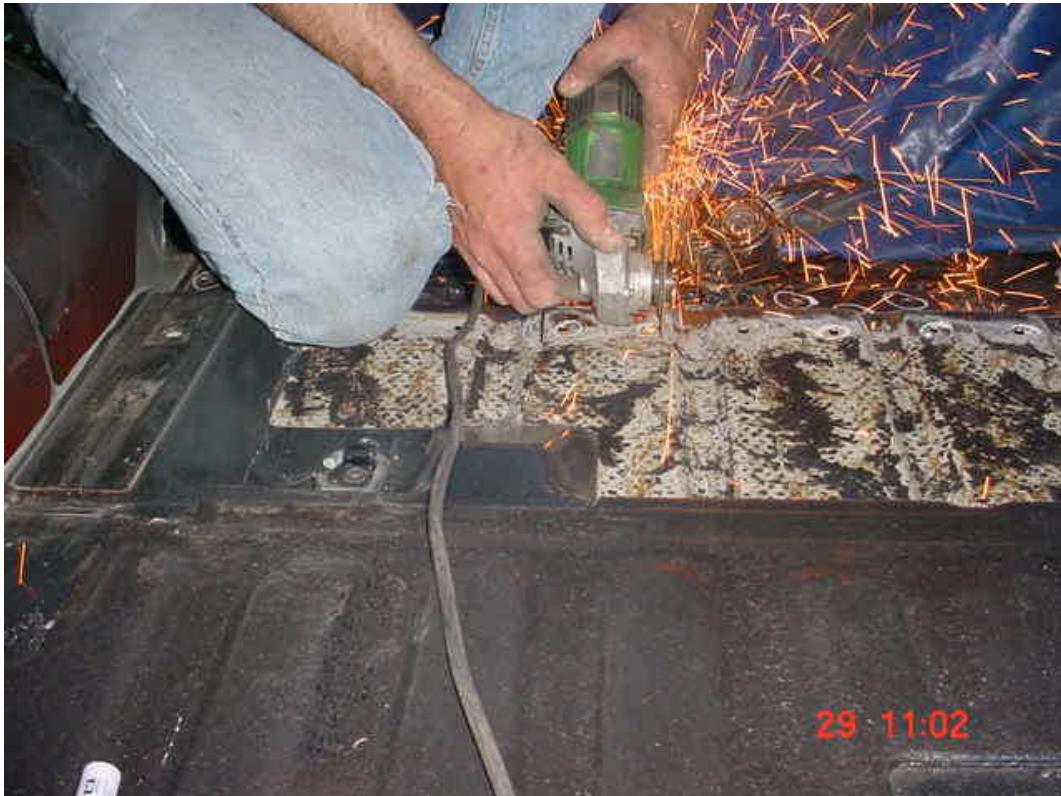
**Q**

Cut out and patch repair (if necessary), any rust damage in the floor.

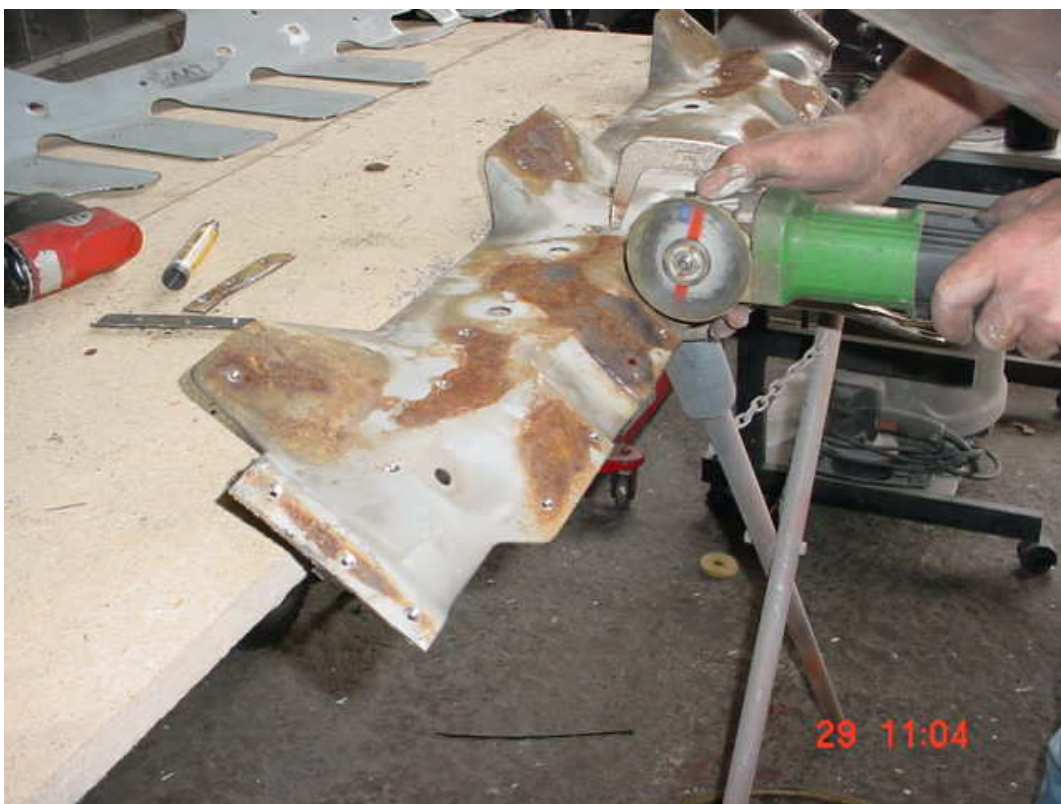
**R**

Cut out and patch repair (if necessary), any rust damage in the reinforcing plate.

- 19) Where rust-holes or excessively heavy rust-pitting are present in either the wheel arch area or the central floor section, carry out localised patch-repairs to a tradesman-like standard. Patch repairs must be carried out by an experienced and skilled trades-person using a MIG-welder, applying a continuous butt-weld (no overlaps) (*Photos P & Q*). Cut out and patch repair any rusted areas in the reinforcing plate (*Photo R*).

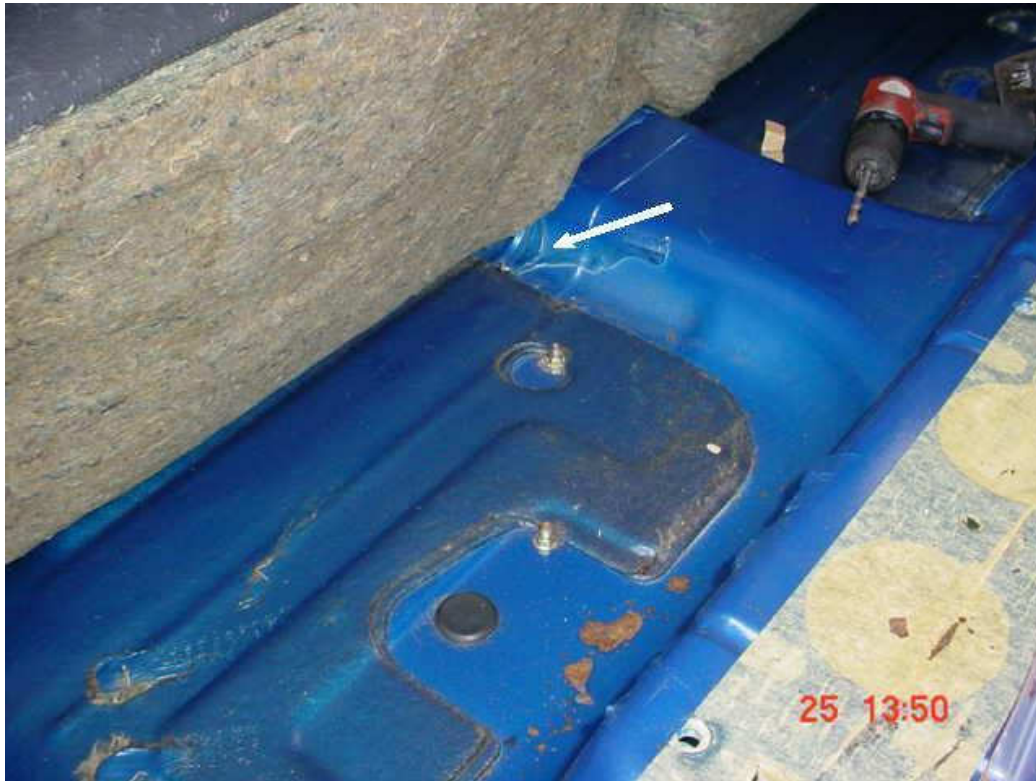
**S**

Check the front floor seam (arrowed) under the carpeting at the rear of the front seat. Look for rust bubbling under the coatings. Repair if necessary.

- 20) Thoroughly inspect any joins where the central floor section attaches to any other floor or wheel-arch sections for any rust-heave, discoloration or staining. Where this is visible, open up these joins, clean-up, rust-treat with an automotive corrosion-converter, apply an automotive epoxy primer and re-weld (using weld-through primer) (*Photos S & T*).

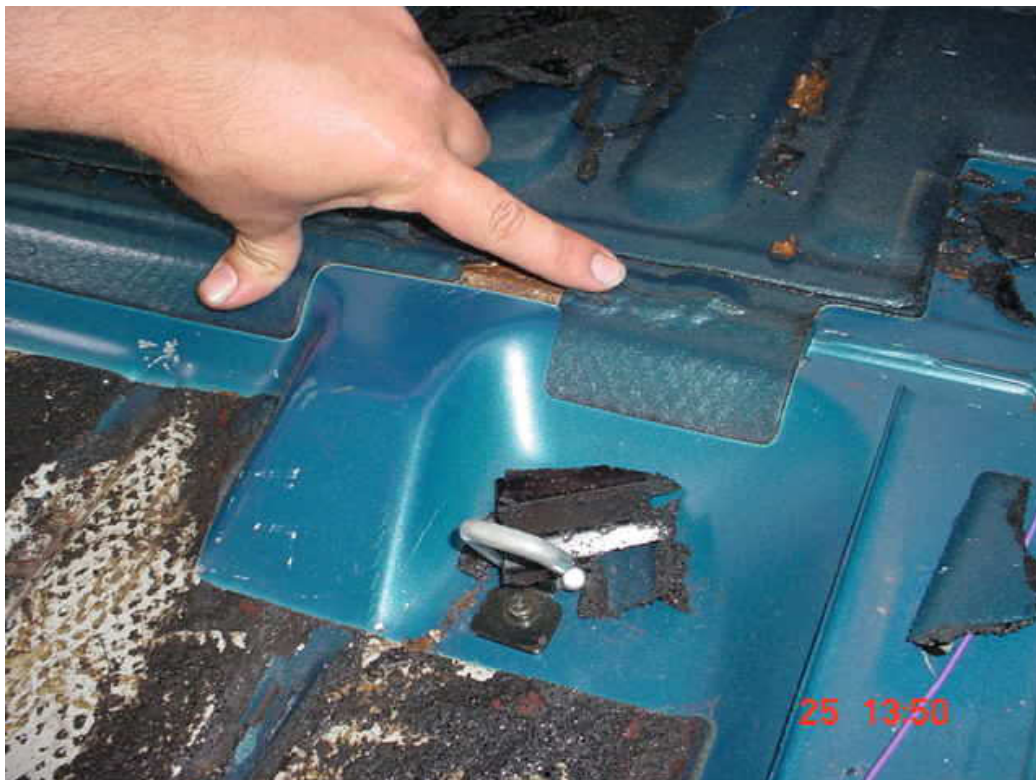
**T**

Check the rear floor seam under the carpeting at the front of the cargo area. Look for rust bubbling under the coatings as in this picture. Repair if necessary.

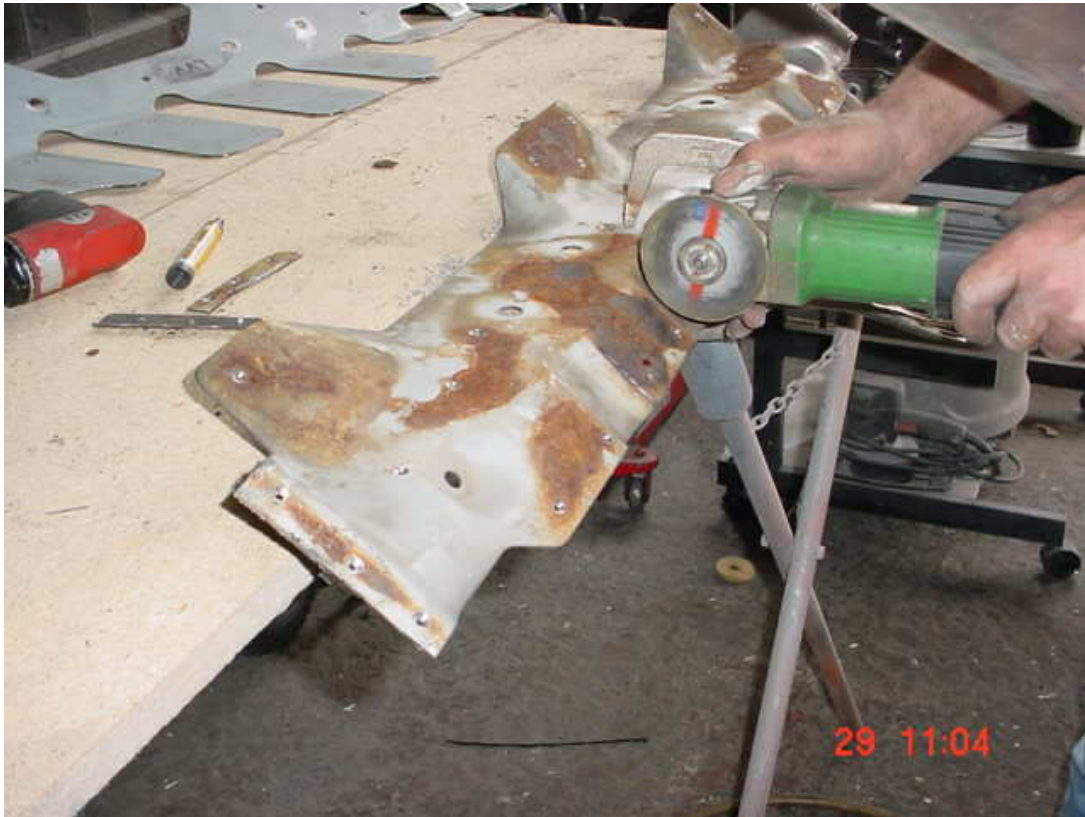
U

Clean up the reinforcer plate to bare metal using a grinder and/or wire wheel.

- 21) Remove any visible signs of rust-pitting, bubbling, discoloration or rust-staining by wire-wheel, grinding, disc-sanding or sandblasting on both the topside and the underside of the reinforcing plate, back to a clean bright-steel condition (*Photo U*). Ensure that all of the area on the reinforcing plate that the load-bar will overlap is also cleaned back to bright steel.

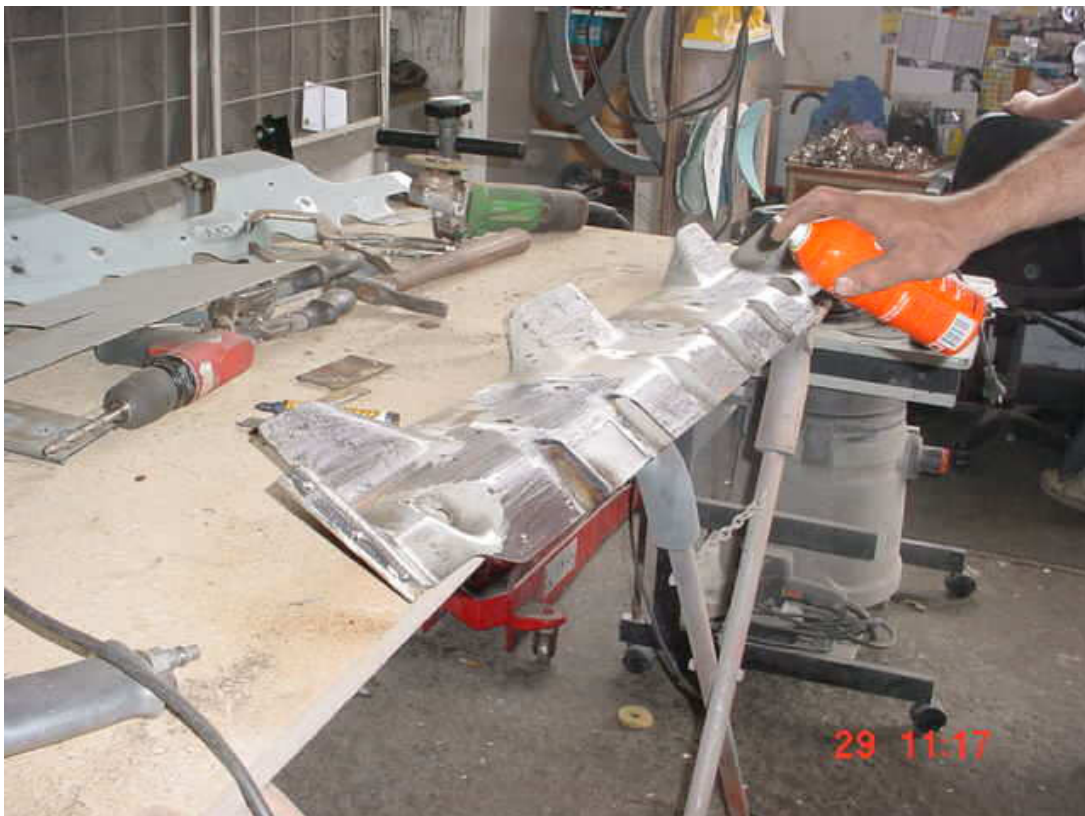
V

Apply corrosion converter/epoxy primer to all bare metal on the reinforcer plate.

- 22) Coat both sides of the reinforcer plate with corrosion converter/epoxy primer. After it has dried, apply a coating of weld-thru primer (*Photos V, W*).

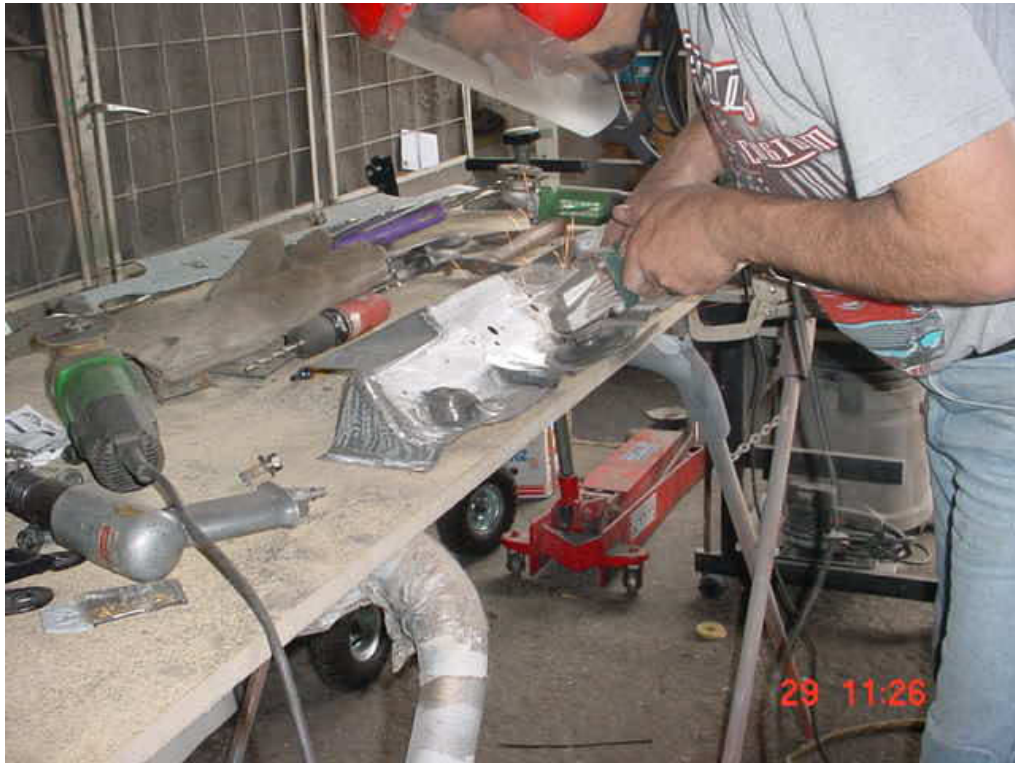
**W**

Turn the reinforcing plate over and lay the LVV load-bar on top to identify areas of overlap. Clean these overlap areas to bare metal using a grinder and/or wire wheel.

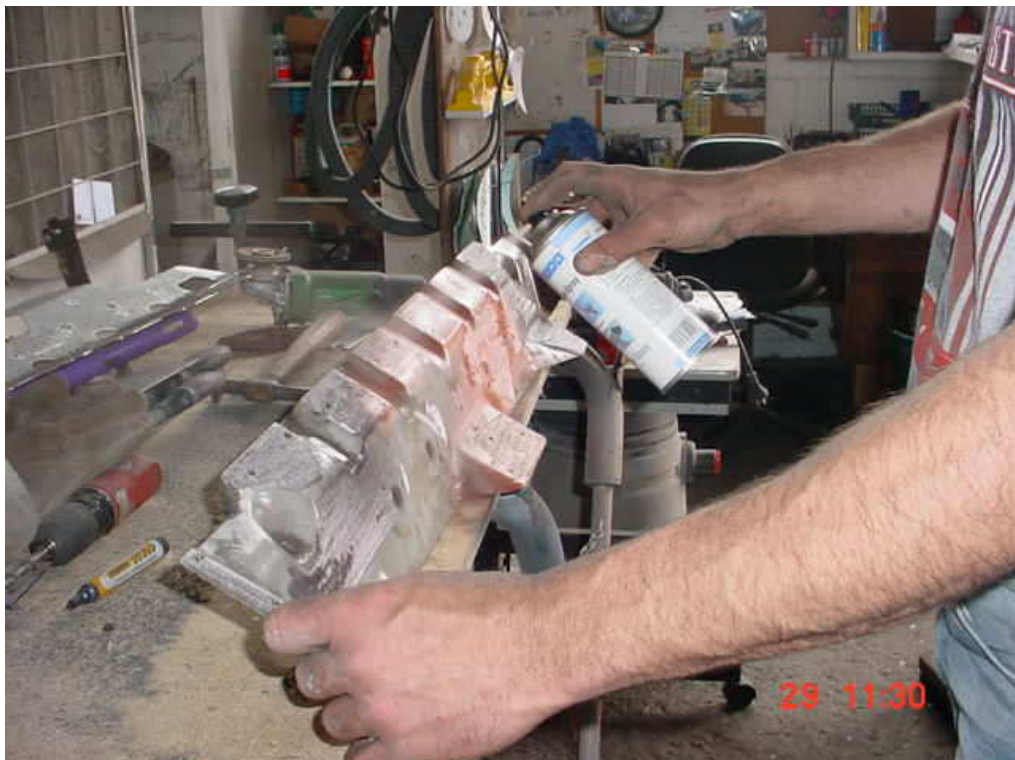
**X**

Coat both sides of the reinforcer with corrosion converter/epoxy primer, followed by weld-thru primer.

- 25) Coat the LVV Seat & Seatbelt Anchorage Load-bar with weld-thru primer where it faces the reinforcer plate (*Photo X*).

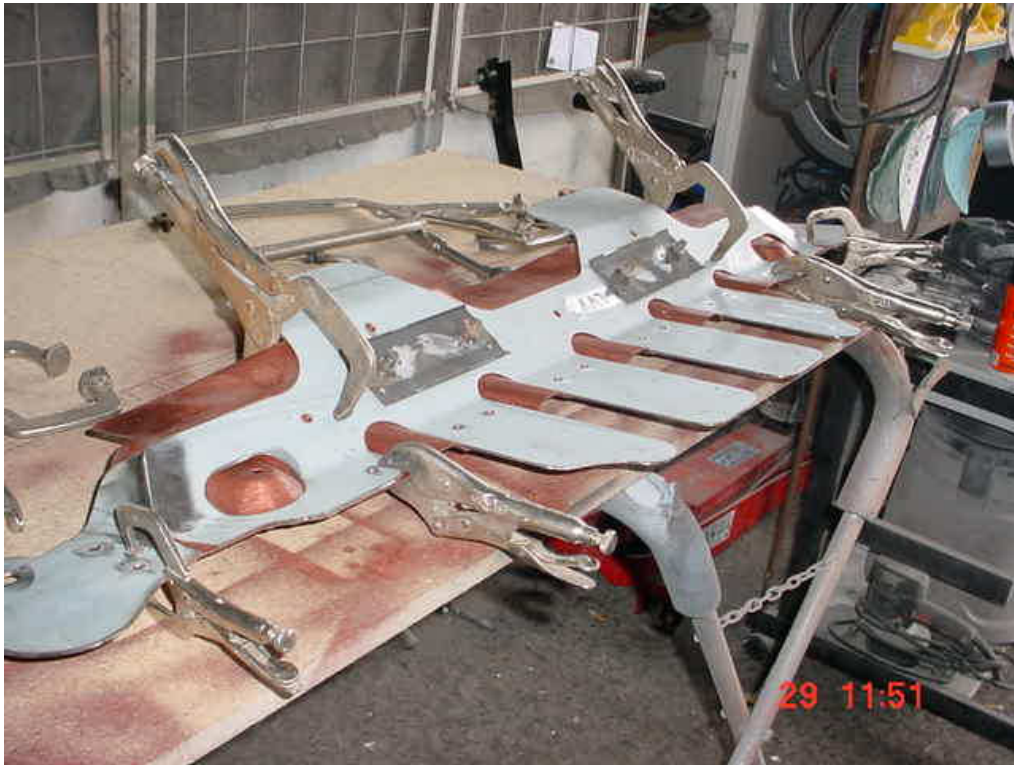
**Y**

Clamp the LVV load-bar to the reinforcing plate, line up the seat anchorage bolt holes and bolt on the seat anchorage plates to help clamp the assembly.

- 26) After the primers have dried to a handleable condition, position the LVV Seat & Seatbelt Anchorage Load-bar against the underside of the reinforcing plate. Position the two seat anchorage plates to the underside of the LVV Seat & Seatbelt Anchorage Load-bar over their pre-drilled seat anchorage holes. Temporarily clamp the LVV Seat & Seatbelt Anchorage Load-bar and the reinforcing plate together, and the two seat anchorage plates into place using the seat anchorage bolts, ensuring a firm close-contact fit between the LVV Seat & Seatbelt Anchorage Load-bar and the reinforcing plate. (*Photo Y*)
