## Nissan Mistral Rear Seatbelt Anchorage/Floor Rust Problem and LVV Modification Solution

As a follow on to the LVV Loadbar solution to the Nissan Terrano, Land Transport NZ has asked LVVTA to provide a similar solution under LVV Seatbelt Anchorage Standard 175-00(01) for the rust problem that the Nissan Mistral has. Like the Terrano, the Mistral has been required to have a full rear floor replacement carried out if any rust is evident at WoF or entry inspection. This has been achieved, and an alternative cost effective solution is now available for these vehicles under the Low Volume Vehicle Code. This Information Sheet outlines the problem, the solution and the procedures involved.

## **Nissan Mistral Load-bar Modification & LVV Certification Procedure:**

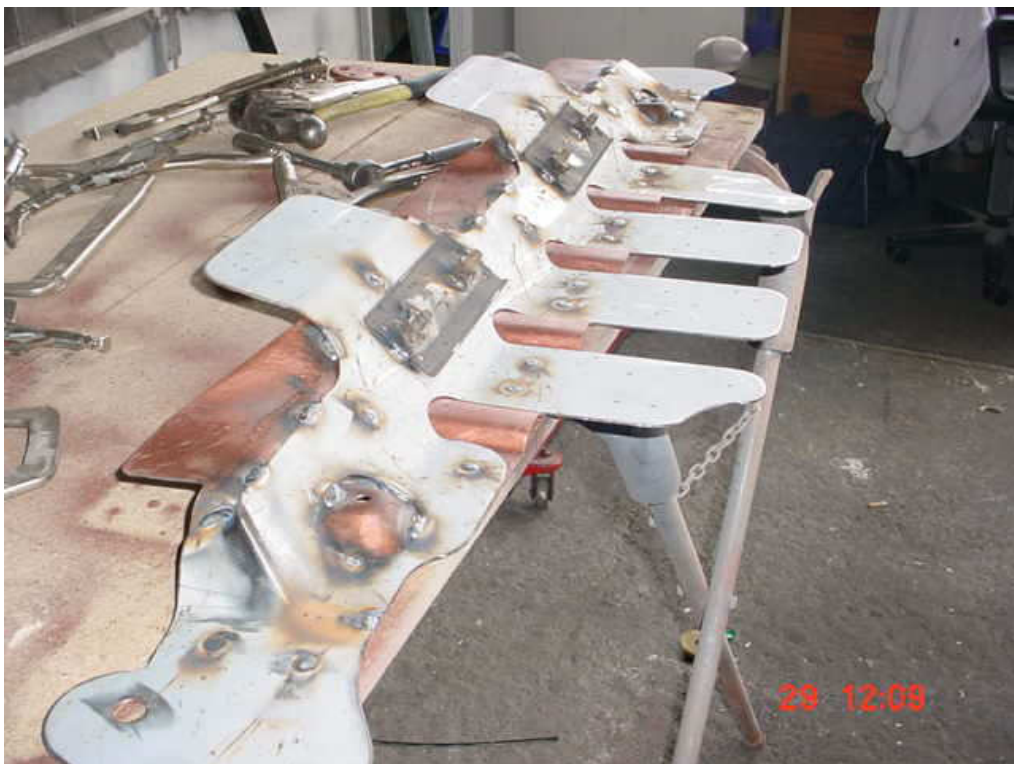
**Z**

Weld the assembly together through the pre-cut plug-weld holes in the LVV load-bar, and stitch-weld around the cutout at each end. Plug-weld the two seat anchorage plates to the load-bar.

Small stitch-welds are encouraged, in order to prevent moisture or debris from entering any gaps between the two surfaces during the life of the vehicle.

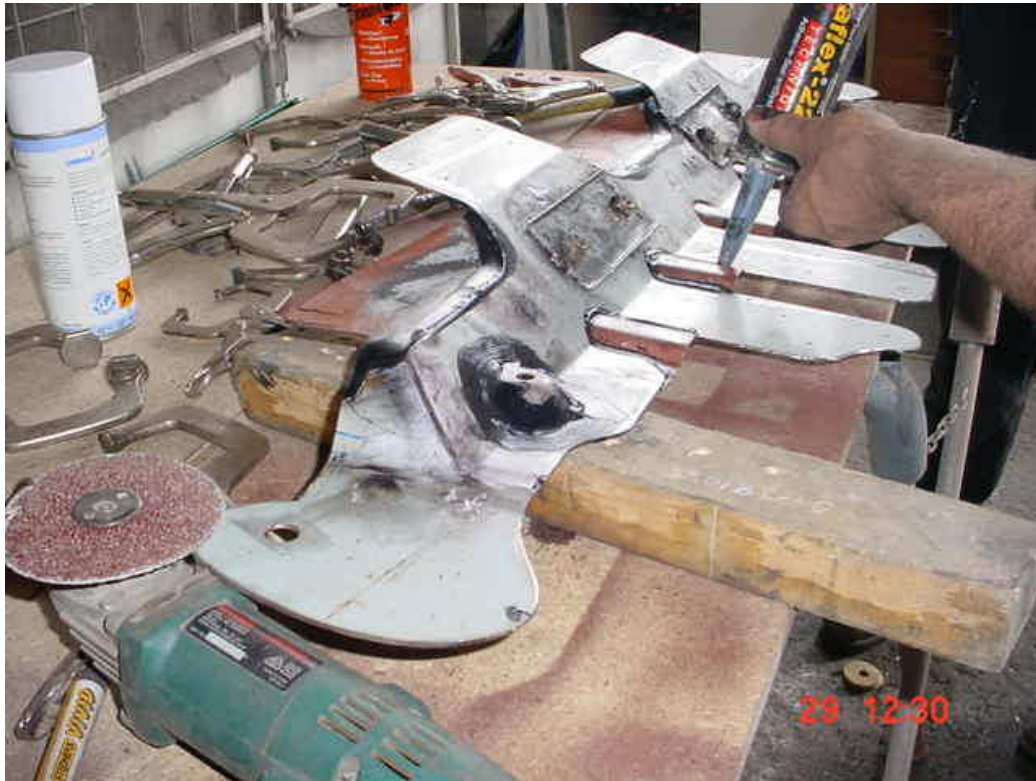
**AA**

Clean up any rough or burnt areas after welding and apply epoxy primer on both sides of the assembly. Remove the seat anchorage bolts. Apply weld-thru primer on the top side of the assembly. Seal all joints and edges where moisture could penetrate with urethane sealant.

- 28) After appropriate cleaning and preparation of welds and heat affected areas, apply an automotive epoxy primer to all plug-welds and any stitch-welds on both the topside and underside of the reinforcing plate, the LVV Seat & Seatbelt Anchorage Load-bar, and the two seat anchorage plates.
- 29) After the automotive epoxy primer has sufficiently set to a handleable condition, apply weld-through primer to the areas on the topside of the reinforcing plate, which will be plug-welded to the underside of the central floor section.
- 30) Apply automotive urethane seam sealant to all edges where the LVV Seat & Seatbelt Anchorage Load-bar mates with the reinforcing plate. (*Photo AA*)

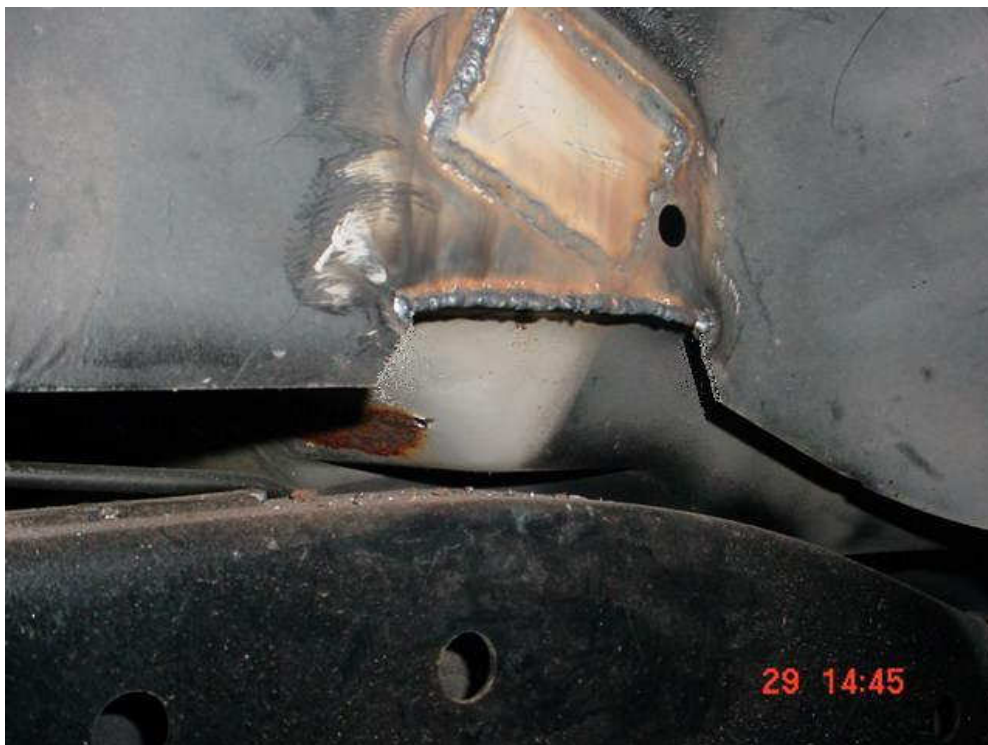
**AB**

In the wheel-arch area, remove any sealer from the interior floor area directly behind the wheel arch, and weld the joint between the floor and the wheel-arch cutout. It may be easier to weld this from inside the vehicle. Apply corrosion converter/epoxy primer followed by weld-thru primer.

- 31) In the interior of the vehicle, remove any bead of sealer along the join between the floor and the wheel arch, and weld the joint between the floor and the wheel-arch cutout. It may be easiest to weld this from inside the vehicle. Clean-up the welds, coat with corrosion converter/epoxy primer, after it has dried apply weld-thru primer to this area. (*Photo AB*)

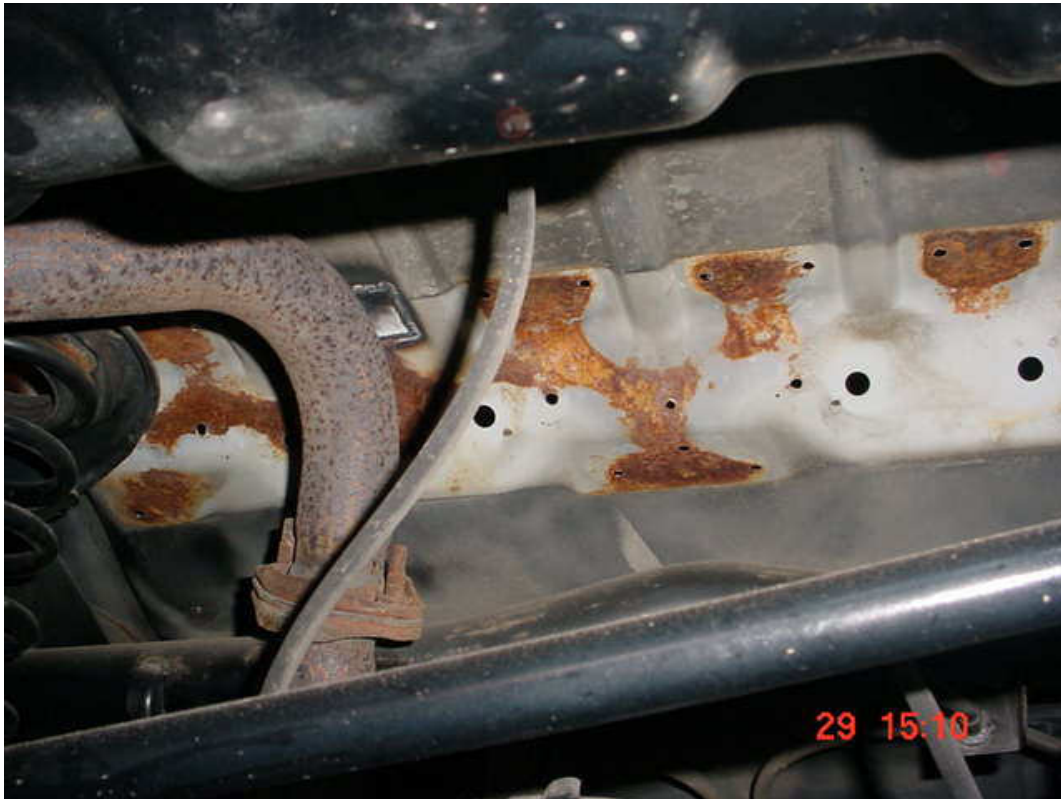
**AC**

Clean up all under-floor rust areas to bare metal with a wire wheel. Clean off any undersealed areas to bare metal where the LVV load-bar will overlap.

- 32) From underneath the vehicle, (*Photo AC*), remove any visible signs of rust-pitting, bubbling, discoloration or rust-staining by wire-wheel, grinding, disc-sanding or sandblasting on the central floor section, back to a clean bright-steel condition.

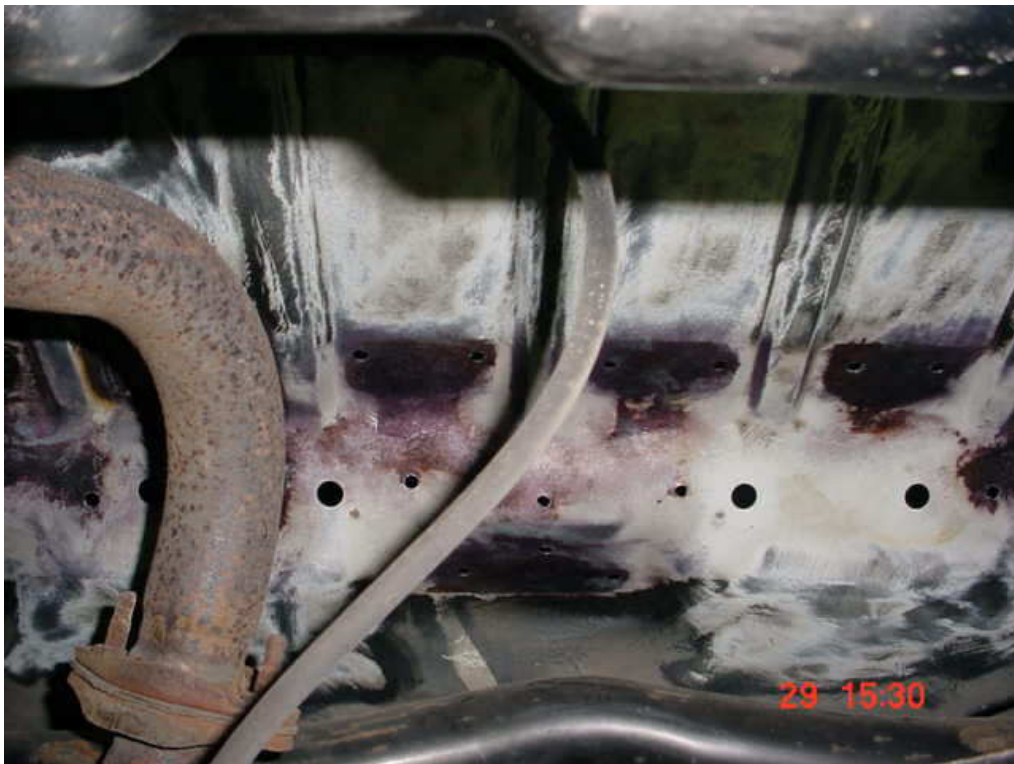
**AD**

Coat all bare metal and previously rusted areas with corrosion converter/epoxy primer.

- 33) Coat the cleaned-up underside bare metal with corrosion converter/epoxy primer. After it has dried, apply a coating of weld-thru primer (*Photos AD, AE*).

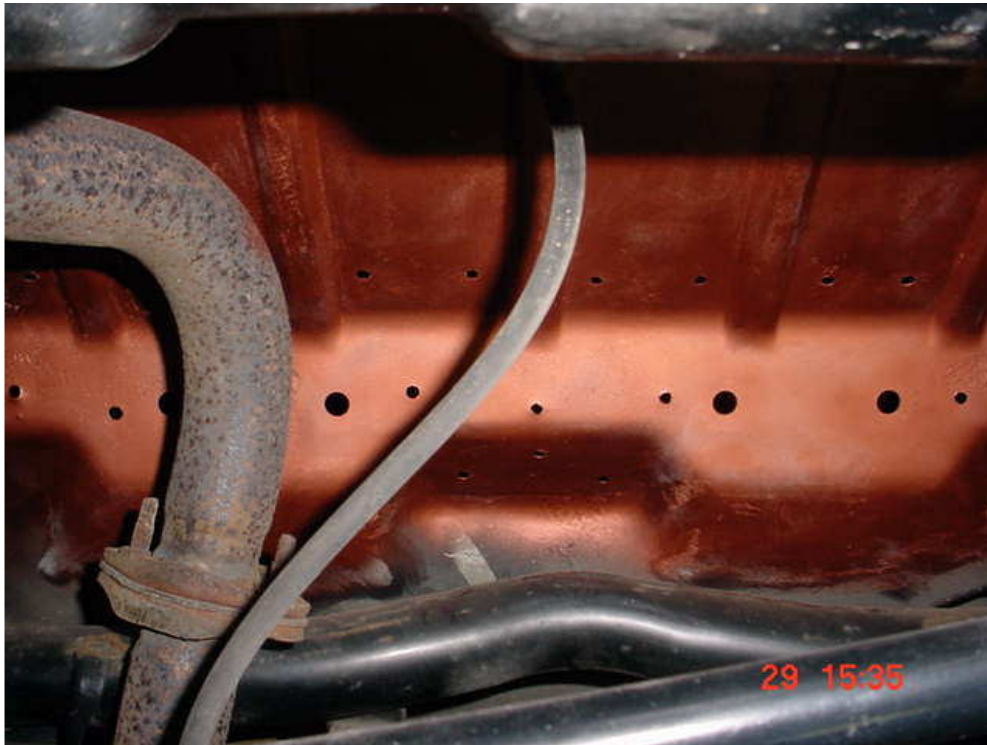
**AE**

When epoxy primer is dry, apply a coating of weld-thru primer.

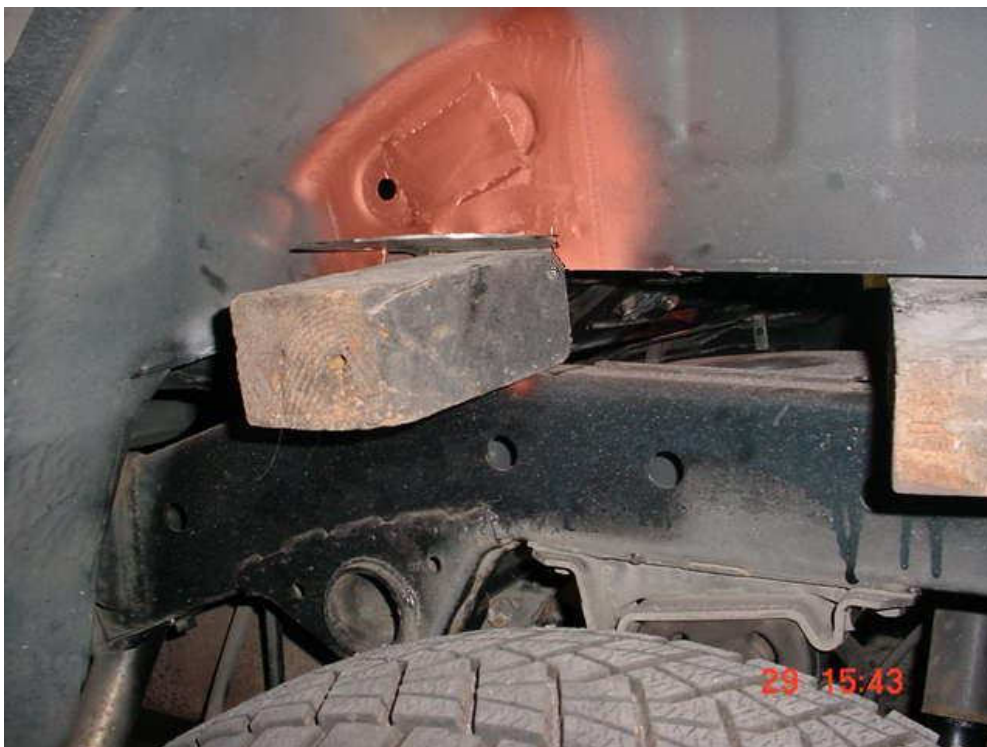
**AF**

Slide in the load-bar/reinforcing plate assembly, jam in place with wood blocks and fit the seat anchorage bolts to pull into location. From inside the vehicle, weld the three plug-welds across the wheel-arch, to stop the plate bending down.

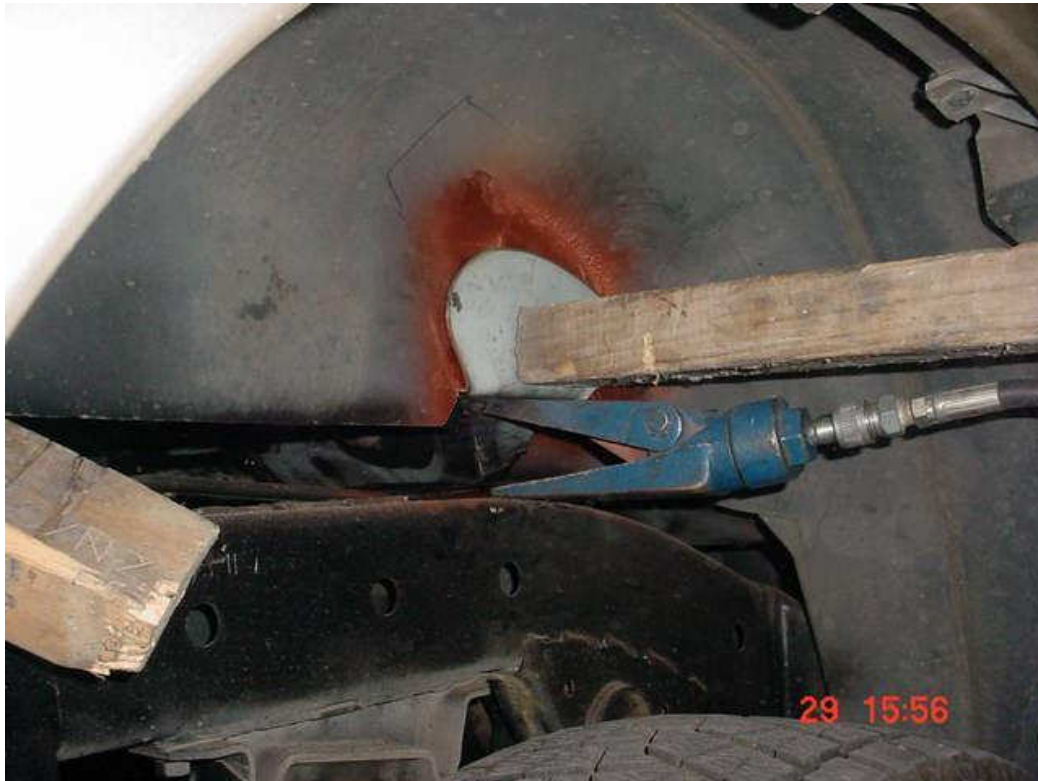
**AG**

In the wheel-arch area, bend up the “ears” on the load-bar by hand, then by using a piece of wood. Apply weld-thru primer. Check the bolt hole is properly aligned.

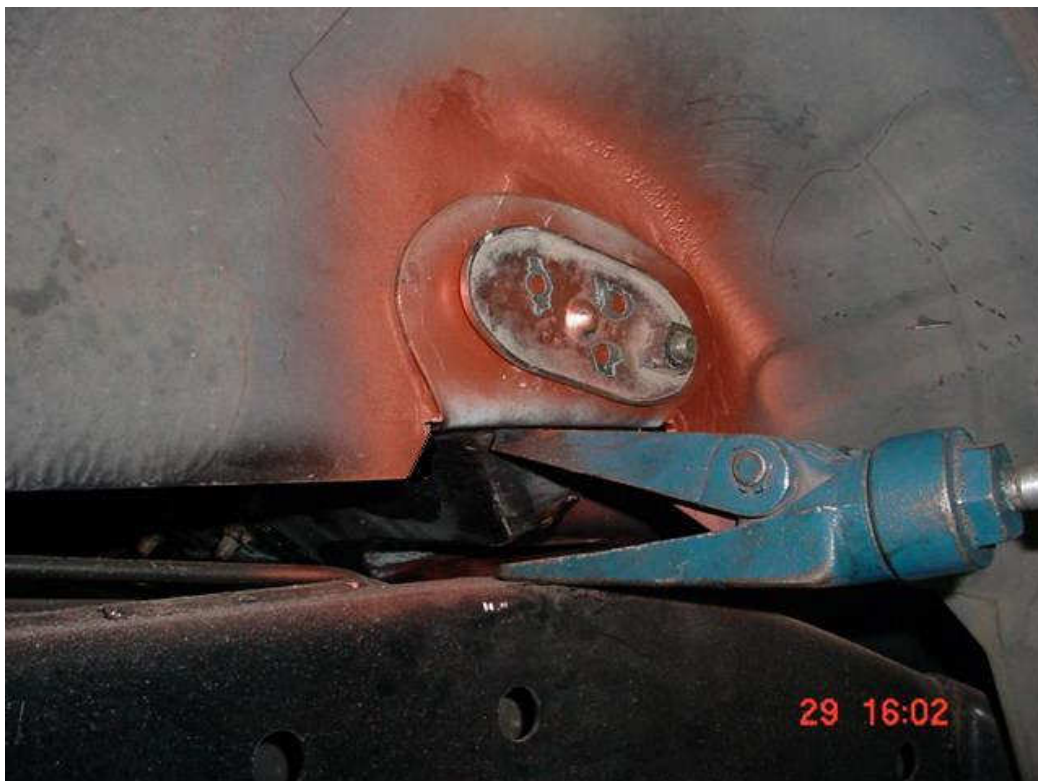
**AH**

Locate the seatbelt anchorage plate centrally, fit and tighten the bolt.

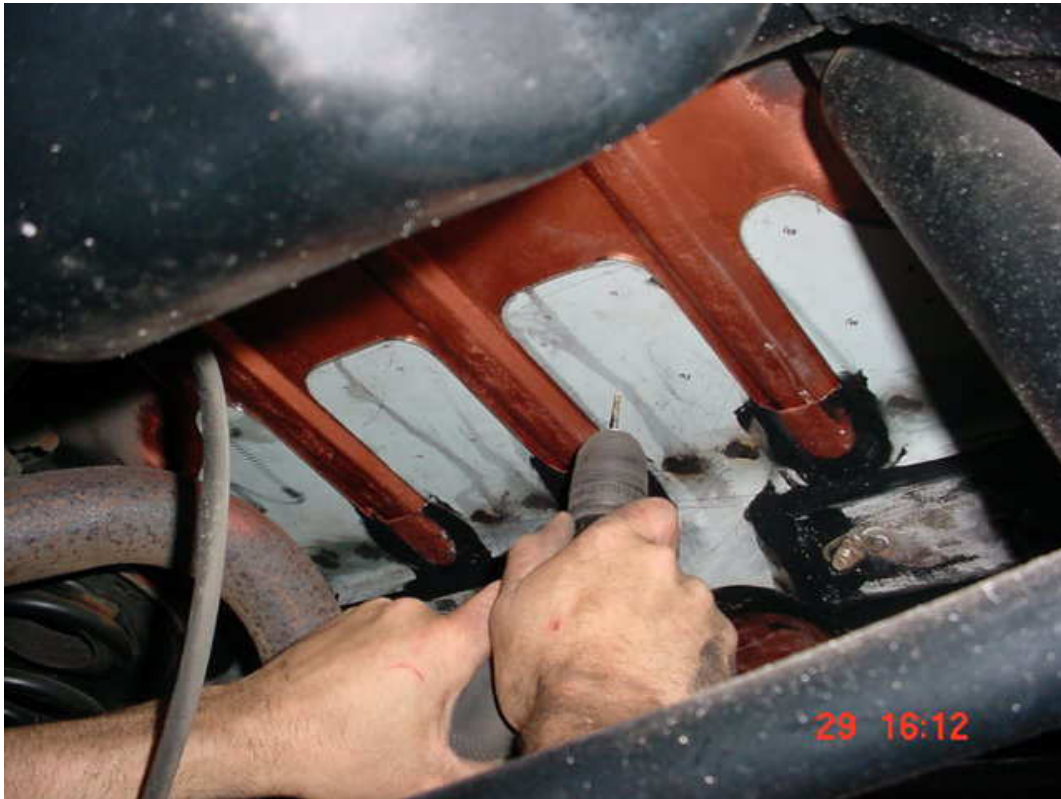
From underneath the vehicle, drill sixteen 2 mm (1/8") holes through the floor, **AI** using the pre-cut pilot holes in the loadbar.

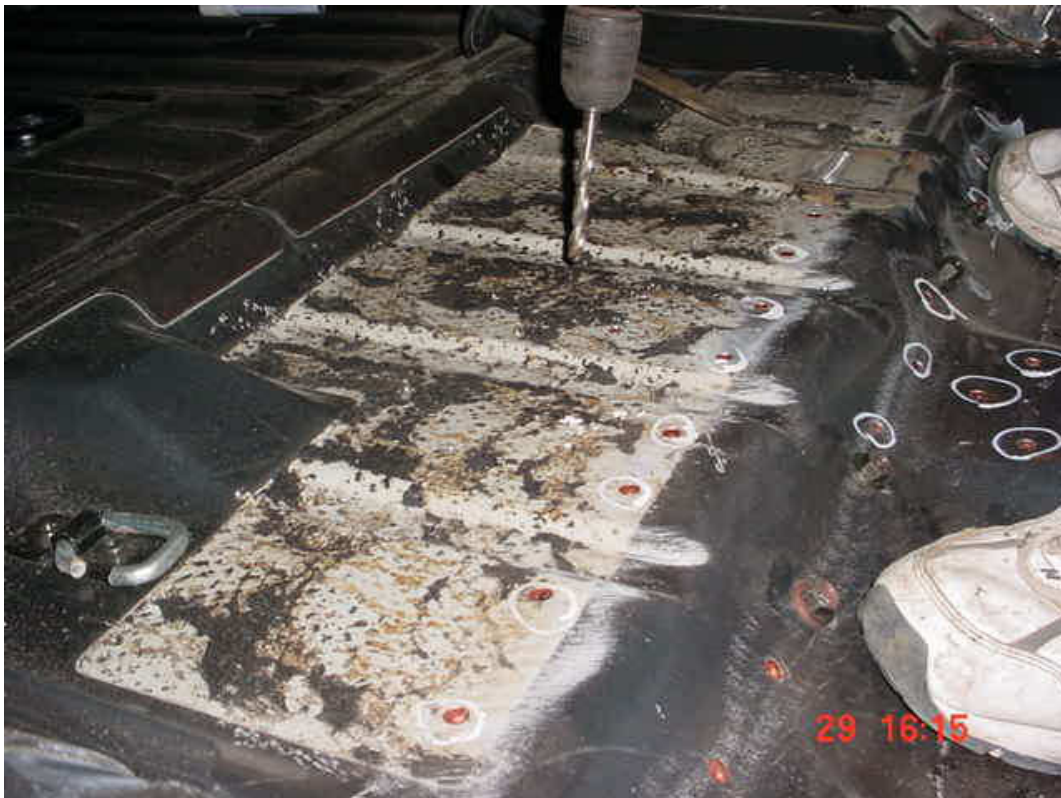
From inside the vehicle, open out the sixteen 2 mm holes just drilled. Drill 8 mm (5/16") through the floor (one layer), these are now ready for plug-welding. Fit some PK screws and panel washers to pull the plate assembly firmly against the floor if necessary. Plug-weld all holes. **AJ**

- 41) If necessary in order to further achieve a firm close-contact fit between the LVV Seat & Seat Anchorage Load-bar & reinforcing plate assembly and the central floor section, some PK screws and panel washers can be temporarily installed to pull the sections together. Plug-weld all holes in the vehicle's interior where the reinforcer-plate was drilled out, and the sixteen holes drilled in step 40. (Tip: using an airgun to cool the weld immediately after each plug-weld minimises the flame damage to the coatings underneath each plug-weld).

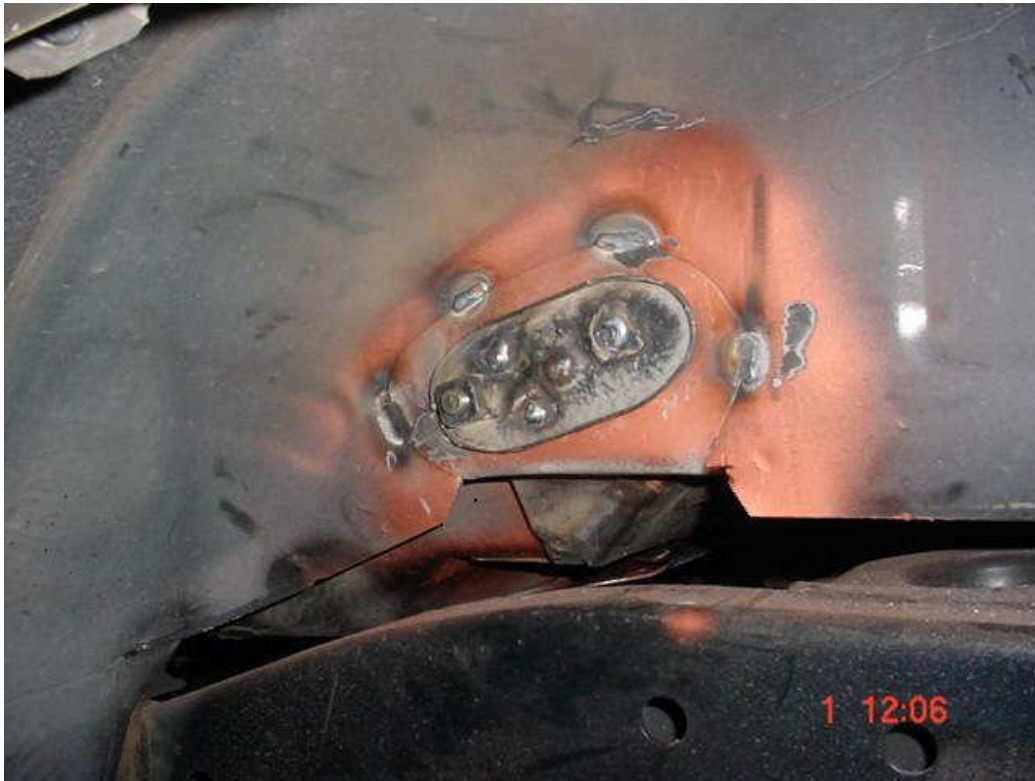
**AK**

Plug-weld all holes in the wheel-arch area and stitch-weld around the “ears” of the LVV load-bar.

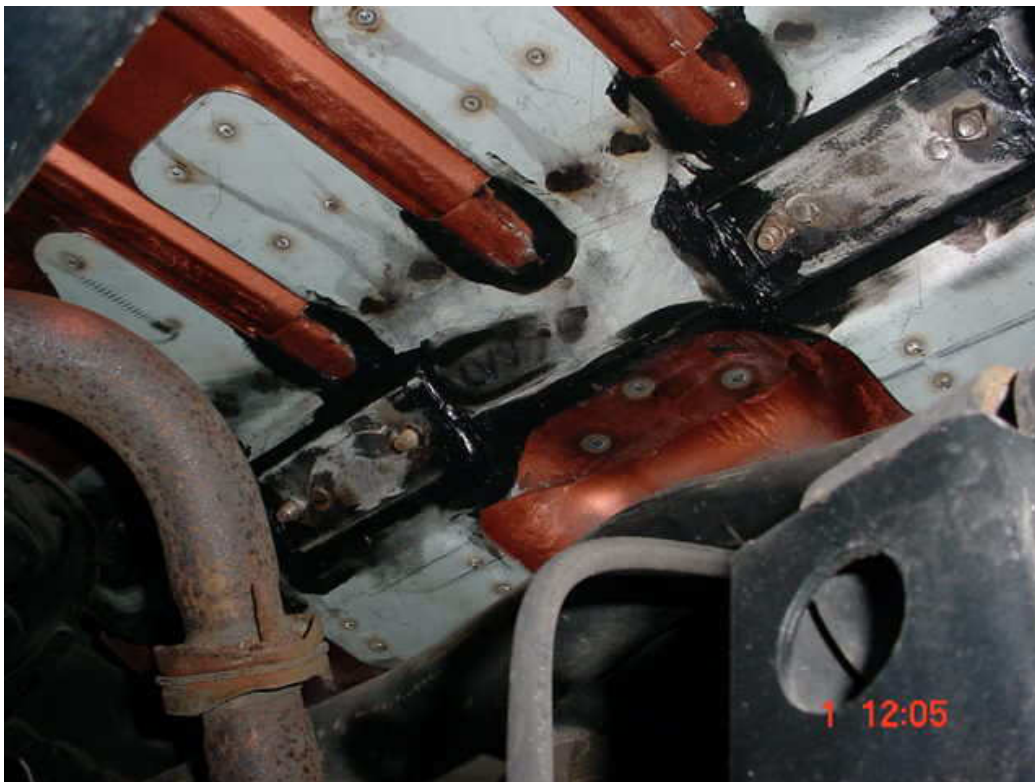
**AL**

Epoxy coat the underside and wheel-arch area, allow to dry and apply urethane sealant to all edges. Finally apply underseal.

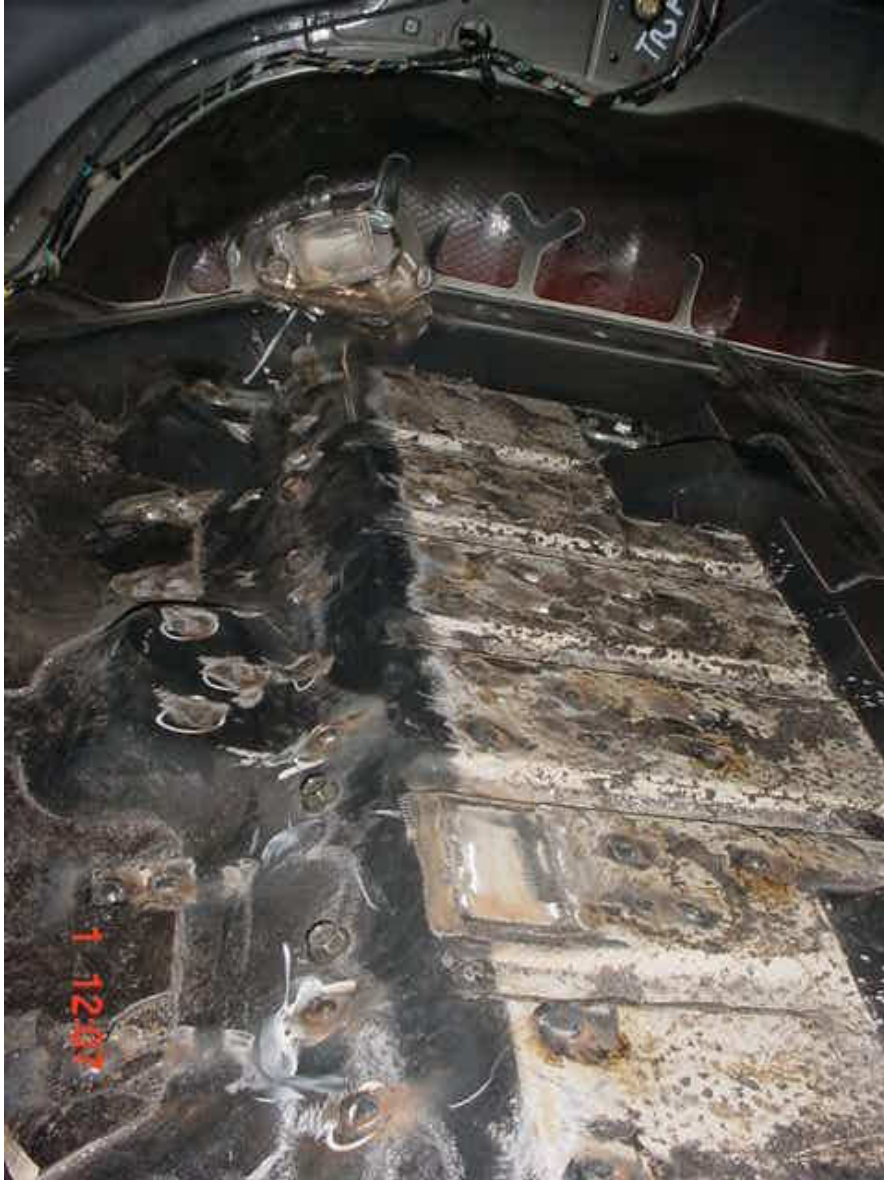
**AM**

Cleanup interior welds, apply final interior surface finish, refit seats, carpet and trim.

- 46) Lower the body back down and re-bolt it to the chassis. Re-install the rear seats, and re-install the seatbelts, applying the correct torque to the seatbelt anchorage bolts. These settings can be found in LVV Seatbelt Anchorage Standard 175-00. Refit the rear bumper clips.
