Nissan Terrano D21 Rear Seatbelt Anchorage/Floor Rust Problem and LVV Modification Solution

This Infosheet replaces Infosheet #02-2004

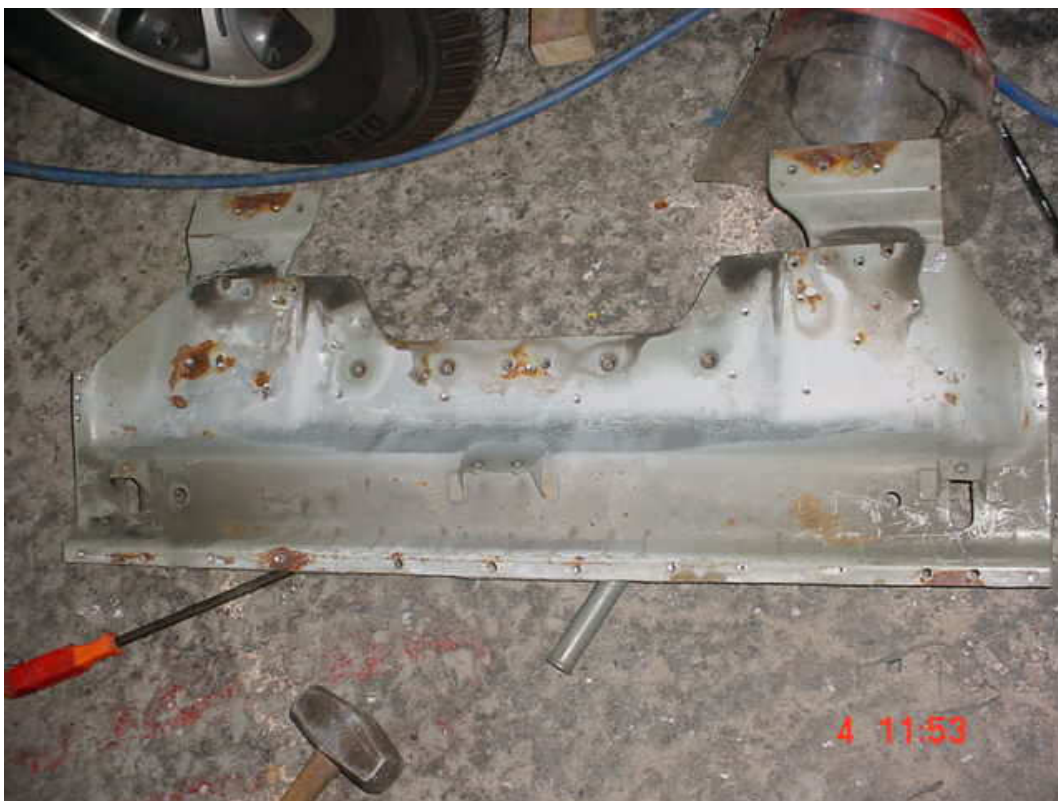
The reinforcing plate upper face (hidden from view when in the vehicle) is inspected. This example is one of the better ones. Any patch repairs to the reinforcing plate are done at this stage.

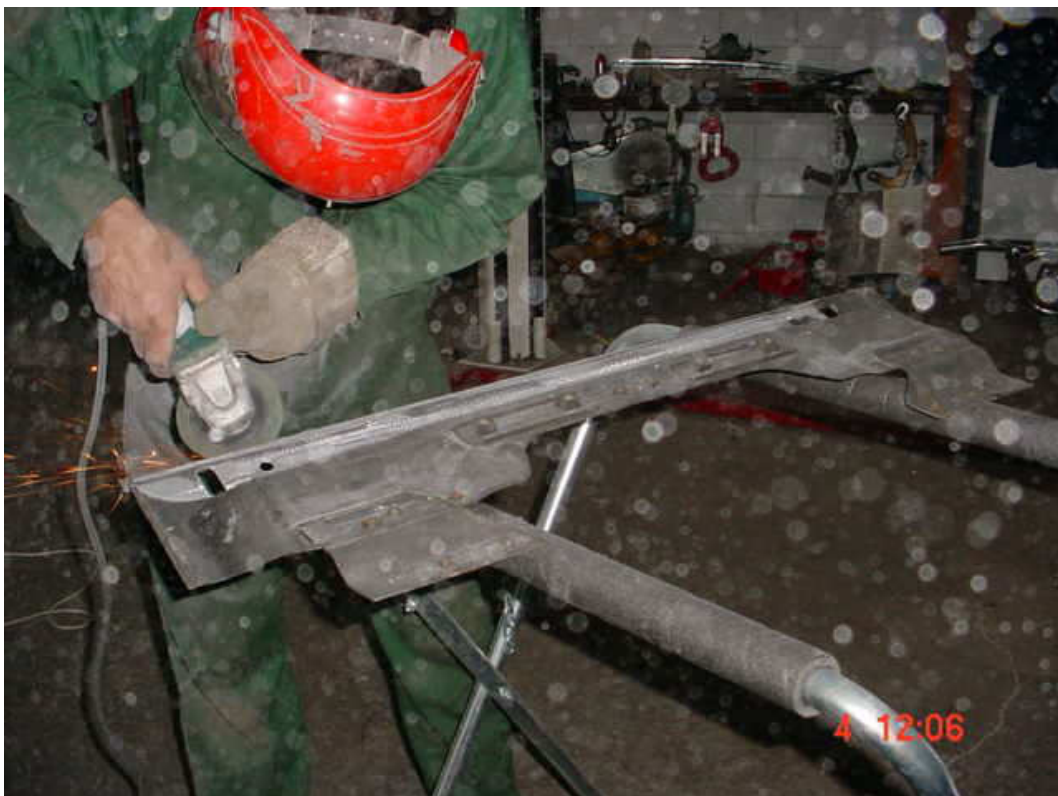
The reinforcing plate underside is cleaned to bare metal by wire-wheel and grinding to remove rust, etc and where the LVV load-bar overlaps.

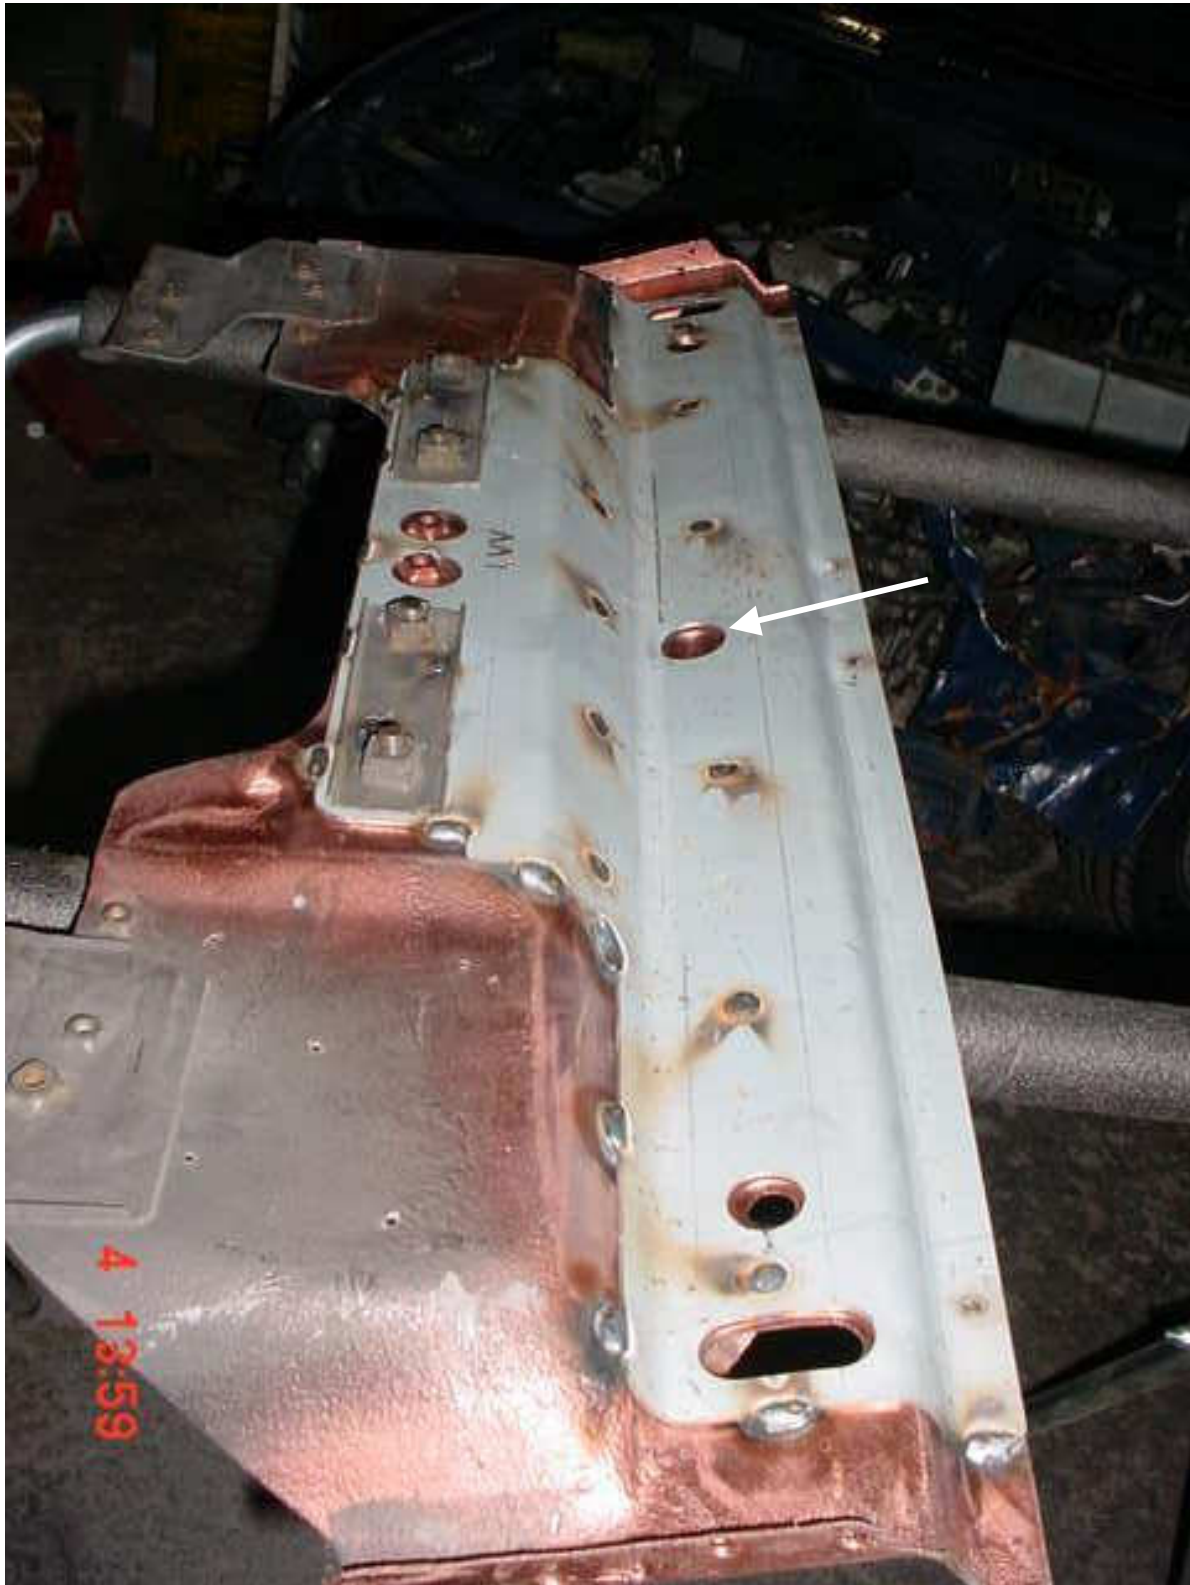
Plug welding of LVV load-bar and seat-belt anchorages is completed. The arrow shows where a 12 mm hole may need to be drilled to allow for injecting penetrating rust-proofing coating later.
