## Rear Shelf Speaker Aperture Modification

If you have any queries or require any further clarification relating to this Information Sheet, please feel free to contact Kendall Bradley at the LVVTA office on (09) 268-9550.

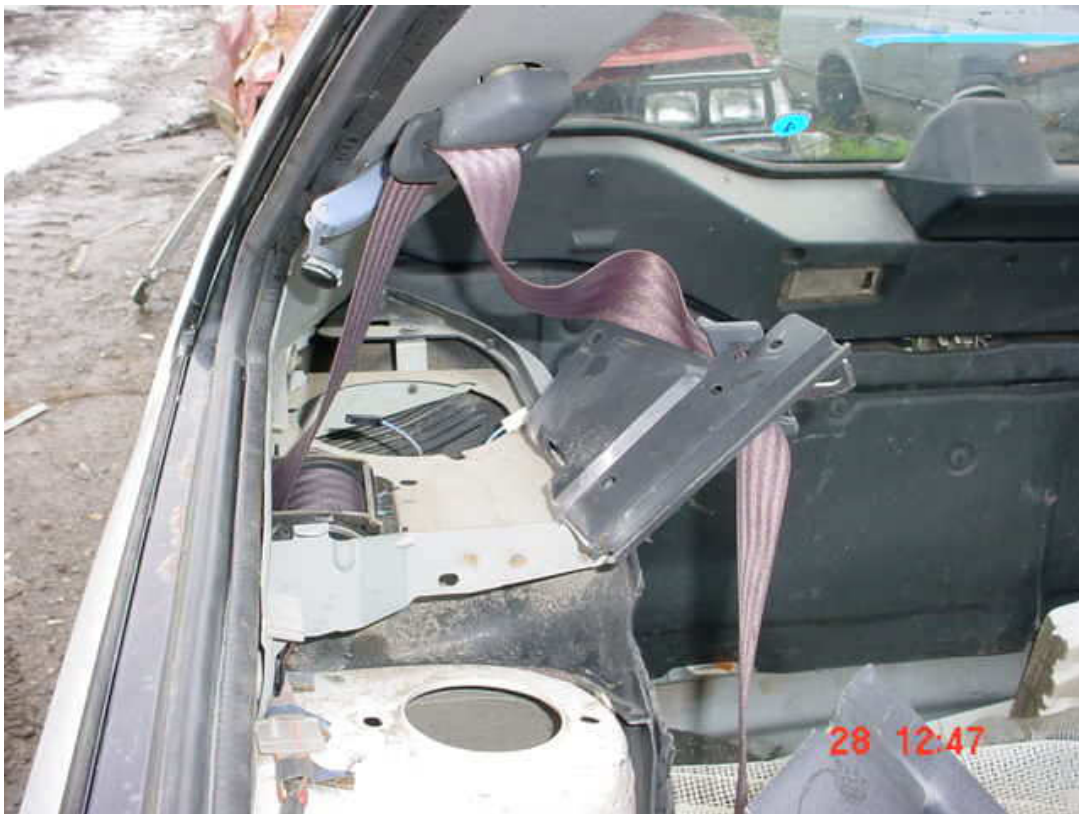
#### **3-door Ford Laser**

An example of a 3-door Ford Laser hatch (looking through the right side window aperture, rearward toward the tailgate) shows how the seatbelt anchorage is attached to the vehicle's C-pillar. The speaker structure around the seatbelt retractor is bolt-on, of flimsy construction, and plays no part of the seatbelt anchorage's strength.

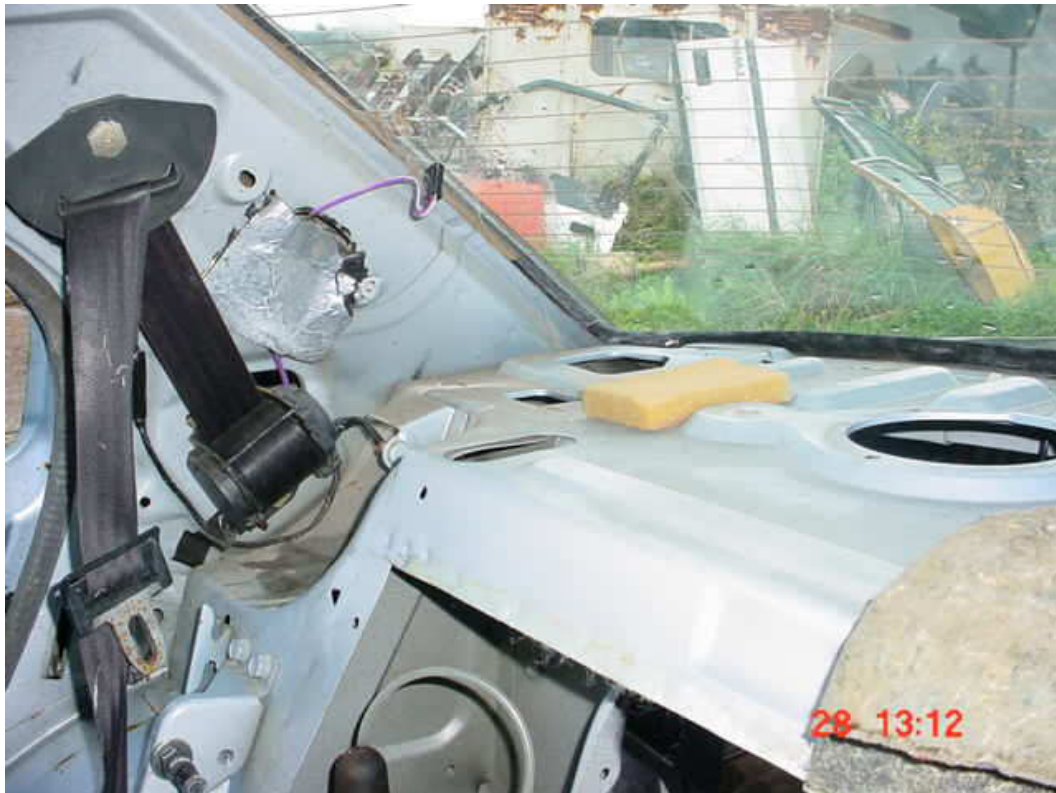
#### **Ford Fairmont**

To follow is an example of a seatbelt anchorage which is attached into the C-pillar of the vehicle, but which also has a substantial rear shelf.

This anchorage is from a Ford Fairmont, which has a strong rear shelf/rear of seat structure attached to the bodywork near the retractor anchorage. However, the relative positioning between the anchorage and the speaker aperture is such that a minor modification to the rear shelf would have no effect on the strength of the part of the vehicle structure to which the seatbelt retractor anchorage attaches, which is pulling upwards towards the running loop.

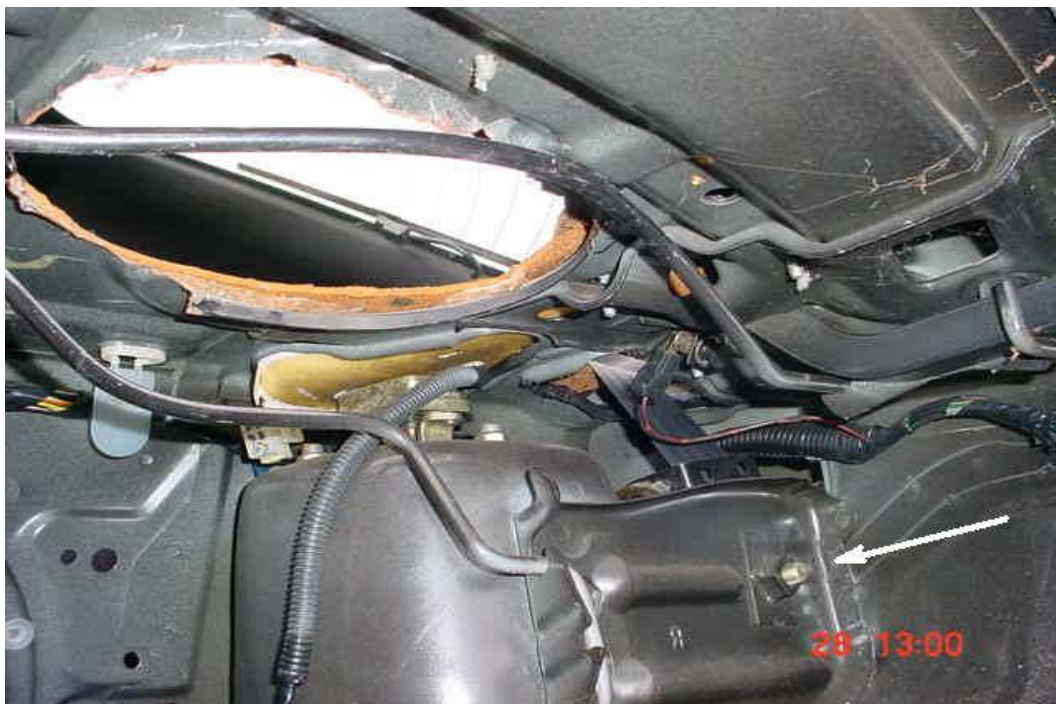
### Nissan Skyline

This 2-door sedan Nissan Skyline has an enlarged speaker aperture already, but as can be seen when viewed from within the boot looking forward, the retractor anchorage bolt (can be seen 'arrowed') is attached to a part of the rear structure, which is unrelated to the rear shelf. This speaker aperture modification would not affect the strength of the vehicle structure to which the seatbelt anchorage attaches.

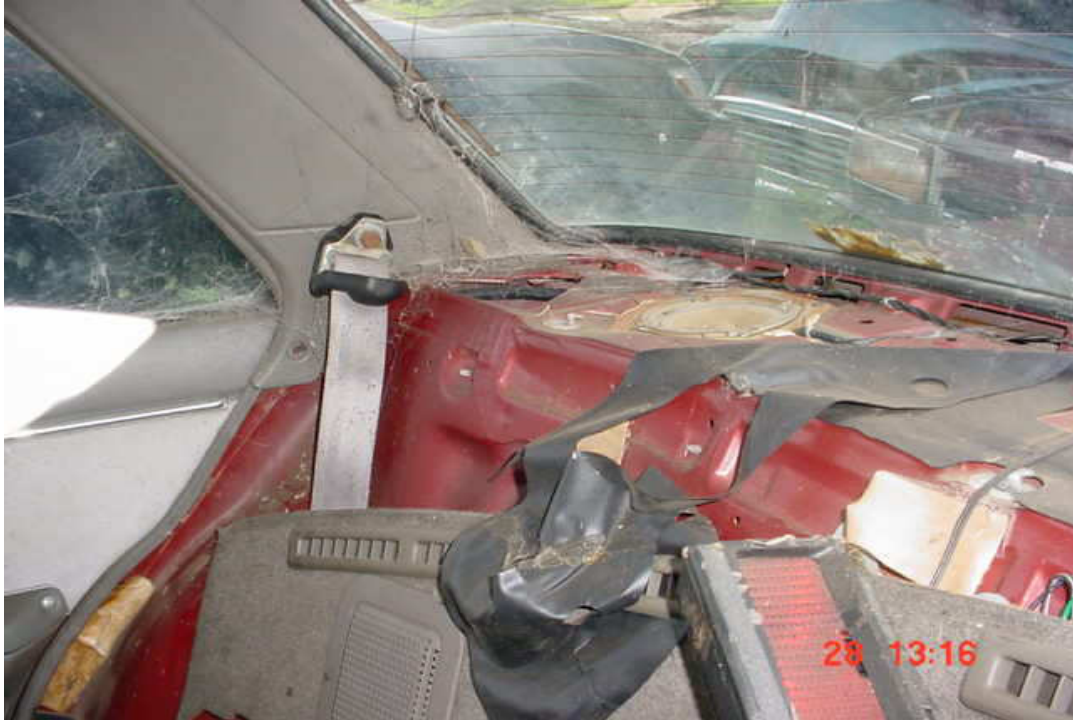
### **Early Nissan Bluebird**

This Nissan Bluebird static anchorage would pull forwards on the C-pillar and inwards during an impact. The sheet metal structure forming the rear of the seat would still provide support to the C-pillar's inward loading, even if the rear shelf speaker aperture were to be enlarged.

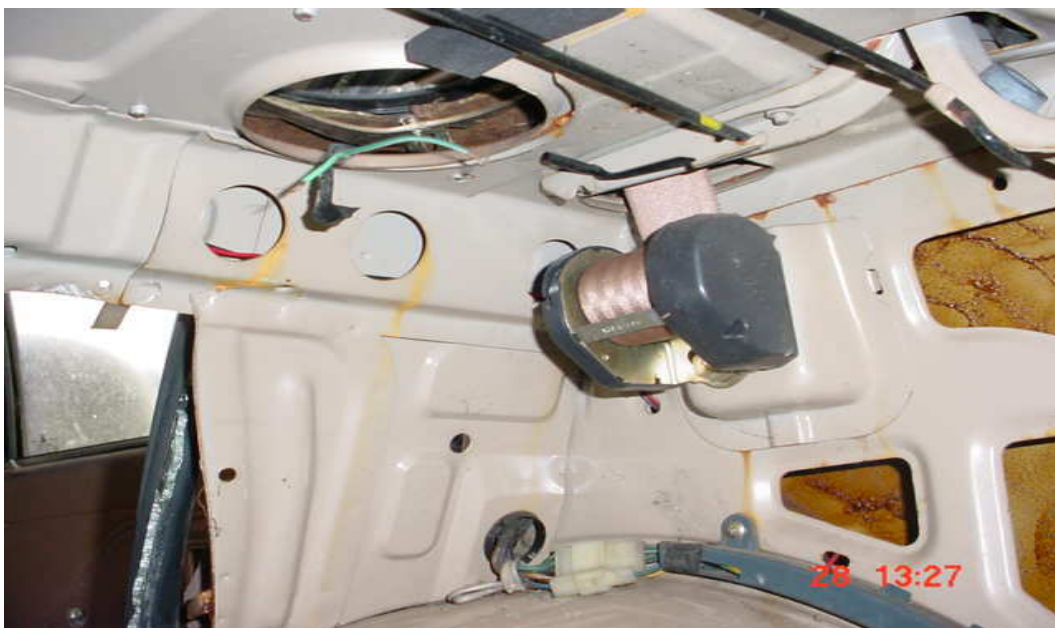
### **Hyundai sedan**

This Hyundai 4-door sedan also has a running loop in the C-pillar. The pull on the retractor will be vertical, and the removal of some material on the rear shelf speaker aperture will not affect the strength of the vehicle structure supporting the seatbelt retractor mount or the running loop.

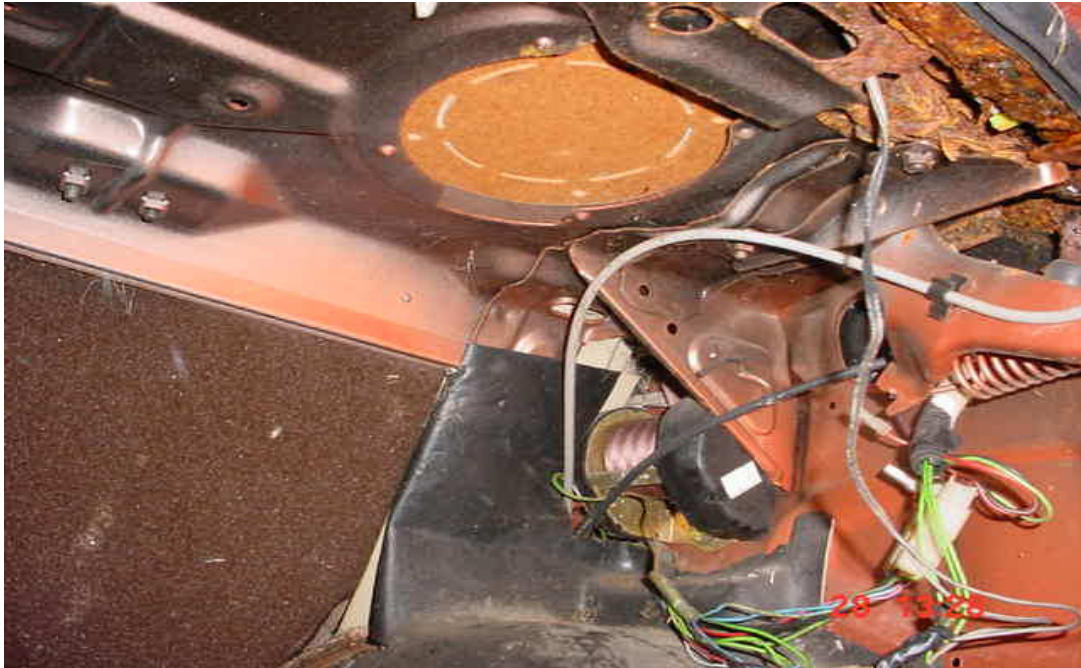
### **Mitsubishi Mirage Geneva**

Again, the retractor and running loop are attached to the C-pillar, so the rear shelf is contributing little to the strength of the structure where the seatbelt anchorage attaches, provided the aperture was increased inwards toward the centre of the vehicle's longitudinal centreline, and the angled stiffener beside the retractor mount was not modified or removed.

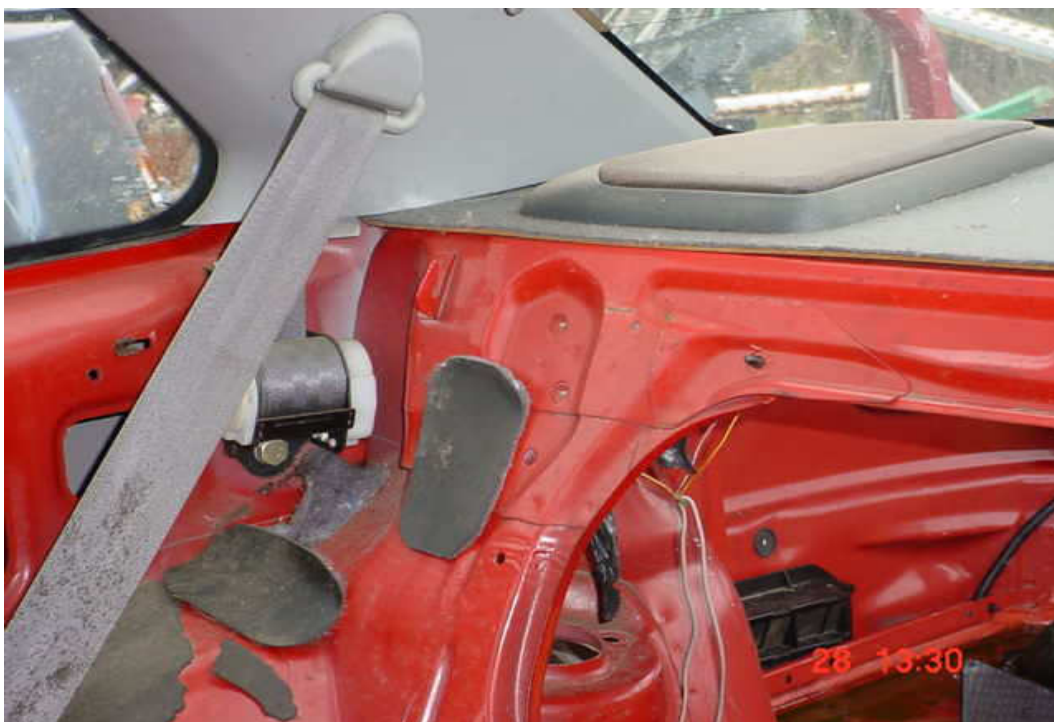
### **Mitsubishi Mirage 2-door**

A Mitsubishi Mirage 2-door sedan: the retractor and the running loop both pull vertically against each other, with no inward load component at the retractor anchorage point.

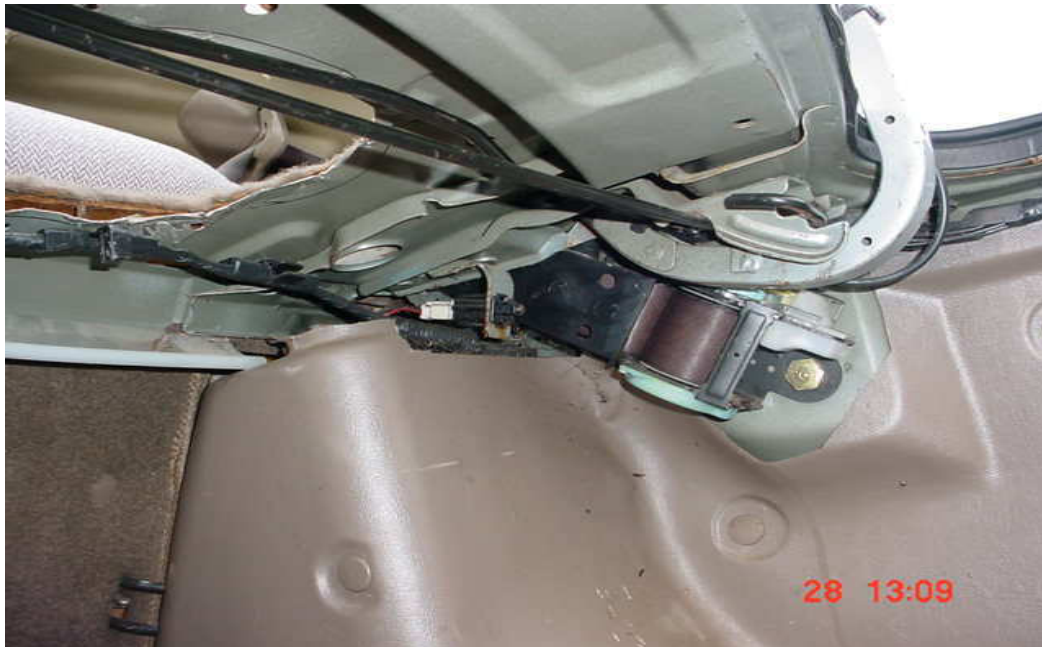
### **Ford Telstar**

This Ford Telstar has a running loop in the C-pillar (as most of them have). In this vehicle, if the C-pillar were to be supported by anything, it would be from the much more robust section further back that supports the boot hinges, and not from the rear shelf where the speaker apertures are.

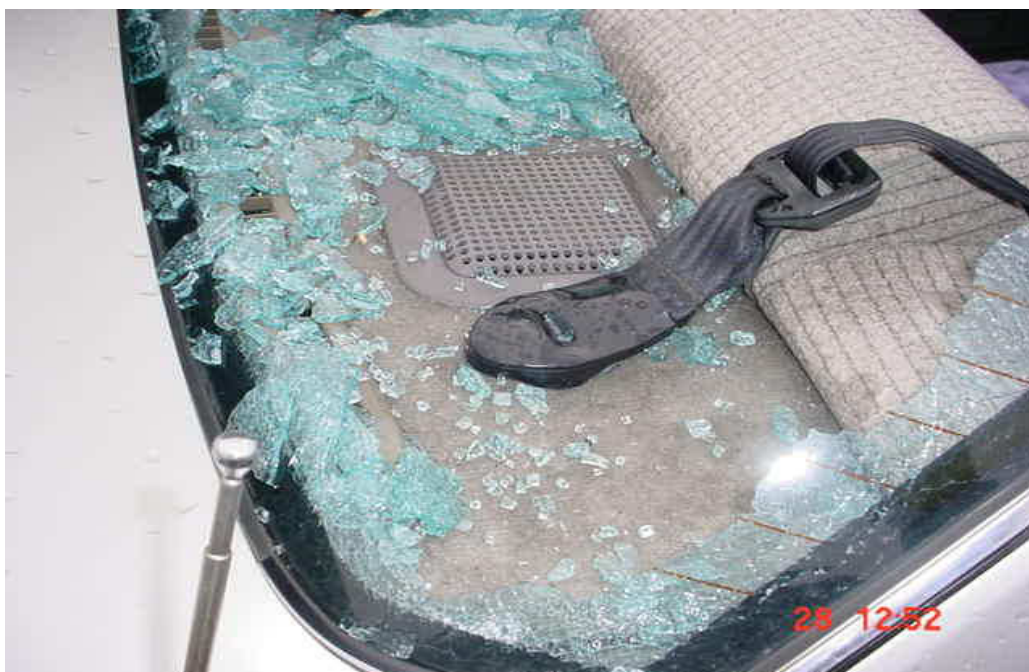
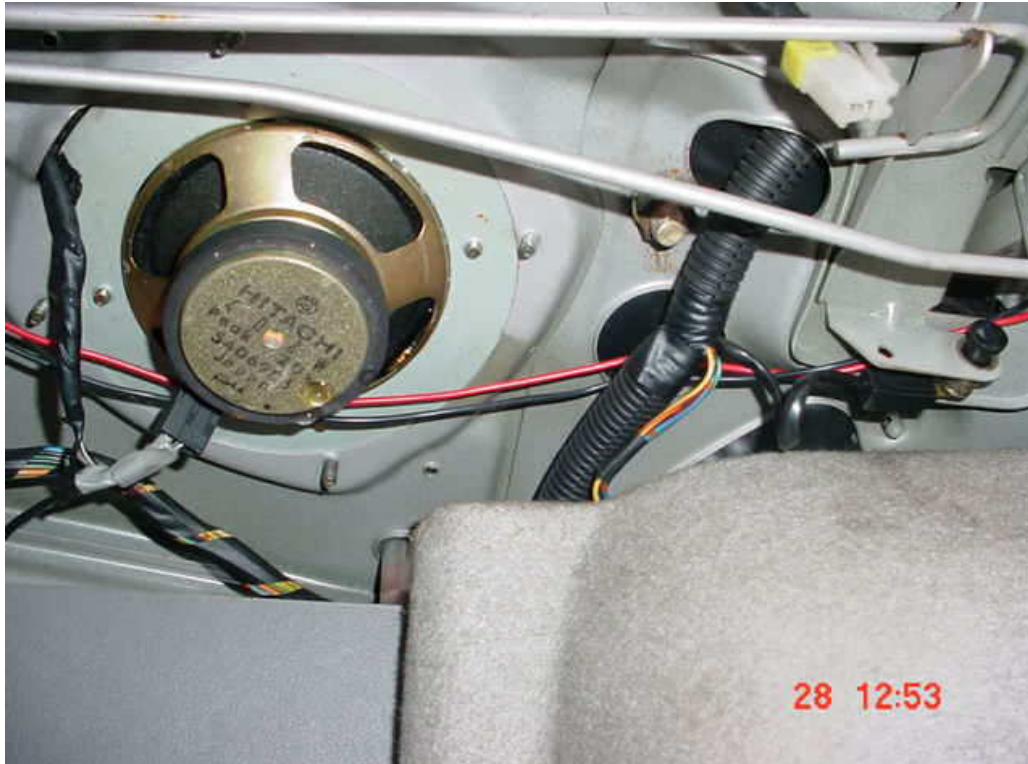
#### **Nissan Bluebird**

This Nissan Bluebird sedan (this photo and next page) has a static upper seatbelt anchorage attached directly to the rear shelf. This is typical of a rear shelf that should never have its speaker aperture increased in size without having the vehicle LVV certified.

A rear shelf which has an upper seatbelt anchorage attached directly into the shelf, and has an enlarged speaker aperture (or any other structural modification for that matter) must be referred to a LVV certifier, who will ensure that any strength lost to the shelf as a result of the modification will be reinstated by some suitable method.
