Bump-steer Measurement Background Information

Introduction:

This document is intended to summarise the development process of the bump-steer swing-check bars and the measurement system used with the bars, and the questions that arose during that development process along with explanations and answers. Understanding this background information is not essential in order to conduct a bump-steer swing-check, but rather is intended for those who want to understand the subject further.

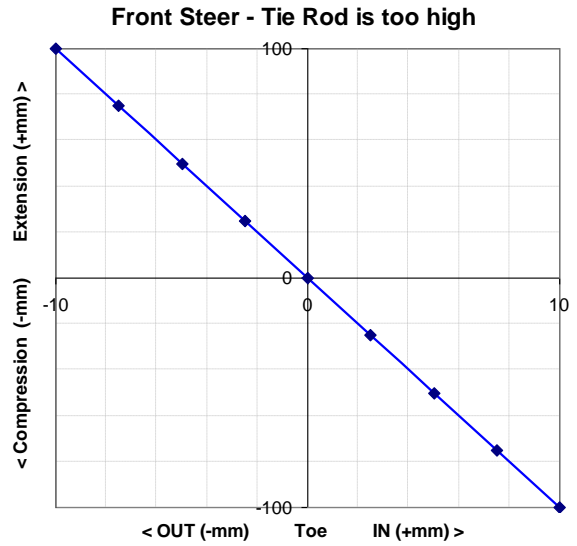
- Steering arms facing to the front of suspension ('Front steer'):

The shape of the graph produced by the bump-steer swing-check will indicate which aspect of the geometry is incorrect. Note that the solutions are reversed for rear-facing steering arms compared to front-facing arms. Ensure that the correct graphs are referred to below, and check that the axes on the graph are the same way round as the graph of the measured data.

The bump-steer data can be a combination of the curve and straight line, creating an 'S' shape.

- The lowered tie-rods did their job of providing noticeable toe change. Comparing the data to the graphs on page 4 indicates that better toe-change requires the tie rod end to be raised – this is consistent with the change made and indicates the standard tie rods will give less toe-change.

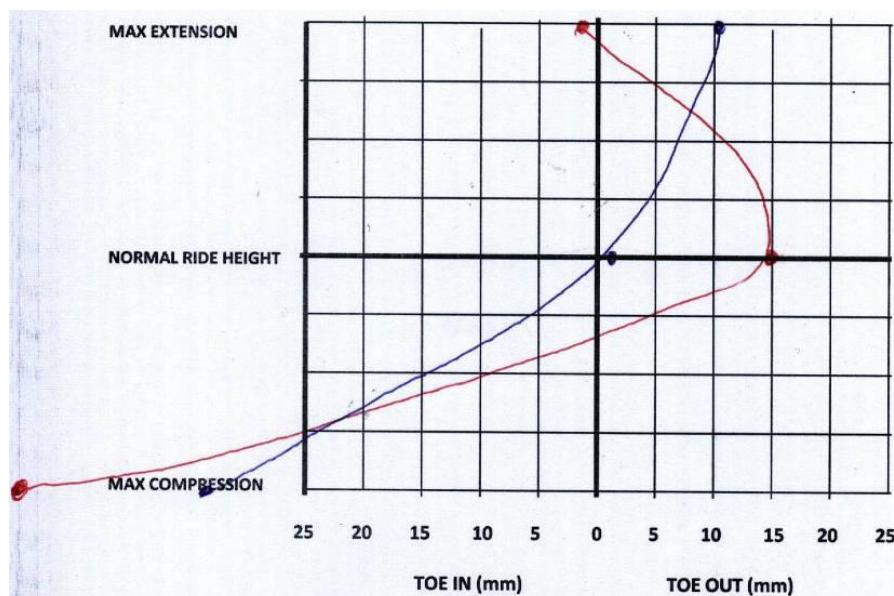
This vehicle was fitted with an airbag suspension system which allowed bump-steer to be checked without removal of suspension components. Three measurements were taken using the bars, and then the vehicle was driven a short distance and checked on a Hunter wheel alignment machine. The machine was set to read in mm and not degrees, and the machine measurement diameter was unknown. At the time (being our first comparative test) we were unaware of the importance of knowing the wheel diameter being used by the machine, or the necessity for having the machines set at degrees and not mm. The results are as shown in the graph below.

As can be seen, the curves cross over, indicating no correlation between data. This could be caused by one or a combination of several factors, including:

- the toe was not set to zero prior to the check;
- the steering wheel was not centred or locked in place;
- the suspension was unloaded with the bump-steer bars, but loaded on the wheel alignment machine with vehicle weight on the wheels;
- there may have been worn or soft suspension bushes, ball joints, steering joints, and steering box free play;
- measurement error.

Regarding the measurement error, if one measurement across the bars was taken to the inside edge of the bar instead of the outside, it would give a 25mm error. If this happened during the normal ride height measurement, the bars would give -10 mm instead of +15 mm and the difference between the bars and alignment machine would then be -12 mm, -9 mm, -11 mm which is much more consistent.

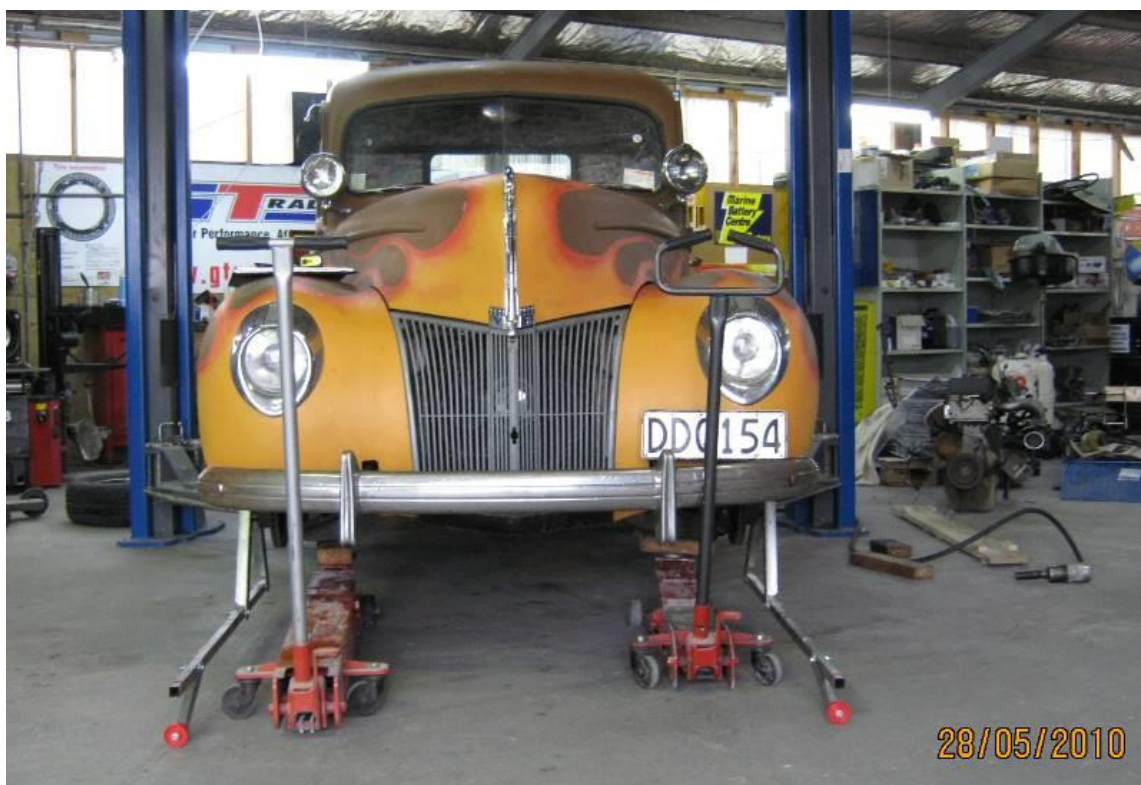
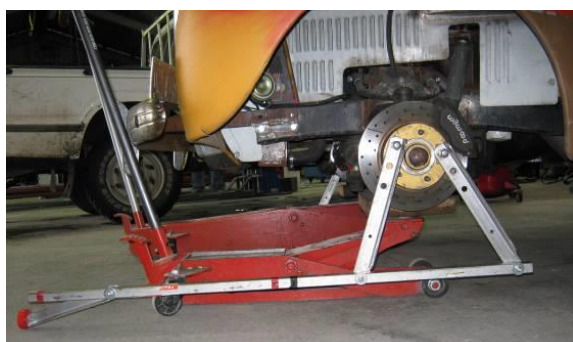
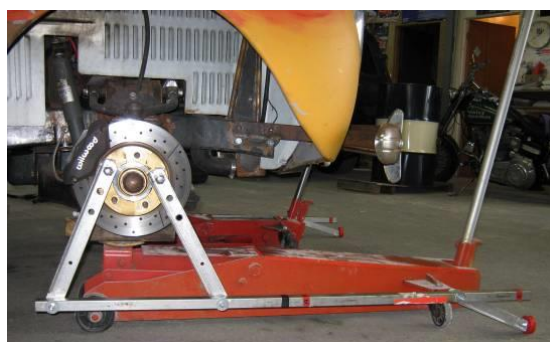
Ford pick-up data

The bump-steer bar measurement is over 600 mm (distance from AA measurement to BB measurement). The electronic alignment machine does not specify measurement distance, but by switching between mm and degrees on the read-out it could be calculated. This was done on the Commodore and it was found that 2 mm toe equates to zero degrees and 15 minutes. This indicates that the machine uses a measurement distance of about 460 mm (18 inches). However, this may change depending on the vehicle type entered into the computer – the Commodore had 18 inch wheels as standard.

Assuming the 460 mm figure is relevant for the truck measurement, the aligner data can be corrected to be equivalent to the bars (600 mm) and the measurement difference between bars is reduced. Here is a comparison of the corrected machine figures (to 600 mm):

These figures are slightly closer but still not comparable. If the alignment machine was using a smaller wheel diameter to measure across, the data would be closer (13 inch wheel would change the 7.8 mm figure to 10.9 mm). Regardless of this, the data will not match up exactly as the slope of each line on the graph is different, indicating that there are other differences present.

Unfortunately, the exercise on the Ford pick-up remains a head-scratcher for us, and we still don't know exactly what happened to give us the large and unaccounted for difference in figures. As a result of this unresolved outcome, LVVTA tested a number of different vehicles in different ways at different locations (outlined further on in this Information Sheet), to try and better understand the process and gain confidence that if everything is set correctly and used correctly, the outcome between the LVVTA bars and a wheel alignment machine will be very close.

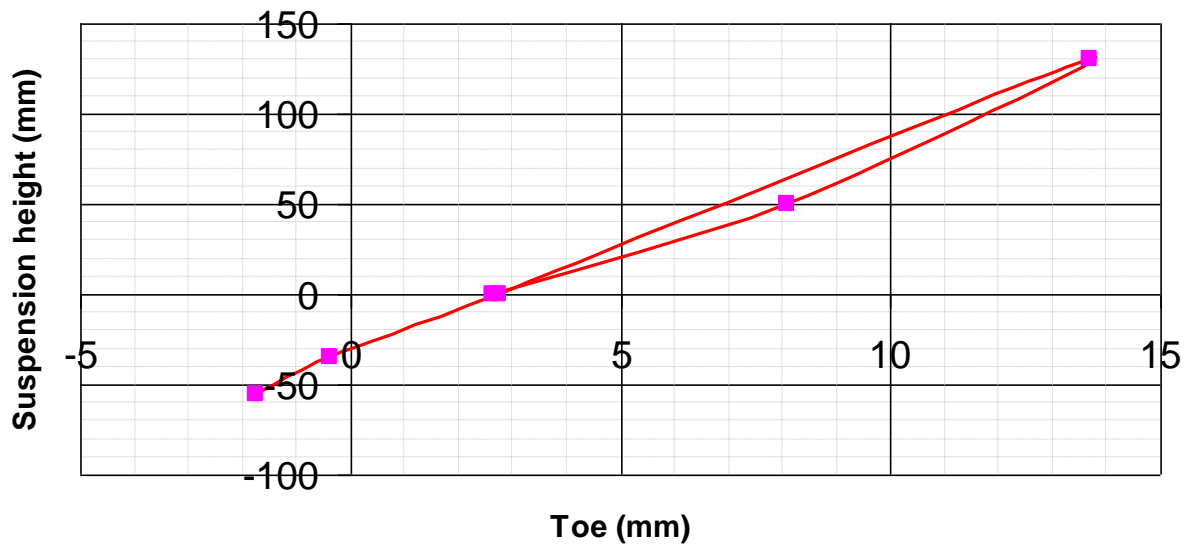
2009 Commodore alignment machine data adjusted to 575mm

The reference distance is known so these figures have been adjusted to the equivalent of a 575 mm reference distance in order to be comparable to later data. The Commodore toe figures on the alignment machine are shown in the following table and graph (575 mm reference distance).

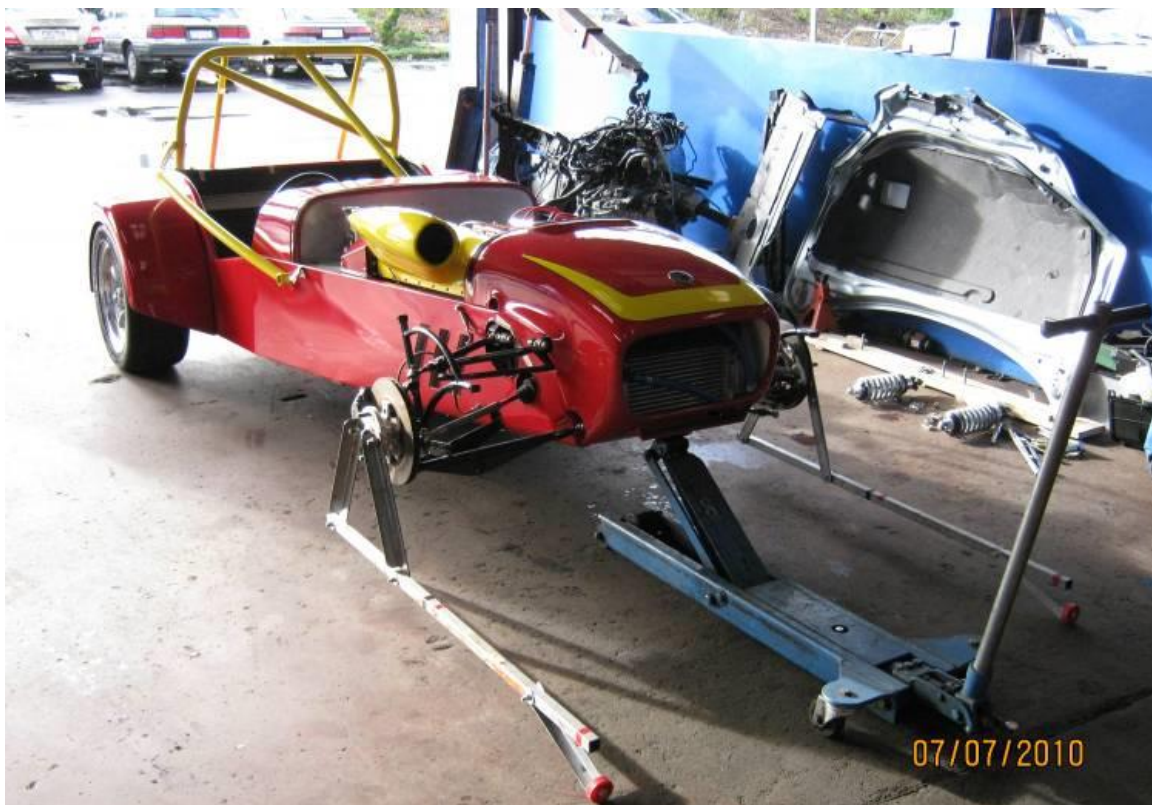
Chris Litherland (LVVTA Technical Advisory Committee) and Justin Hansen conducted a comparison test of bars and alignment machine on a scratch-built Fraser 7 sports car. This vehicle was chosen as the suspension features heim joints and so will not suffer from rubber bush compression. Some spacers were made up to fit between the steering arms and the tie rod ends to create some geometry problems so that we would have some toe-change to measure.

This test showed a very close correlation between the LVVTA bars and the wheel alignment machine.

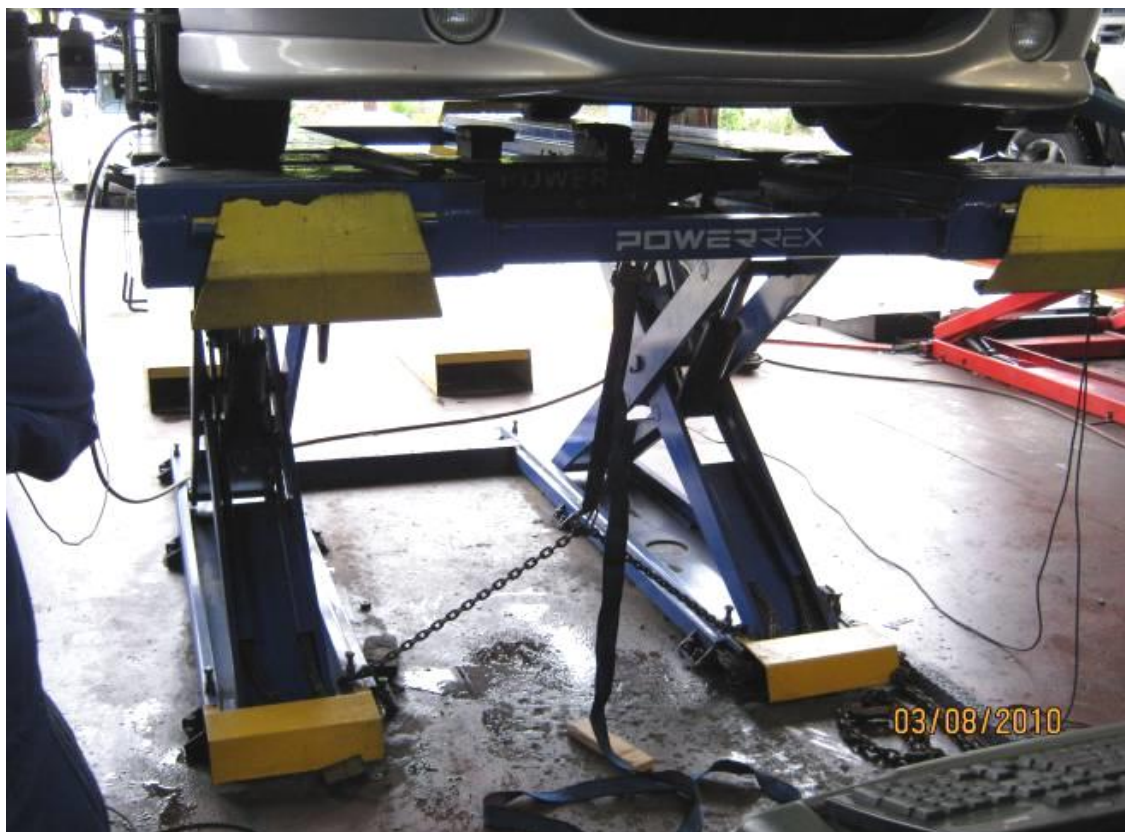
The 2003 Holden Commodore was also measured using the bars, with the springs removed, and also measured on the wheel alignment machine with springs removed and by the pull-down method. See below the graph showing all of the data (all three different measuring methods) for the Commodore. The following photo shows the chain and tie-down strap used to pull down the vehicle.

The data for the alignment machine with and without springs fitted is separated by about 2 mm but is very consistent. Flex on the suspension bushes will account for the 2 mm variation. The data from the bars is also very close, especially for suspension extension. These tests gave LVVTA the confidence that if carried out correctly the results between all three different ways of carrying out the test will be more or less the same.

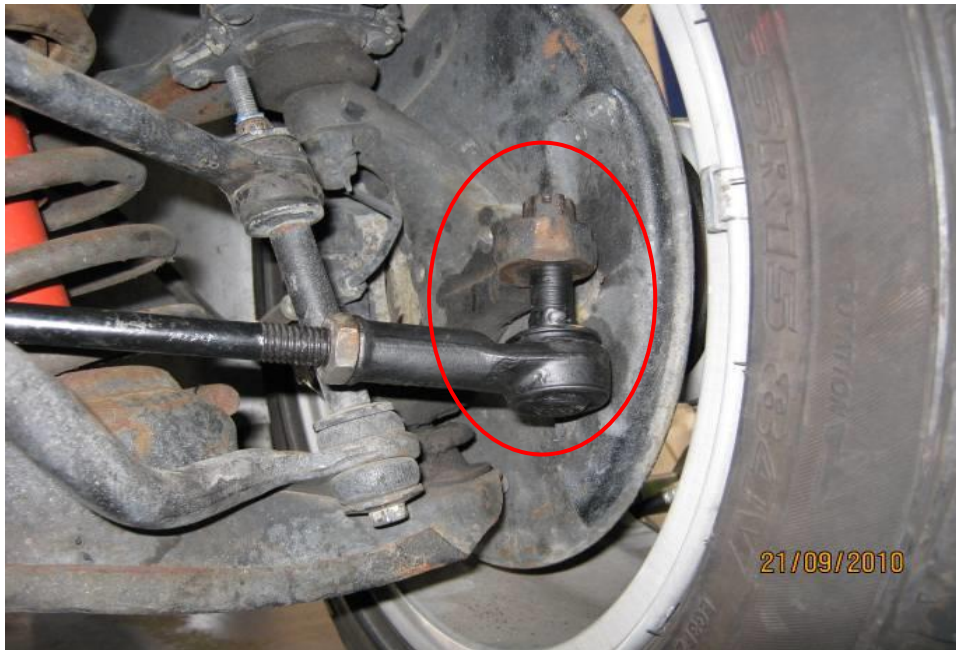
Lastly, with our theories sorted out, and with a better understanding of the whole issue, a final and very thorough of three consecutive comparative tests were conducted on a Cortina-based Almac with a pair of extended tie-rods (to create some geometry problems) as circled in the photo below.

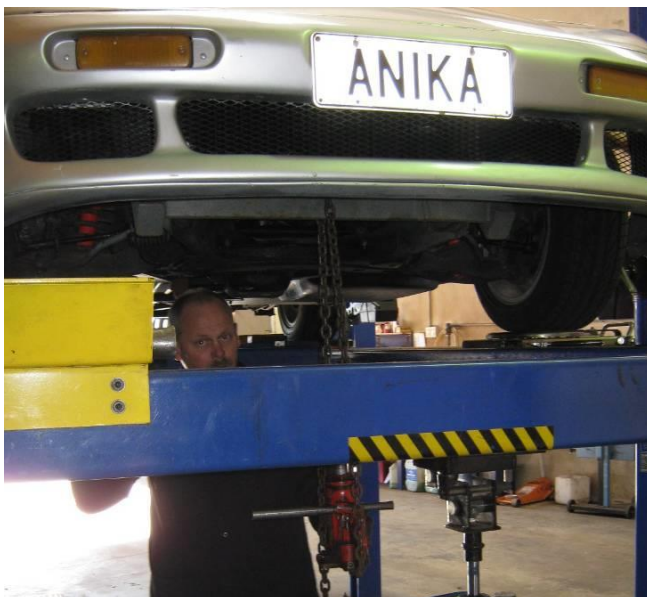
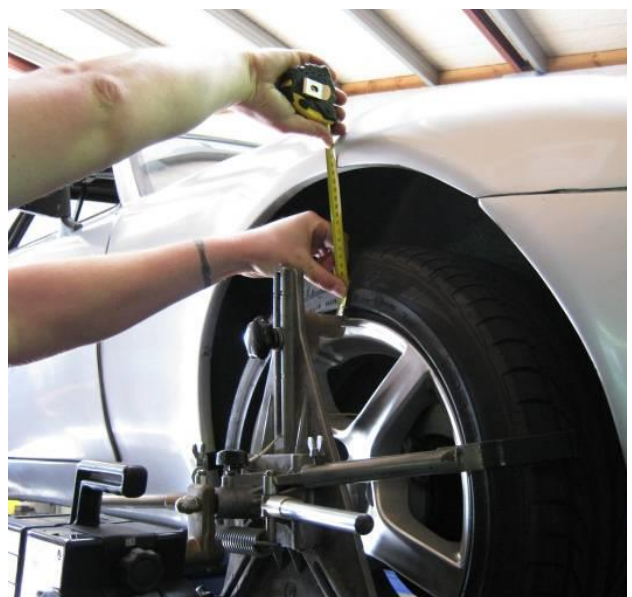
Test 1 - Alignment machine:

Vehicle on 4-post hoist, pulled down with a chain and bottle jack, as shown. Measurements were taken first with raising the car up, then by pulling it down. The alignment machine was set to measure in degrees, to avoid any question over the measurement distance. The bar's measurement was set at 575 mm to enable a direct comparison (1 degree = 10 mm).

Ride height measurements were taken from top of wheel rim to arch. The wheels are 15" so 190 mm can be added to give centre of wheel to arch measurements.

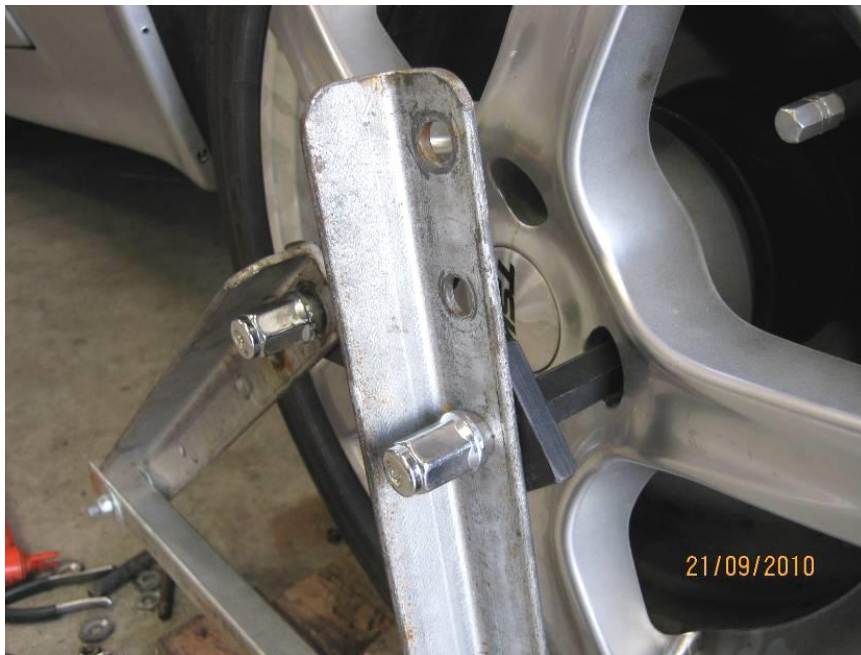
Test 2 - Bars fitted over the wheels, springs in:

Vehicle on 4-post hoist, pulled down with a chain and bottle jack. The bump steer bars were fitted over the wheels by using long adaptors (accurately machined) mounted to 2 wheel studs. Measurements were taken first by pulling the car down, then raising the car up. Toe at static ride height was measured again after pull-down and the same toe figure was recorded.

The bars were not levelled for each test - the brakes were locked on instead - so at full droop the bars were away from horizontal. To check that this had not affected the results the bars were levelled by readjusting the fitment to the wheels - the result changed by only 1 mm from +37 mm to +36 mm.

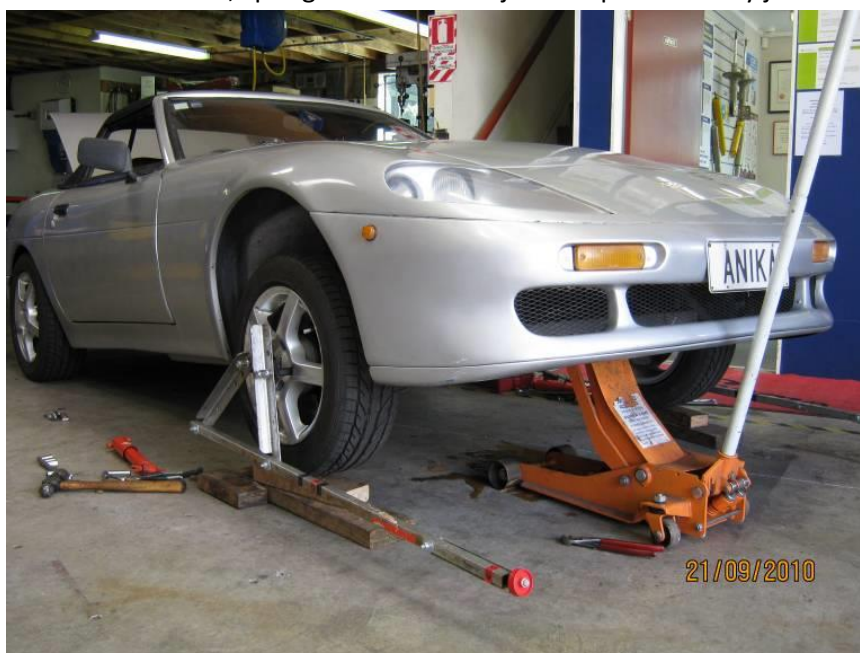
Test 3 - Bars fitted over the wheels, springs removed. Car jacked up on a trolley jack:

The workshop did not have 2 trolley jacks to lift each hub up while the car is on axle stands as we have done previously, so the test was conducted slightly differently; - the wheels were left on the vehicle and the trolley jack lifted the chassis. This will give a similar result to the usual method, with the loads going through the wheel hub instead of the lower arm under the ball joint.

The bars were fitted over the wheels as in the other tests. The tyres were placed on wood blocks to gain ground clearance for the bars so it was not possible to use slip plates. A check was made to ensure that the tyres were not dragging due to friction with the wood. The wheels were briefly lifted up at full droop and placed back down on the wood to relieve any side loads. The measurement across the bars did not alter.
