TECHNICAL STUFF

Low Volume Vehicle Technical Association (Inc)
E-mail: info@lvvta.org.nz Phone: (04)238-4343

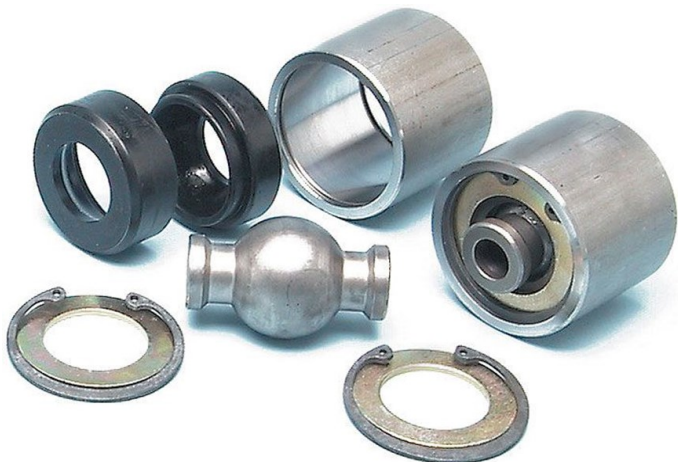
Enter the 'Johnny Joint', named after John Currie of Currie Enterprises. A forged threaded version is shown below.

These joints are a 'hybrid' combination of a spherical joint and a bushing, with a specially-designed ball encapsulated in a nylon bushing, and contained within a re-buildable shell.

This joint features heavy construction, and combines the best aspects of both the spherical joint (articulation) and the bush (ability to isolate shock and road-noise). These are potentially an ideal solution for many different suspension set-ups. Shown below is a photograph (of a 'weld-on' joint) that shows how they are constructed, in order to allow both articulation and bushing compliance.

However, being a relatively new innovation, 'Johnny Joints' don't fit into any specific technical section within the HCTM suspension chapter, and they don't come with specific load ratings from the manufacturer. This has resulted in some uncertainty as to whether they actually meet LVV requirements.

The LVVTA Technical Advisory Committee (TAC) recently looked into the suitability of these joints, to determine whether or not they were fit for purpose on road-going vehicles. TAC members assessed an actual joint, supplied by the NZ agent *The Kryslar Shop* in Tauranga, along with documentation supplied by the joint manufacturer. The TAC were very impressed with the design and construction of the joint, and have approved it for use in New Zealand. This means that LVV Certifiers can now approve these joints for use on vehicles being LVV Certified. There are various different styles of joint available; both bolt-on and weld-on, and any of these Currie-brand Johnny Joints are included under this agreement.

- This is applicable only to 'Johnny Joints' manufactured by Currie Enterprises. We are aware of other joints available in the marketplace, however none of these other joints have been assessed. If an LVV Certifier is presented with a similar joint from a different manufacturer, please call the LVVTA office for advice.
- Ensure that all jam-nuts are tightened correctly to prevent loosening, as there will be additional resistance in the joints (especially when new) which could cause fasteners to loosen.
- These joints must not be used in a situation where there are side-loadings (referred to correctly as axial loads), on the joint, such as a single swing-arm setup in an air-bag suspension system, as is sometimes seen in mini-truck setups.

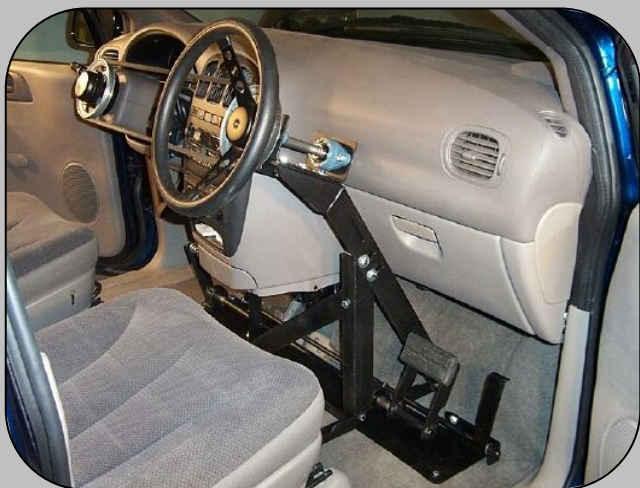
In LVV News issue # 49, we showed a picture similar to the one below of a right-hand drive conversion using a fabric belt. We genuinely thought the picture in the last newsletter was some Photoshop-manipulated joke, or someone with too much time on their hands having a laugh, but we've just discovered that in fact it wasn't a joke at all.

Not only is this right-hand drive conversion for real, it's a commercially-available kit made for many common makes and models of vehicles in the USA, designed with posties in mind! If you think we're pulling your leg, check the website: <http://www.postalthings.com/Right-hand-Drive-Conversion-Kits-RHD/rhd-kits.html>

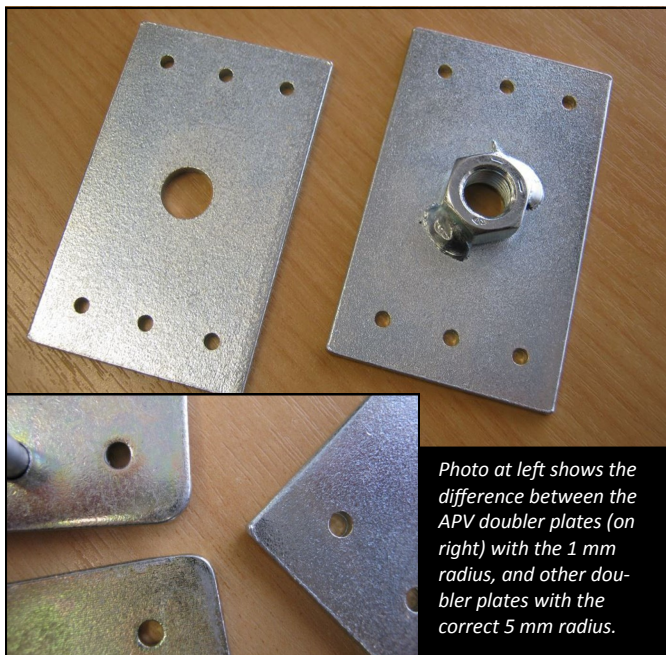
Photo at left shows the difference between the APV doubler plates (on right) with the 1 mm radius, and other doubler plates with the correct 5 mm radius.

Some seatbelt anchorage doubler plates have been discovered on the New Zealand market which incorporate only a 1 mm corner radius, instead of the 5 mm radius required by LVV Standard 175-00 (Seatbelt Anchorages). The doubler plates are made by APV Australia, and have been sold through Repco outlets, amongst others. APV are aware of the problem, and they have undertaken to remove the plates from the market. LVVTA reminds LVV Certifiers and the modification industry that these doubler plates are non-compliant and cannot be LVV certified. They must be rejected until replaced, or re-radiussed and re-corrosion protected.

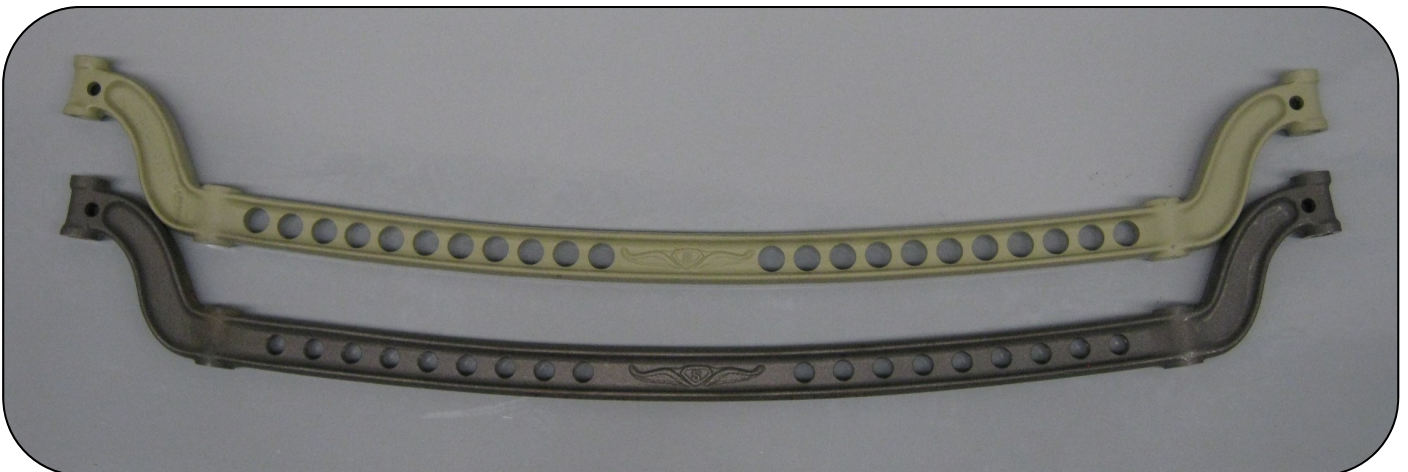
The photograph below shows that the holes in the home-drilled (green primer) axle are significantly larger when compared to the Superbell-drilled axle (dark grey colour).

The Superbell axle's holes are 19 mm in diameter, there's approximately 35 mm of space in between the spring-perch boss and the first drilling, and about the same 35 mm spacing exists between the centre drilling and tip of the wing on the Superbell logo.

By contrast, the home-drilled axle has holes that are 25 mm in diameter, and are spaced much closer to the spring-perch (which we believe would be the area of most concern as this is the failure point of the axles that LVVTA has tested), and also closer to the centre of the axle. The holes are also spaced much closer together than the Superbell axle.

Pictured is a cast 'Superbell'-brand dropped I-beam axle (in green primer) which came to LVVTA's offices for testing recently. Upon initial inspection, the axle was found to have been incorrectly drilled. LVVTA confirmed with Superbell that this axle was not drilled by them, and that Superbell's drilling process is very different to the way in which this axle has been drilled.

specify that the hole size does not exceed 20 mm, not less than 5 mm of beam material remains above and below the holes within the vertical web section of the beam, not less than 20 mm of beam material remains between the holes, and that the outboard holes are positioned no closer to the perch-bolt housing than 80 mm.

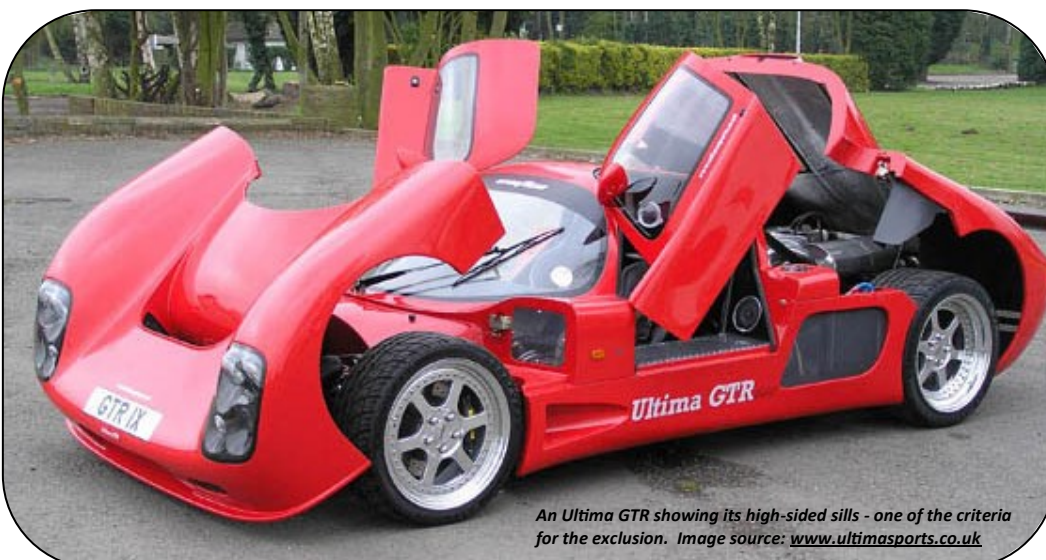
An Ultima GTR showing its high-sided sills - one of the criteria for the exclusion. Image source: www.ultimasports.co.uk

The LVV Standard 155-00(01) 'Door Retention Systems', sub-section 3.5 Design Criteria Exclusions, allows a scratch-built low volume vehicle that does not have a permanent roof structure and which meets specific design criteria, to be exempted from complying with sub-section 2.3 (latch and striker plate assembly requirements), sub-section 2.4 (hinge assembly requirements), and sub-section 2.5 (and door structure strength requirements).

The TAC were shown a selection of examples of such 'roofed' vehicles which meet all other aspects of this design exclusion criteria. These vehicles are generally space-frame replicas of early Ferraris, or 'Ultima'-brand kit-type cars. The TAC agreed that the LVV Standard and the HCTM should be amended to include vehicles with a permanent roof within the exclusion at the next amendment opportunity. In the interim, LVV Certifiers can apply this exclusion. For clarification or assistance, please call a Technical Team member at LVVTA.

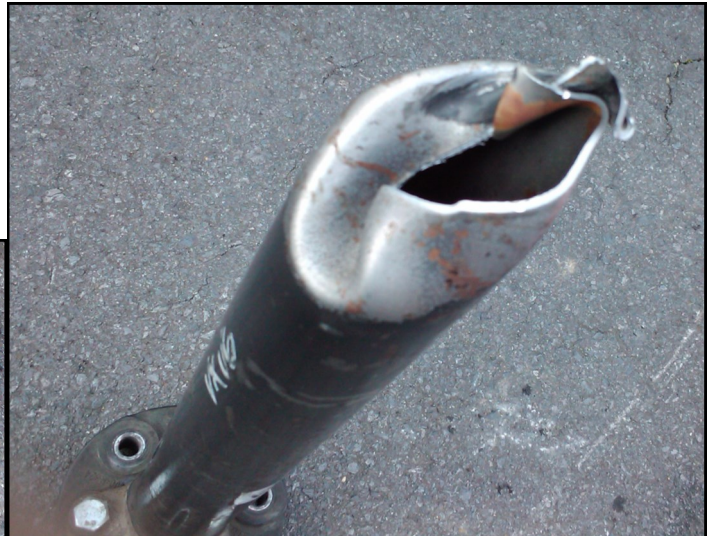
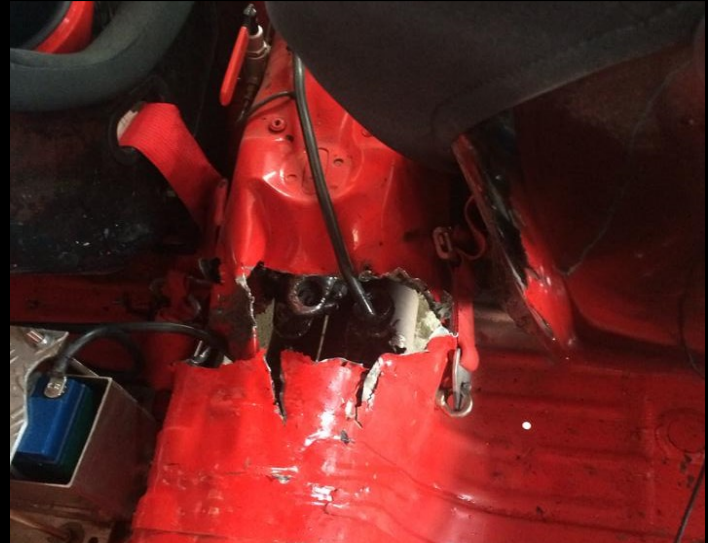
This little number at left and above came from a drift car, spotted by Dan Myers at a drift demonstration. So too did the drive-shaft in the vehicle pictured below (thanks to LVV Certifier Ken McAdam for the photo), that when it failed, the ensuing out of control energy tore the vehicle's floor apart, and almost tore through the seatbelt webbing and brake line.

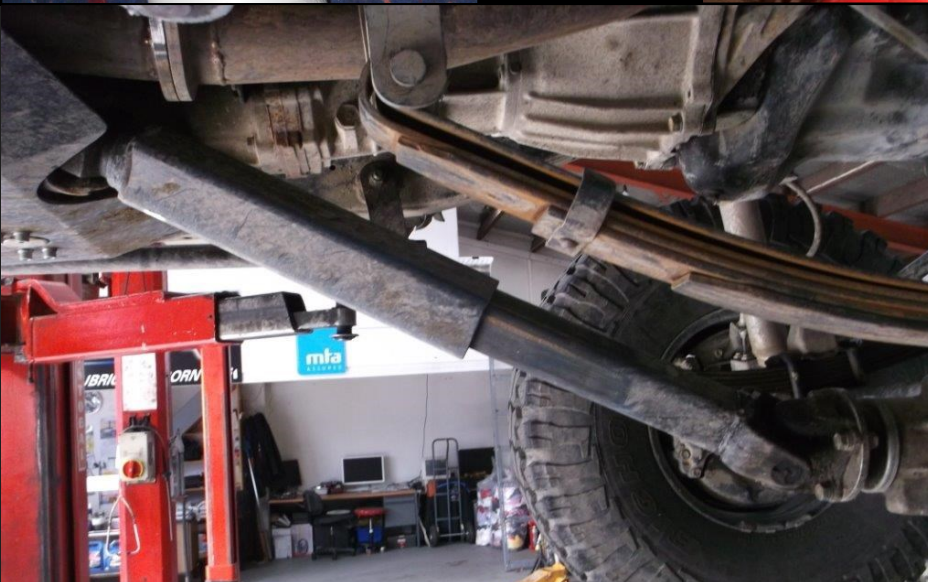
This, at left, is a joke, I hear you say. The result of someone with too much time on his hands giving an LVV Certifier a wind up. No; this was a serious effort, and is how the vehicle was presented to an LVV Certifier (thanks to LVV Certifier Don Hoff for the photo) for certification. The fertile mind of an off-road enthusiast came up with this cunning plan to deal with the age-old conundrum of ensuring sufficient gearbox output shaft engagement with a lot of suspension articulation; - a sliding section from a power take-off donated from a piece of agricultural equipment!

We never cease to be amazed by the number of people who don't understand what devastating force is pent up within an automotive drive-shaft, how much damage can be done, and that cars can be over-turned by the force of a flailing drive-shaft that digs into the ground at the wrong time. So simple, but so important to get this part right.

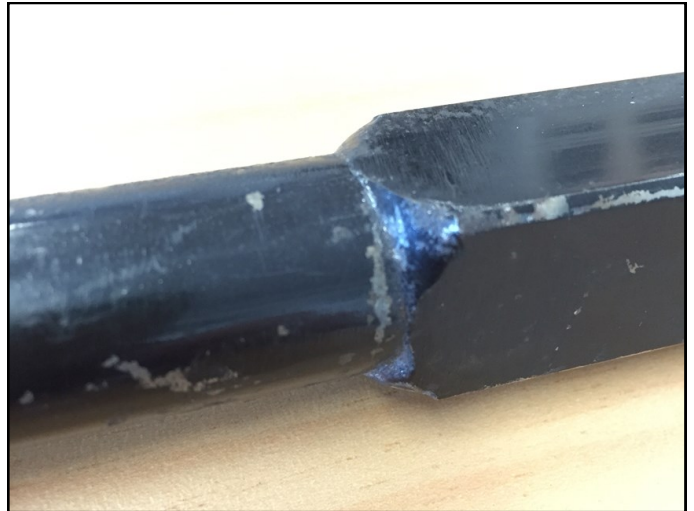
'Birkin' steering shaft:

This steering shaft was removed from a South African 1995 Birkin Lotus 7 replica. The thin-walled square-section tube (19 mm x 1.4 mm) clearly isn't adequate from a strength point of view, and the attaching welds are not only poor quality, they're also ground. This shaft was rejected and a new one-piece shaft was made.

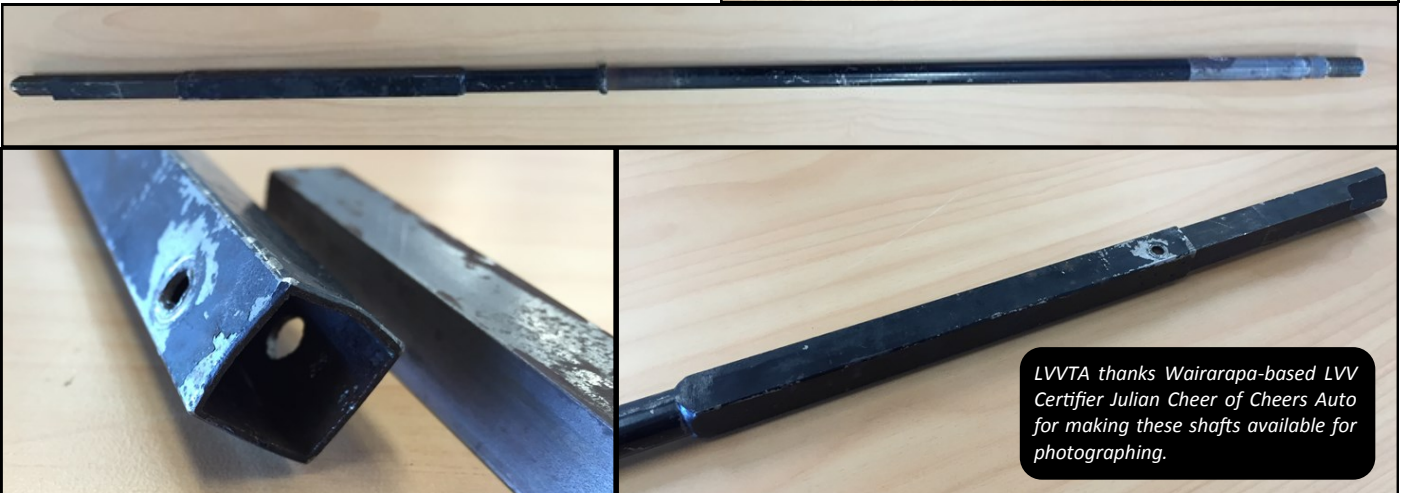
'Suffolk' steering shaft:

This shaft was removed for inspection from a UK-built SS Jag replica kit car. There was some helpful documentation provided by the manufacturer, which provided info stating that the steering column was 'unmodified Jaguar column'. The shaft comprises a welded joint between two shafts of slightly varying sizes, and appears to have a spigot. There's also a collar, which has been fitted to allow for a steering lock – this modification on its own may be OK as the welds attaching this collar aren't relied upon for steering control, however the column could still not be LVV Certified, and a new one-piece shaft was made.

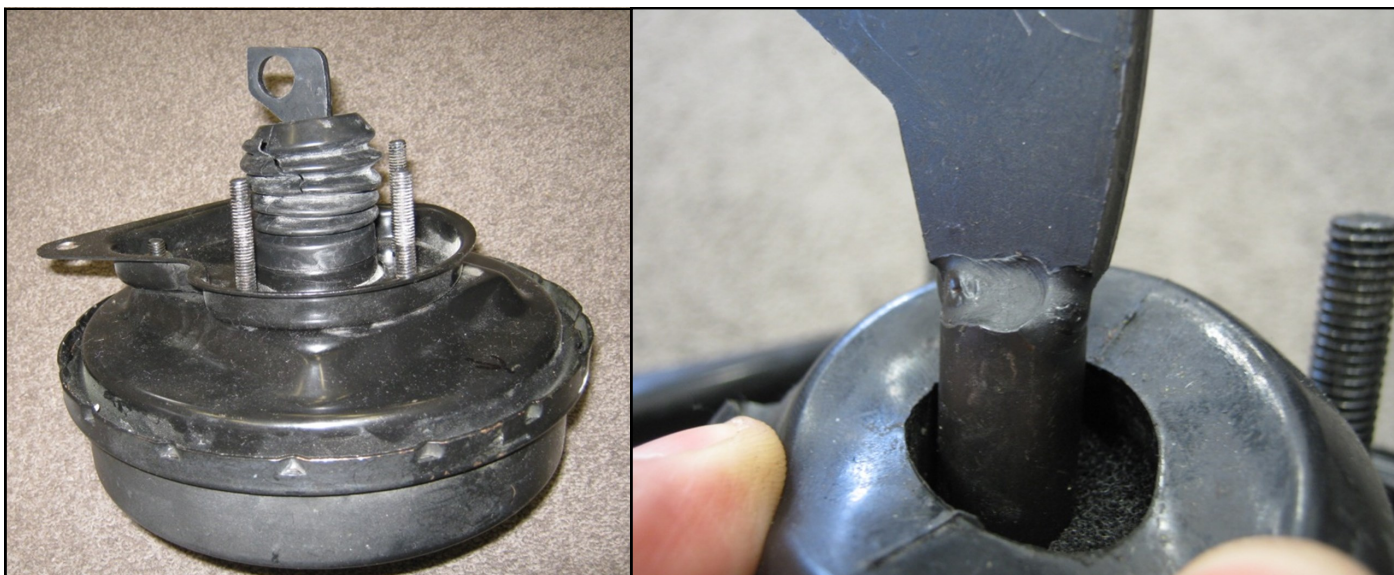
Upon a cursory glance the booster looks like any other, but when the rubber dust seal is pulled back to expose the brake pedal push-rod (an item that is customarily one-piece), a welded two-piece rod is found. LVVTA considers this to be unnecessary, and poor engineering practice. Worse, LVVTA's welding experts within the Technical Advisory Committee (TAC), quickly concluded after inspecting the push-rod that the welding is of poor quality with pronounced undercut causing a reduction in material. One TAC member's comment was that "One side shows obvious undercut and insufficient weld volume".

Wellington's Mark Russell brought a new aftermarket parts problem to LVVTA's attention after discovering a potentially serious safety problem with an aftermarket brake booster. The booster is branded as 'CPP' (an acronym for 'Classic Performance Products'), and is a bolt-on replacement for Ford Mustangs.

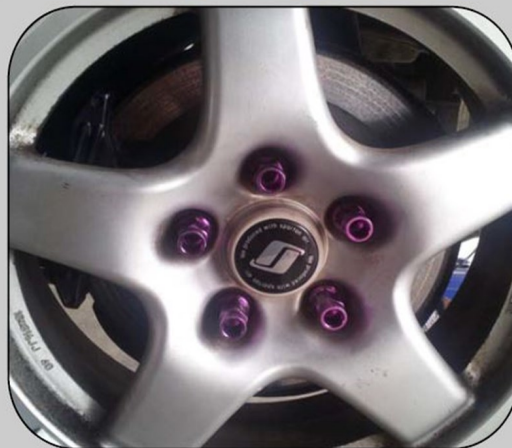
Occasionally LVVTA has it reported by LVV Certifiers that vehicle owners are turning up for LVV certification with aftermarket wheels fitted, which are attached with aluminium wheel nuts. LVVTA emphasises that due to an inherent lack of tensile strength in commonly-available aluminium compared to high tensile steel, aluminium wheel nuts must never be used.

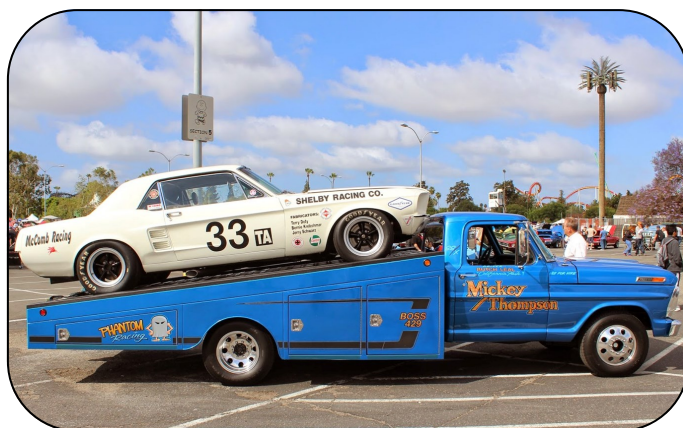
The likelihood is that, if the vehicle is a dually chassis-based 'ramp truck' (such as in the photo below), the vehicle will be a heavy vehicle, and will therefore need to be certified by a Heavy Certifier.

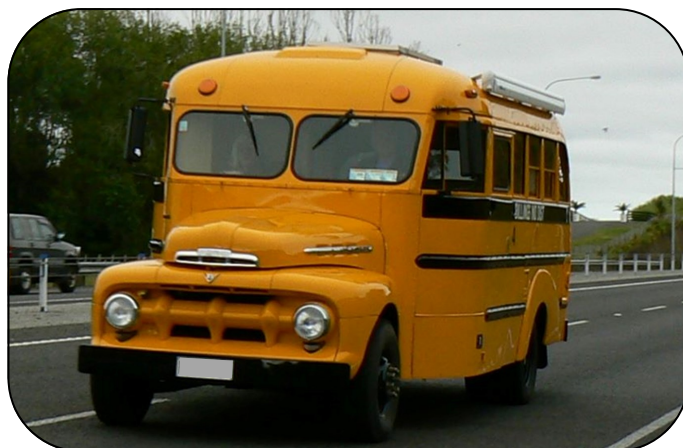
It is probable that, if the vehicle is a dually chassis-based 'school bus' camper (such as in the photo below), the vehicle will be a light vehicle, and will therefore be able to be certified by an LVV Certifier. There are a couple of fish-hooks though, so always talk to an LVVTA Technical team-member before embarking on the certification of one of these potentially-problematic vehicles.

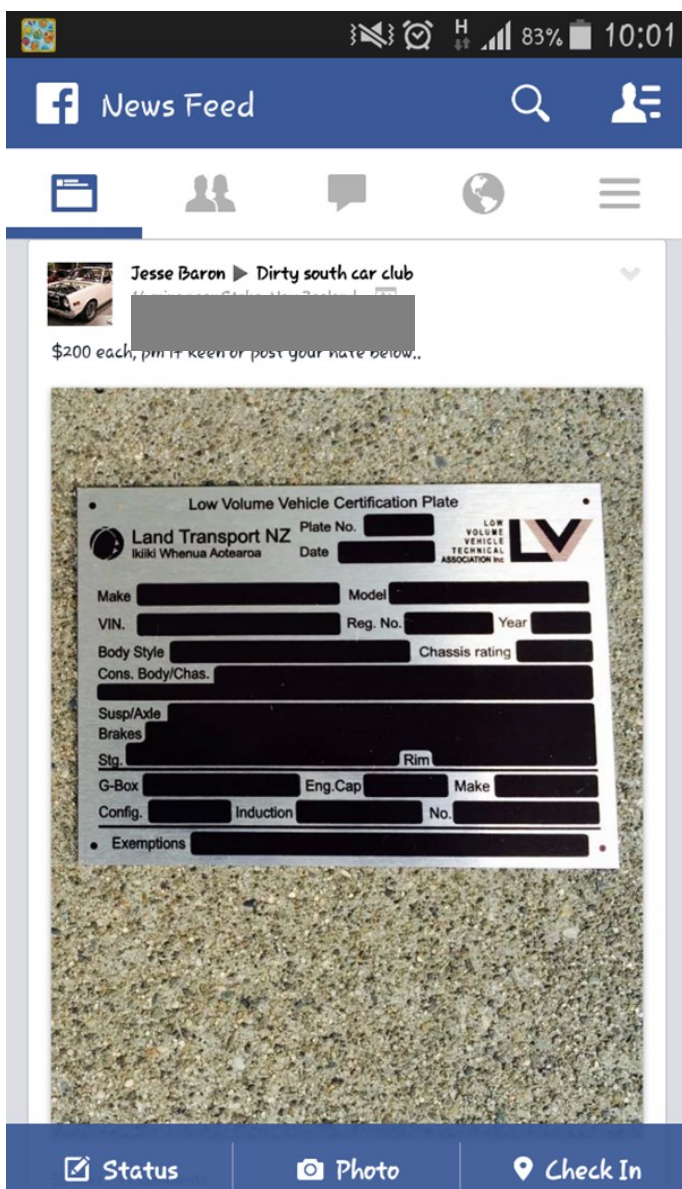
The Police are currently investigating another man (from Nelson) who has been selling fake LVV certification plates through his Facebook page. Shown below is the advertisement for the fake plates.

While a printed label on a piece of trimmed aluminium is relatively simple to create these days, a giveaway that a plate is fraudulent will be the quality (or lack thereof) of the engraving. LVVTA would be grateful if AVIs can inspect LVV certification plates thoroughly, and check that the engraving is computer generated and uniform, and that the engraved information sits neatly within each text field. If in doubt, AVI's are welcome to send a photo of the plate to the LVVTA office at info@lvvta.org.nz
