## NEW PRE-APPROVAL PROCESS FOR SERIES-PRODUCTION MODIFICATIONS

## TECHNICAL STUFF

### The Complexities of Right-hand Drive Conversions Today

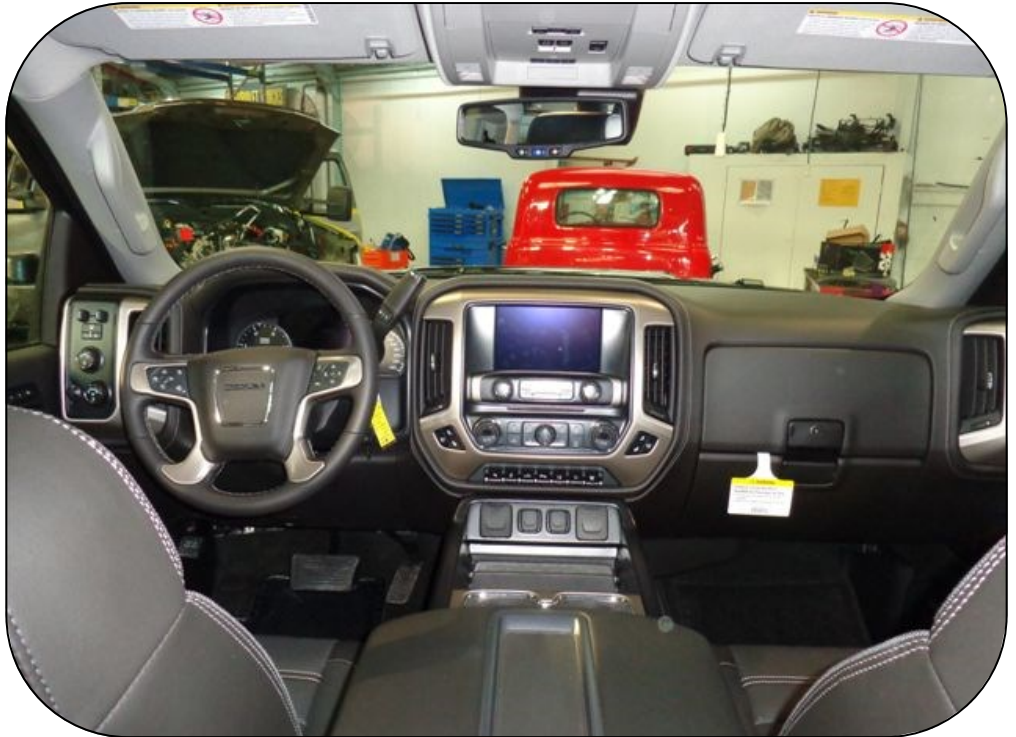
The dashboard presents more problems. Obviously, it is an appearance item that also serves many functions as a mounting point for all sorts of controls, instruments, and more. Additionally, the passenger airbag is deployed through a section of the dash body which has no visible break lines. This main dash body is attached at the bottom to a steel bar which runs from either side of the cab which serves as a mounting point for the steering column, passenger air bag, and many other critical items. It is reasonably simple to decide where the various components mount, and the passenger airbag is attached into place on the bar and then, when deployed, it bursts through the dash. The Bunce dashboards are covered with vinyl, and through the testing they have undertaken over the years they know that it is just about impossible to get an air-bag to break through or rip vinyl without some form of mechanism to create the puncture cut-out required to allow the deploying bag to come out through the dash and inflate correctly.

This means, therefore, that the simple dashboard becomes quite a complicated construction. Bunce's dashboard uses fiberglass, foam, vinyl, and digital 3D printed components to achieve the look, feel, longevity, and the air-bag break-through feature that is required to ensure correct airbag direction and timing of deployment.

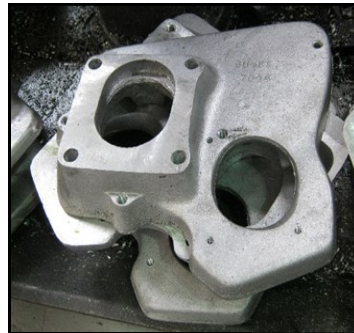
Bunce go to great lengths in order to provide full functionality and performance equivalence to original. An example is the brake booster mount. The booster is switched from the left of the vehicle to the right side and the firewall is not a compatible shape, so an adaptor bracket is cast and machined. This provides a strong mount in the correct position.

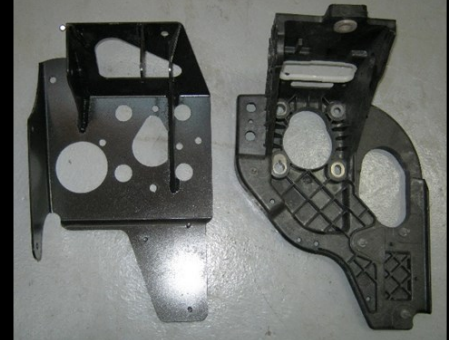
Another example is the pedal box. The original, (shown on right of photo) is made from injection moulded plastic and hard to modify or replicate, so an equivalent sheet metal part is designed – shown to the left of the original part.

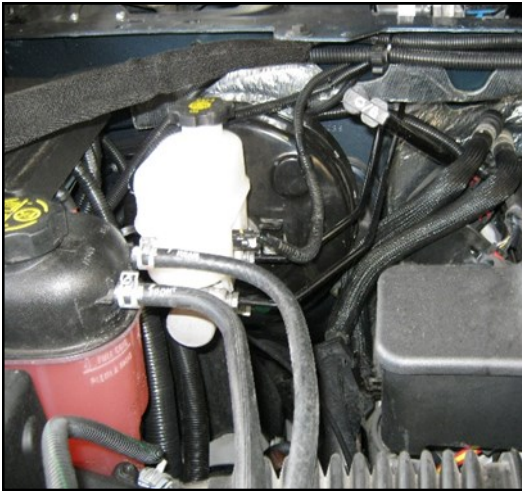
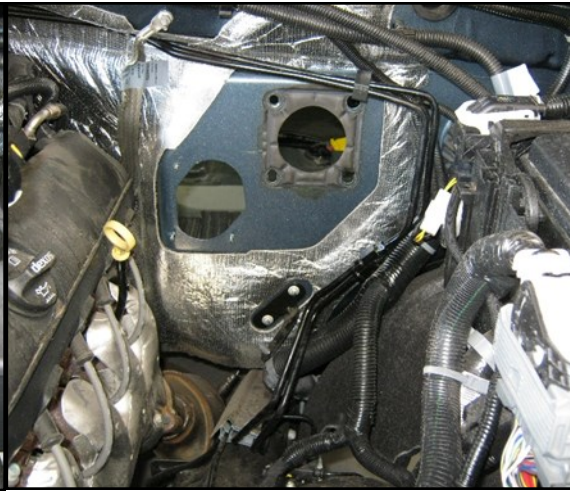
The photograph at left shows the original firewall mounting point for the master cylinder and booster, while the photograph at far left shows the master cylinder and booster relocated into its mirror-imaged position on the right hand side of the firewall. With due attention to detail, such as the repositioning of the factory heat-shielding, and correct clamping systems, the post-conversion result is indistinguishable from how the General Motors factory originally built the vehicle.

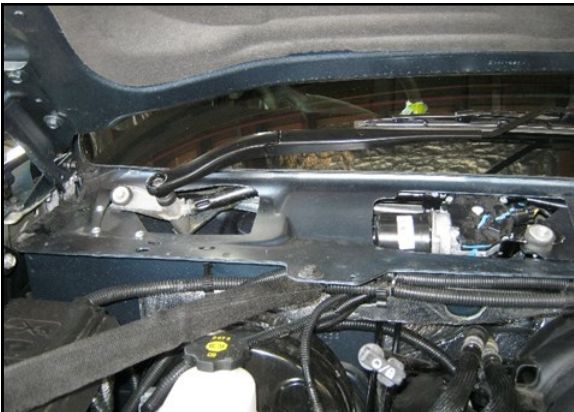
Another problem to overcome is the switching of wipers to get full sweep coverage in front of the driver. This is achieved by a redesign of the mechanism and arms, using as much of the original components as possible. Such is the level of workmanship that the end result, as shown in the photos at left and right, cannot be easily identified as modified.

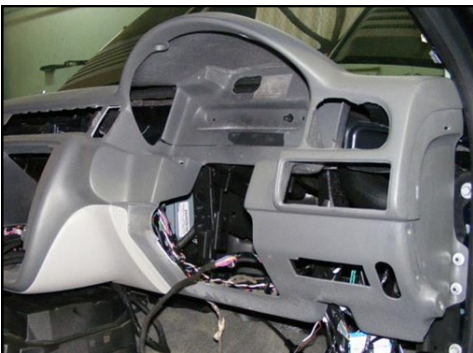
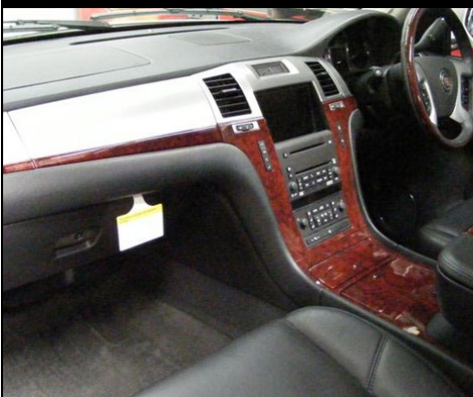
Above and below is the dashboard style of the pre-2014 Chevrolet/GMC pick-ups, completely re-manufactured by Bunce Motor Company during the right-hand conversion process.

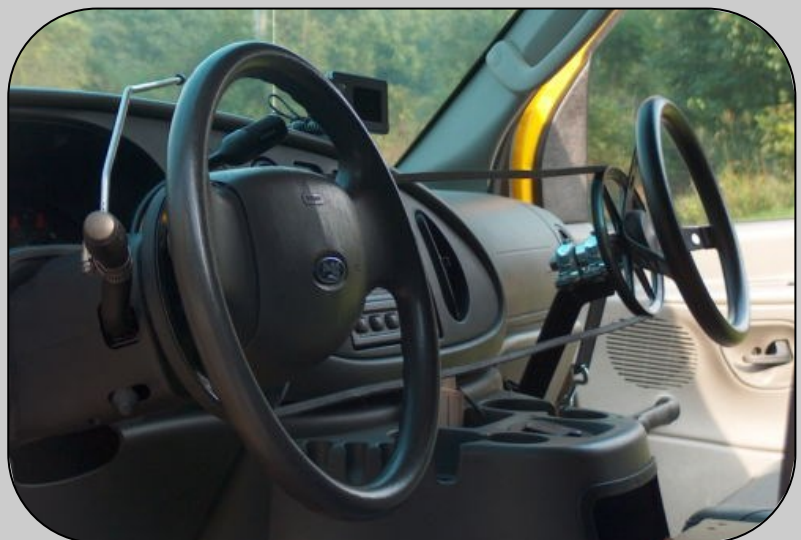
Question: Identify the modification in the picture below, determine whether or not it complies with New Zealand low volume vehicle certification requirements, and if not, why not?

Answer: No, not legal. The problem is that the relationship between the drive-belt and the drink holder is such that when large drinks are positioned in the drink-holder, movement of the belt could cause the drinks to be spilt.

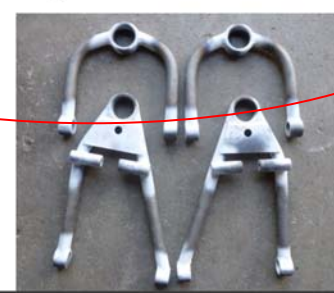
X-RAY LABORATORIES LTD	
PO BOX 12650, PENROSE, AKL 1642 PH/FAX 09 5794972	43A LEONARD RD, MT WELLINGTON, AKL 1060 WWW.XRAYLABS.CO.NZ XRAYLABS@XRAYLABS.CO.NZ
MAGNETIC PARTICLE INSPECTION TEST REPORT	
TEST REPORT No. 4025B	
Client: [REDACTED]	
Reference: Magnetic Particle Inspection of fabrication welds in Pickup Arms at our workshop.	
Order No: 19491	Job/Project No: NA
Identification: '56 Ford Pickup Upper & Lower Suspension Arms (see image below)	
Welder ID: Terry	Material: Ferrous
Weld Process: GTAW	Thicknesses: Variable
Reason for Testing: LVVTA requirement	Dimensions: ≈380×240×50mm ≈260×245×35mm
Stage of Testing: >24hrs after welding	Weld Requirement: Full size fillet
Surface Condition: As welded, wire brushed	Heat Treatment: NA
Areas Tested: Weld & HAZ	Surface Temp: ≈19°C
Date of Test: 12/02/2014	Test Procedure: XRL012
Test Standard: AS1171:1998	Acceptance Code: AS/NZS1554.1 SP
Inspection Method: Continuous wet visible	Equipment: Y6 electromagnetic yoke

Contrast: Ardrex 8901W white	Field Direction: Longitudinal
Magnetic Ink: Ardrex 800/5 black	Pole Spacing: ≥70mm
Viewing Light: Natural & incandescent	Demagnetize: Not required
Restrictions: Nil	Technique Variations: Nil
Technician: A J Maxwell	Qualification: CBIP MT2
Results:	
All 20 reworked fabrication welds on the four supplied arms were tested as directed.	
No indication of cracking or other significant weld defects was detected.	
COMPLIES

In addition to the significant cost to the owner for the re-welding process, there is also the cost of additional NDT examination once the rectifications had taken place. As can be seen in the report above (dated 12/02/2014) which was carried out once the arms had been re-welded, the re-welded arms were perfect, and passed the test.

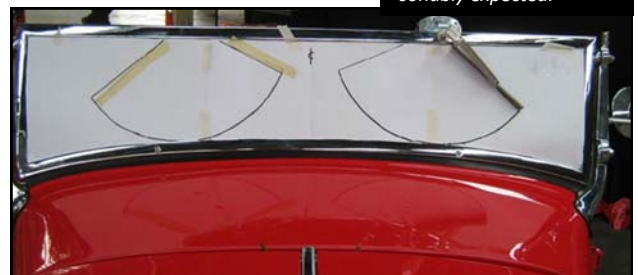
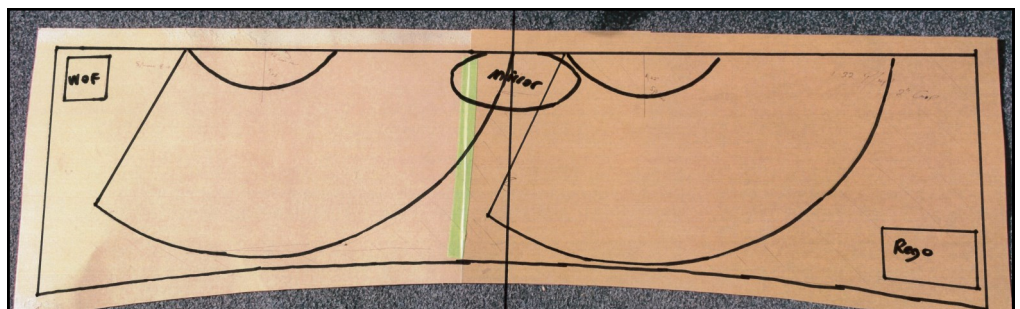
*The swept area shown on the template on the red '32 roadster below is typical of a swept area that is considered unacceptable. LVVTA's expectation is that a far greater percentage of the windscreen is swept, so that visibility in wet weather is as good as could be reasonably expected.*

*LVV Certifiers should advise anyone who is building a vehicle with a chopped windscreen of this directive, and work with them to ensure that their wiping system can achieve the minimum required swept area shown here.*

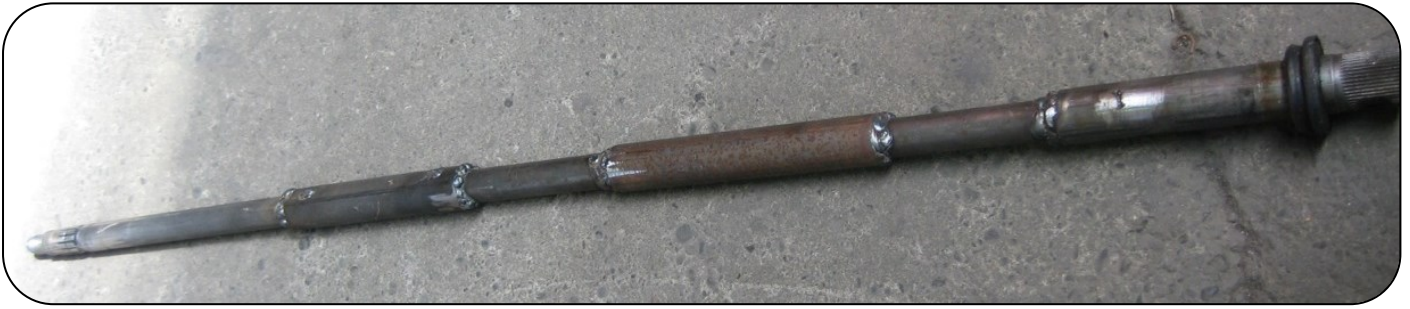
This internal shaft out of a steering column was fitted to a modified vehicle that has been recently imported from the United States. During the LVV certification inspection the LVV Certifier identified that the vehicle had an aftermarket steering column of unknown origin, and on his instructions the column was removed and stripped down, and this is what was found concealed inside the nice shiny chrome-plated steering column housing — no less than five circumferential welds, all of poor quality.

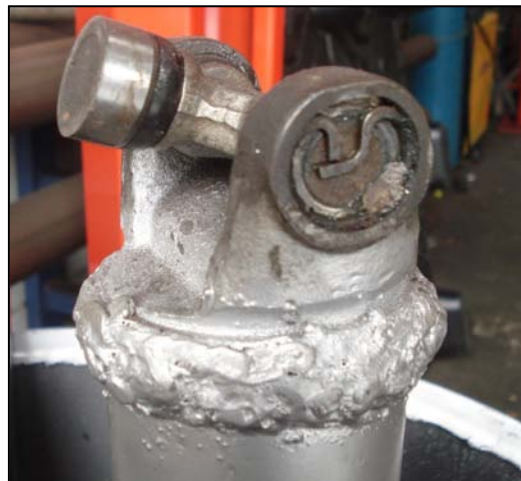
To the right is a section of motorcycle frame that someone has had a few (hundred) attempts at repairing and reinforcing. All jokes aside, one of the realities of LVV certification is that there are some people who just shouldn't be attempting to do their own fabrication and engineering work. LVVTA's philosophy has always been to try and help and support the home builders, to enable them to modify and build something themselves providing that it's done safely and correctly, but one of the challenges for an LVV Certifier is to recognise those times when the only attribute that an enthusiast has is enthusiasm - and that on it's own isn't enough. Sometimes, an LVV Certifier will have to give someone the bad news that "you need to get someone else involved in this - you just don't have the necessary skills." Hard, but essential sometimes, to prevent the problem from becoming the LVV Certifier's problem. Too much kindness in this area can bite the Certifier.

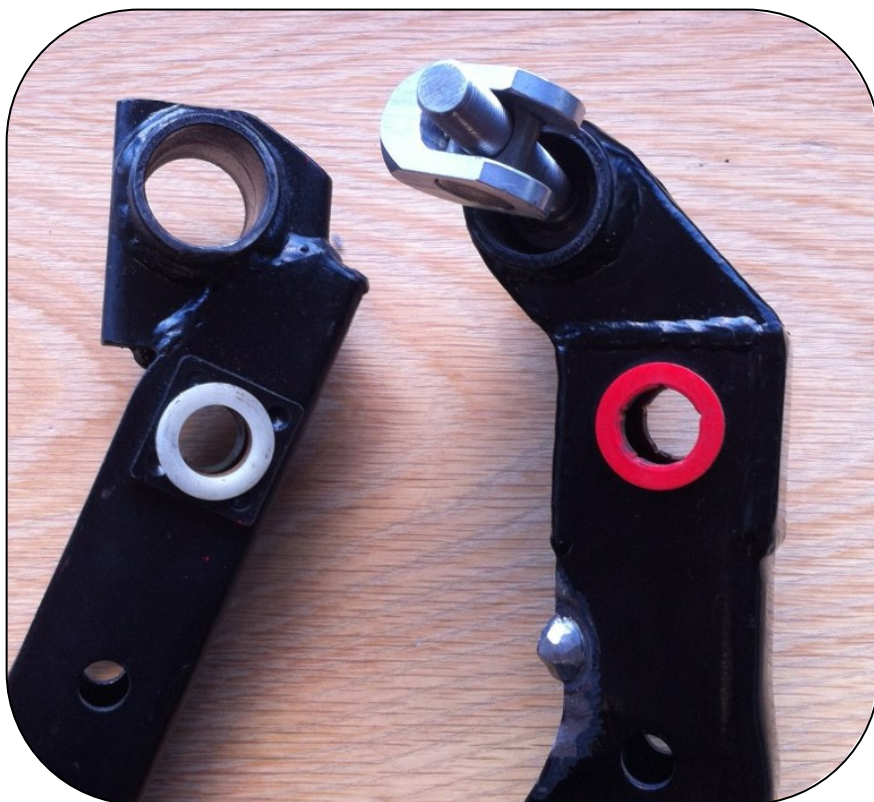
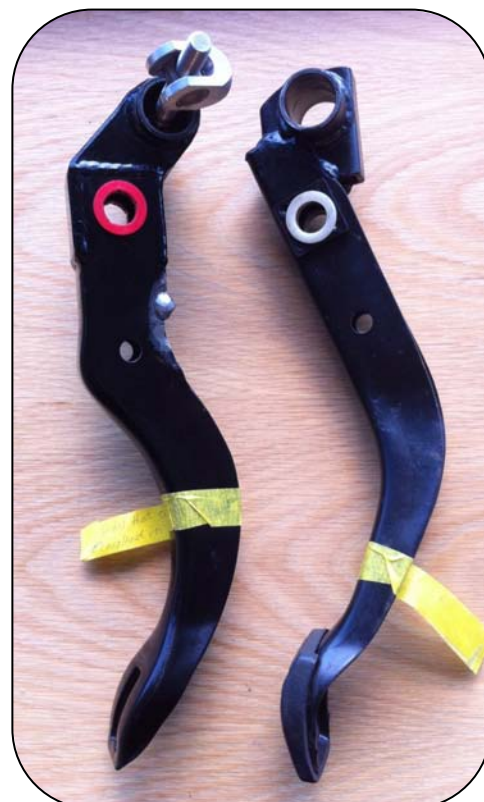
If pedals such as those pictured below are found to be fitted, they must be rejected. If aesthetics are important, the 'brake pedal pad' can be removed from the OE pedal and re-used, and a cover can be made to replicate the appearance of the OE pedal.

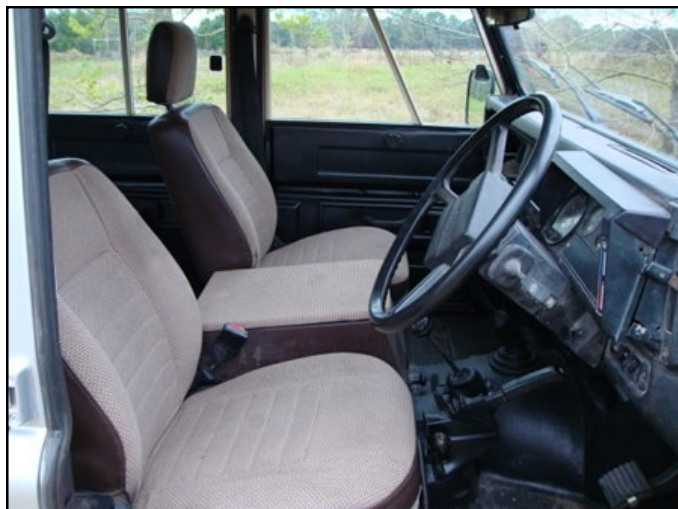
*Above is a previous generation Landrover centre console and gear lever layout, which provides reasonable (if minimal) room for a passenger's legs and feet. A person can sit in the centre seat of a previous generation Landrover, and achieve reasonable comfort without interfering with driver operations.*

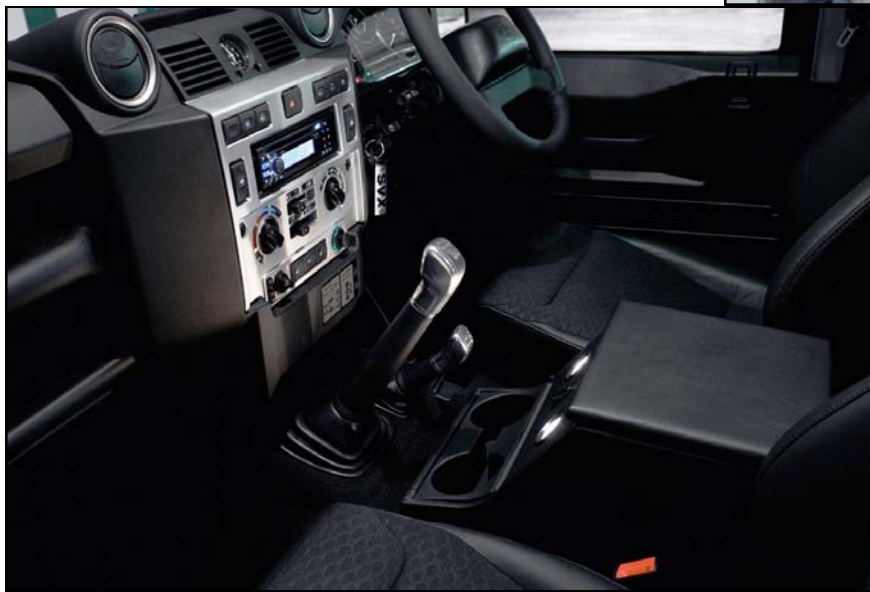
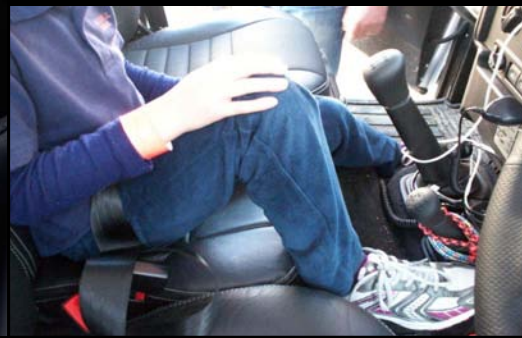
*At left and below is the current model Landrover which features a much busier centre-console and gear-lever layout, leaving no room for a passenger's feet and legs.*

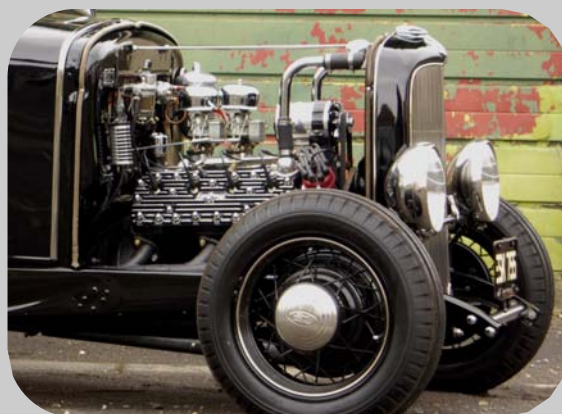
LVV Certifiers should keep in mind, when LVV certifying scratch-built hot rods and sports cars, that old-style cross-ply tyres should not be used in potentially high-performance applications. Section 12.30 of the NZ Hobby Car Technical Manual requires that approved radial tyres be fitted to all new scratch-built vehicles, but provides an exclusion for cases where the vehicle, or replica thereof, could have been supplied as new with a cross-ply tyre as standard or optional equipment. The Manual provides a note to say that "A bias-ply or cross-ply tyre has its place on nostalgia-style hot rods and period special sports cars, but they shouldn't ever be used on a modern performance-oriented hobby car." The reason for this requirement is that cross-ply tyres are not rated for high speeds, and many failures of the tyres have occurred. Earlier this year, the whole tread section of a cross-ply tyre tore off. Cross-plys have a place, as fitment to a traditional side-valve V8-powered car or period special, but little else.

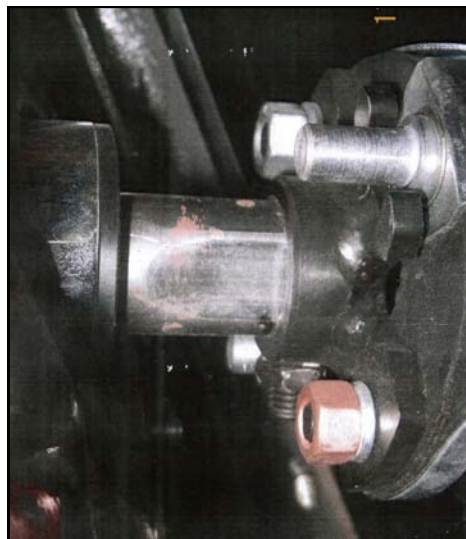
*This 'CPP'-brand steering coupler incorporates a central boss with a series of 'fingers' welded onto it. Chapter 6 'Steering Systems' of the NZ Hobby Car Technical Manual disallows any welded steering components except in the case of specified and approved situations. This clearly isn't one of those situations.*

Wellington company 'Accrete Design' can produce a one-piece replacement component for around \$70.

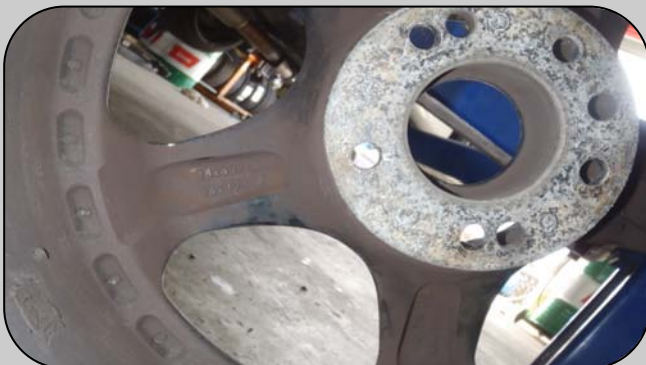
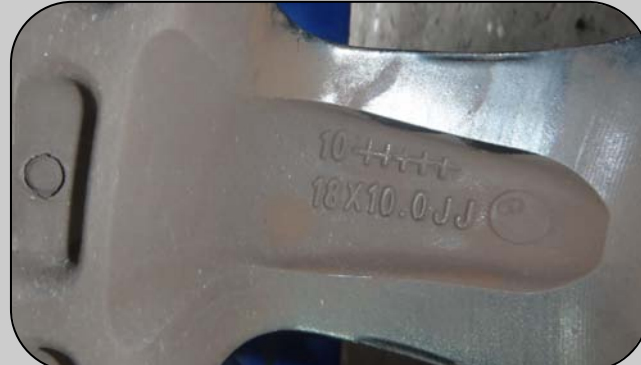
Watch out for multi-sized wheels! What do you mean 'multi-sized sized wheels'? I mean wheels with different wheel sizes stamped on them. What, the same wheel? Yes, the same wheel. Really? Yes, really!

Why? We expect that the multiple sizes are used for multiple wheel sizes, and the intention may have been that a 'pointer' would indicate which size is appropriate in each case.

The moral of this rather odd story is that when inspecting a vehicle with aftermarket wheels, an LVV Certifier should take a careful look at the wheels (particularly on the back-face) to make sure that there aren't multiple sizes cast or stamped into them. If in any doubt, he should measure the wheel himself.

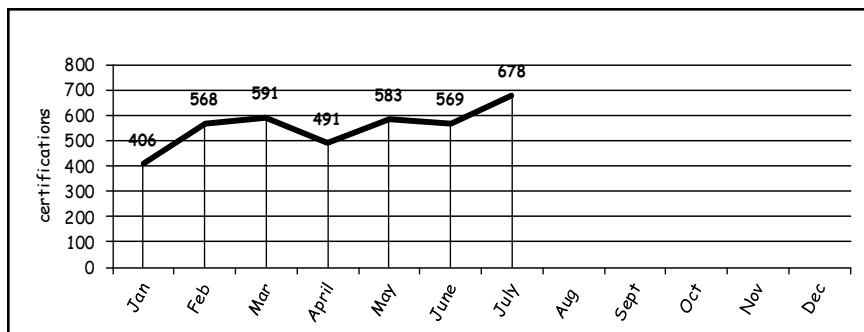
The graph at left shows the national per-month LVV certification numbers for the first seven months of 2014, which shows a monthly average of 555. This figure is slightly up on the monthly average for 2013, which was 530 LVV certifications per month. The used import industry is reporting that their numbers are up significantly, finally climbing back up after the big hit the industry suffered at the end of 2008. An increase in used import numbers may have a flow-on effect of increasing LVV certification numbers.
