MILESTONE FOR INNOVATIVE AXLE TESTING SYSTEM

CONCERNS ABOUT 'BVL/BWD'-BRAND CHINESE SEATBELTS

AFTERMARKET ALERT

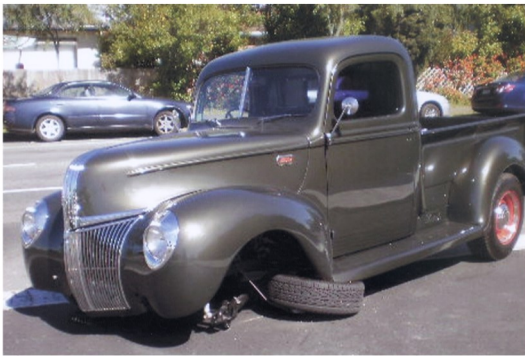
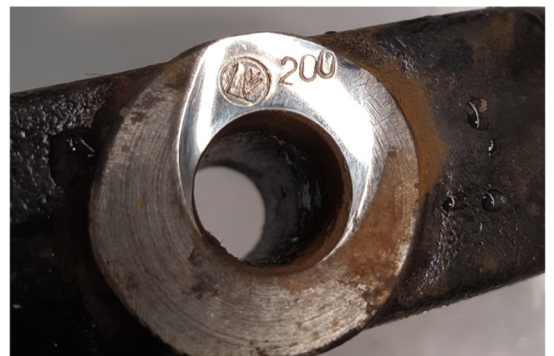
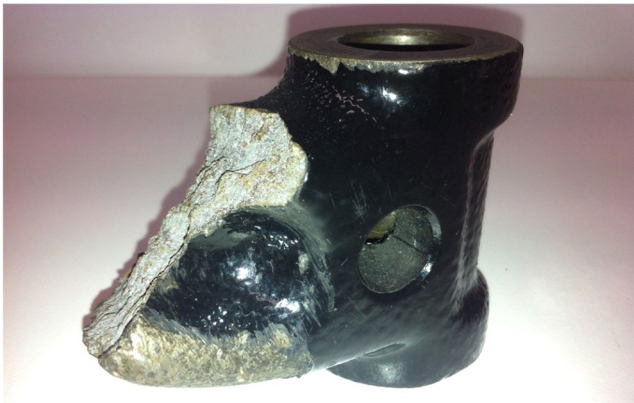
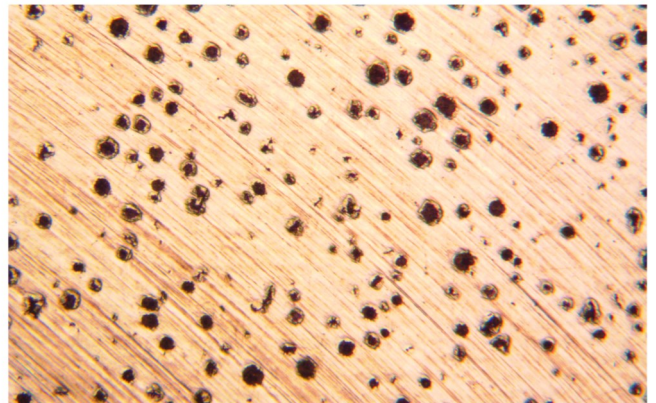
Specialised digital equipment allows for photos to be taken of the ultra-magnified structure of the axle, which enables LVVTA technical staff to determine whether or not the nodularity of the iron is to an acceptable standard. As an additional step to ensure that every decision made is the right one, the micro-images are also provided to a professional metallurgist who then independently verifies LVVTA's assessment.

A nodularity rating of 80% is the global standard for which cast components such as axles must meet or exceed in order to be considered 'nodular iron', however, of the 200 axles LVVTA have processed to date, an alarming 25% have failed to reach this level, with many coming in as low as 20% nodularity, and one at an astounding 10% nodularity.

Anti-clockwise from left: The Ford pick-up that started the investigation five years ago; a close-up shot of the broken aftermarket I-beam axle; the magnified graphite nodules which show compliance with international nodularity standards; 'LV200' stamped on the micro-polished axle spring perch.

The inspection process that LVVTA established for cast iron I-beam axles was developed in conjunction with metallurgical specialists and the LVVTA Technical Advisory Committee members, and follows world-wide industry best practice. It looks into the microstructure of the component to determine the nodularity (which is what gives the component its strength and ductility) of the iron used in its construction, by micro-polishing a small area on the axle's spring perch and carrying out a microscopic inspection of the area.

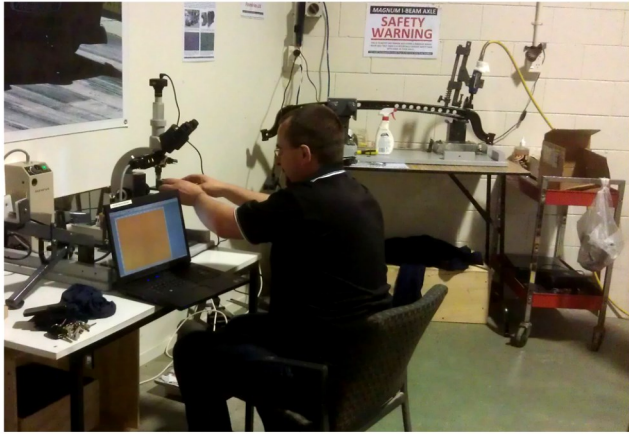
Justin continues, "It's not always the axles you'd expect to fail that do fail, and not always the ones you'd expect to pass, that pass. We've seen brand-new chrome axles with a low nodularity and also seen axles that look like they've been sitting outside for years pass with flying colours".

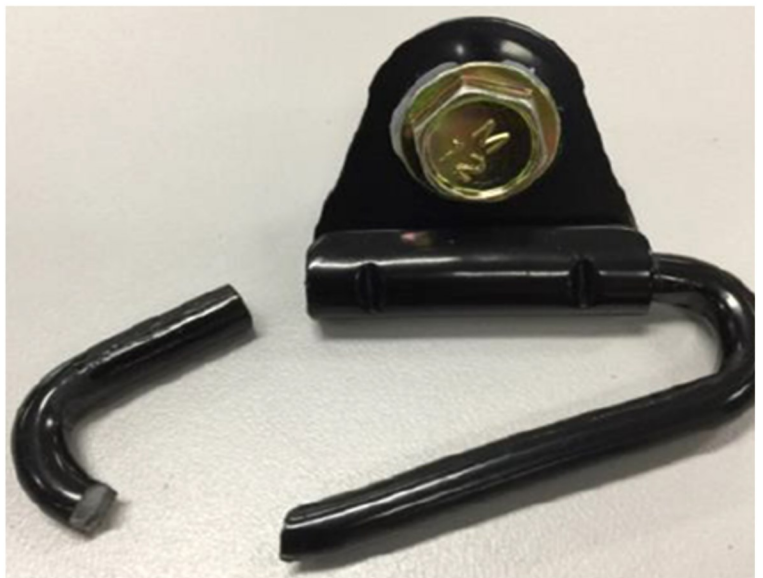
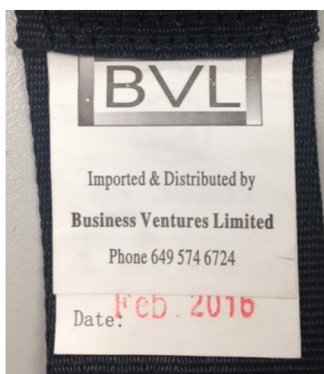
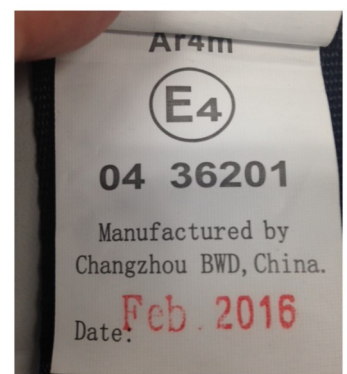
LVVTA has been informed of a failure of a seatbelt during a sled test at an accredited test facility in Australia. The upper guide loop has bent open and then snapped apart, releasing the seatbelt webbing so that the dummy torso was not restrained. The seatbelts have markings to say that they comply with an approved safety standard.

These seatbelts can be identified by a seatbelt label that contains the BVL marking, as well as having a second label underneath which has 'Manufactured by Changzhou BWD China' on it. Examples of the two labels are shown at right.

LVVTA wishes to emphasise to LVV Certifiers that, further to information provided by email and at recent LVV Certifier training sessions, they should contact LVVTA if any of these seatbelts are found.

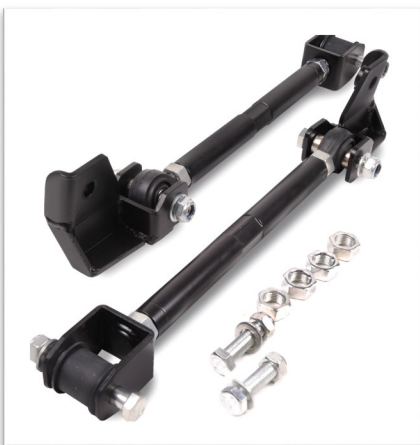
A 1D category LVV Certifier recently inspected a vehicle with a multi-piece Hicas lock-bar system, and managed to mount a Go Pro camera under the rear end of the vehicle so as to observe the system when under operational load. The video footage confirmed his initial opinion that the system was not fit for purpose.

While most lock-bars — fitted to vehicles for the specific purpose of disabling the rear wheel steering mechanism on Nissans — are a one-piece tubular 'bar' to which standard tie rod ends attach (utilising the OEM attachment points as they were intended), this design utilises two separate assemblies, where each part is mounted independently of one another, and as they're not supported by two widely spaced mountings, a much higher bending and fatigue load is being applied on each attachment point.

The outcome of the LVV Certifier's video was alarming, showing the inner mounting points flexing under sedate driving.

This information and video was passed on to the LVVTA technical team, who determined that the LVV Certifier was correct in disallowing the obviously sub-standard components. The multi-piece lock-bar kits are available in many different brands, and cannot be accepted for LVV certification.

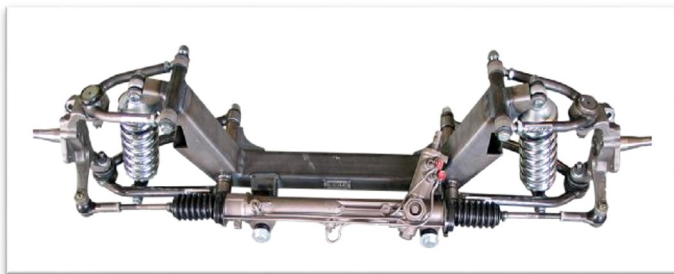
An undersized lower A-arm was recently discovered on a Heidts Superide IFS system, and questions were asked of its suitability. TAC members assessed the arms and discussed all of the information which LVVTA's Justin Hansen had obtained from Heidts.

The TAC's opinion was that due to the higher material grade used by Heidts compared to the minimum specification provided in the NZ Car Construction Manual, coupled with the increased wall thickness, this justifies the lesser outside diameter (OD).

The arms have an OD of 22mm (7/8") with a measured wall thickness of 4.9mm. The material specification is 1020 DOM tube which has an approximate strength of 350 kPa versus Schedule 80 tubing's 200 kPa.

An LVV Certifier presented with undersize Heidts Superide arms, may (if they match the details above) allow the arms to be used.

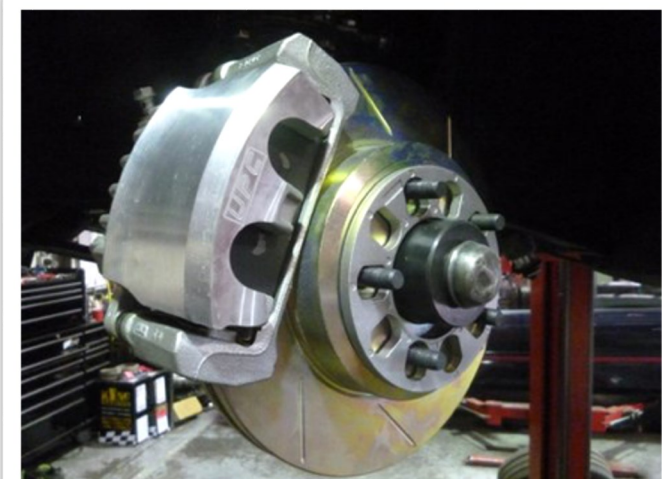
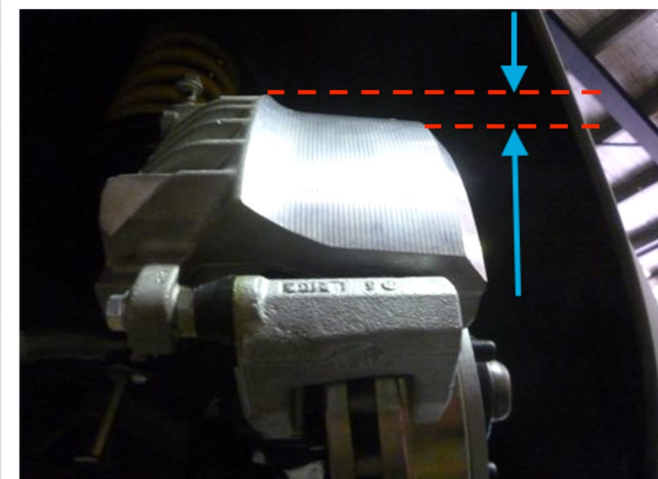
LVVTA has become aware that some OEM brake calipers are being modified to enable the fitment of smaller diameter wheels, and are being sold as a bolt-on aftermarket kit. In producing the kit, the aftermarket company is removing a large amount of material from the most highly-stressed part of the brake caliper. As a result, there is a high risk that these modified calipers may not withstand repeated heavy brake applications and heat cycles over time.

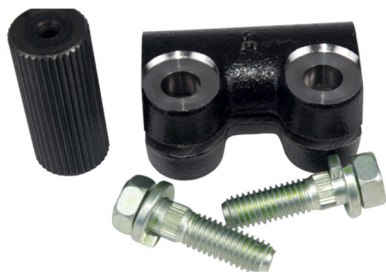
Left: This type of steering extension system (made by VMN) provides better spline engagement when carrying out a body-lift on 2015 onwards Toyota Hilux models.

LVV Certifiers should be aware that when body lifts of 50mm or more occur on a 2015-onwards Toyota Hilux (as with many vehicles) the steering shaft must be extended. According to aftermarket company 'VMN', failure to do this could result in the steering shaft breaking, and VMN claims it is aware of several instances where this has happened. The failure occurs because there is insufficient spline engagement and the 'D' of the shaft flexes, fatigues, and eventually snaps off. VMN recommends that the steering shaft is extended by using the VMN steering extension which is included in all of their body lift kits.

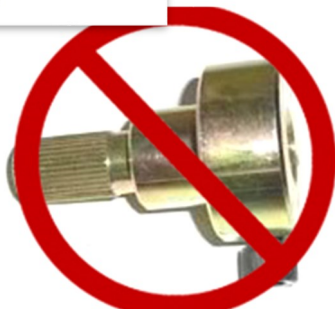
At right: This type of steering extension is suitable for 2005-2015 Toyota Hilux models only. Do not be tempted to use a steering extension like this which is designed for the earlier model Hilux model, and does not extend the steering sufficiently when body lifting the 2015 and on Toyota Hilux.

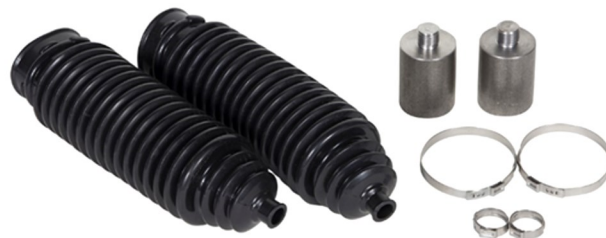
Heidts steering rack extensions that fit between the inner rack joint and the steering rack do not meet LVV certification requirements for attachment, because there is no mechanical locking method. LVV Certifiers will need to pull the rack boot back to inspect for these if it is suspected that this system has been used, as with the boots fitted, they cannot be seen.

At left: With the boots in place, the lack of any mechanical locking inherent with the Heidts kit is virtually undetectable. Below: The Heidts kit as supplied; - and as can be seen, no mechanical locking system is provided.

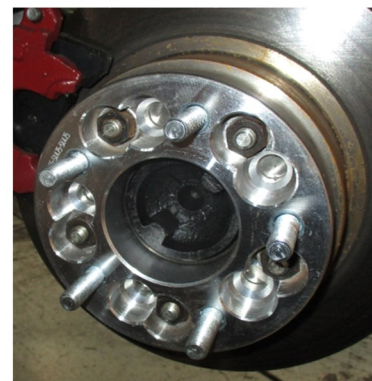
Every day, LVTVA technical staff see something new, and recently it was multi-hole wheel adaptors. The 30mm thick unbranded adaptors pictured below were on a vehicle presented for LVV certification in Auckland.

Upon inspection, it was agreed that due to the design and material, there is insufficient strength around the studs. As such, multi-hole adaptors such as these need to be processed on a case-by-case basis, and LVV Certifiers should contact the LVTVA technical team for guidance.

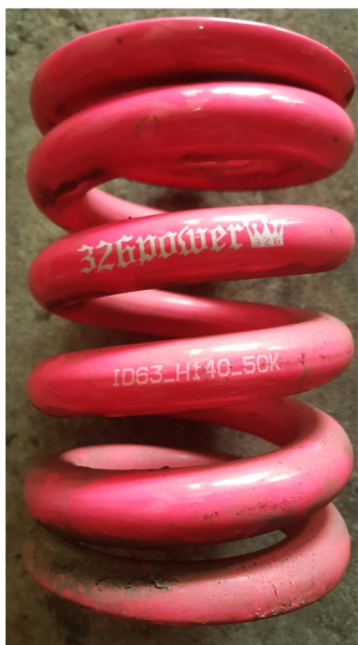
Their suspension spring range is stamped with a code, which, if you know what you're looking at can easily be broken down. In the case of the spring shown here, the code is ID63_H140_50K.

- ID 63 = 63mm id (inside diameter of spring)
- H 140 = 140mm free height (total uncompressed height)
- 50 k = 50kg per mm (measurement of rate)

At a spring rate of 50kg per mm, the springs are rock solid, around five times the spring rate of what would normally be considered a substantial upgrade from OE. When found, these springs were fitted with a pair of shock absorbers that were intended to operate with 10kg per mm rate springs.

These types of suspension setups are becoming more and more popular, so LVV Certifiers are advised to keep an eye out for them and disallow such unsuitable spring rates when found.

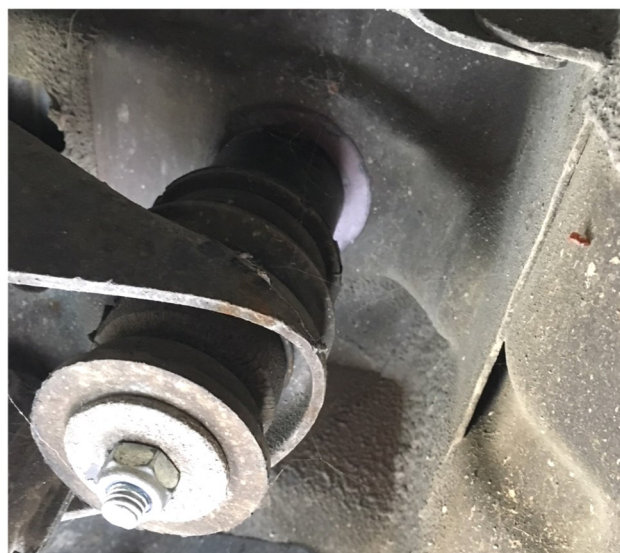
Wellington-based LVV Certifier Ken McAdam was recently presented with a (non-LVV certified) vehicle that had substantial cracking through the floor-pan due to not meeting this requirement, which was a great reminder why the requirement exists.

Unfortunately many of the off-the-shelf lift blocks do not comply. If LVV Certifiers are presented with a vehicle with undersized mounts, they must be rectified.

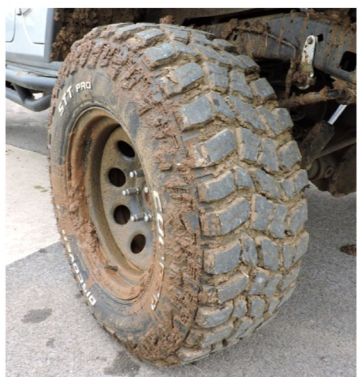
Since its inception, the LVVTA Tyre Size to Rim Size Compatibility Guide Information Sheet has stated that 33 and 35-inch tall, 12.5 x 15-inch tyres can not be fitted to an 8-inch wide rim. However, LVVTA is aware that this fitment has been commonplace in the four-wheel-drive world for many years.

After discussing this situation with multiple tyre manufacturers, LVVTA has now received confirmation that they support this wheel to tyre fitment. On that basis, LVV Certifiers may accept this fitment across all tyre brands. LVVTA's Compatibility Guide will be updated to reflect the allowance.

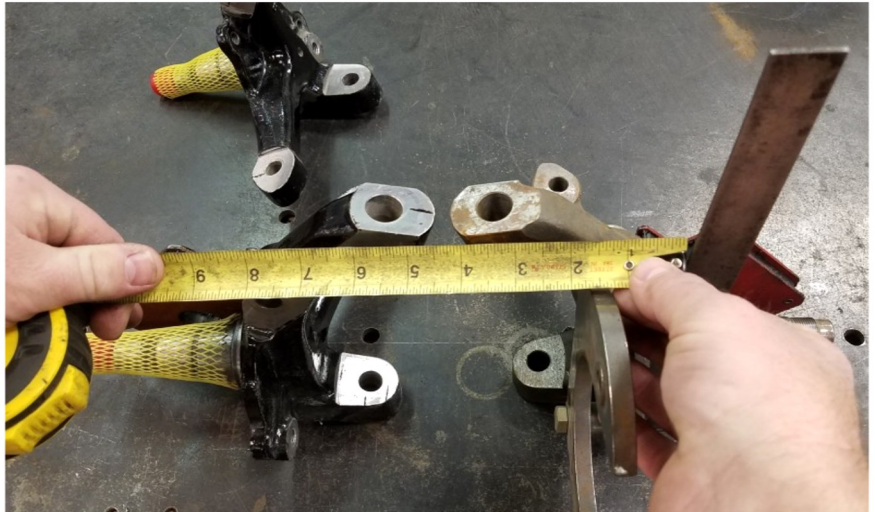
There appears to have been some Heidts stub axles that have been incorrectly manufactured. The manufacturing fault positions the top ball-joint hole in the wrong location, approximately 12mm from the OEM location. This has been causing wheel alignment issues, and has had vehicle owners and repairers overseas scratching their heads.

LVV Certifiers should be on the look-out for vehicles with a Mustang II-type front end which utilises 'Heidts'-brand stub axles. If one is found during a certification inspection, there may be a difficult-to-spot problem which needs to be identified and fixed.

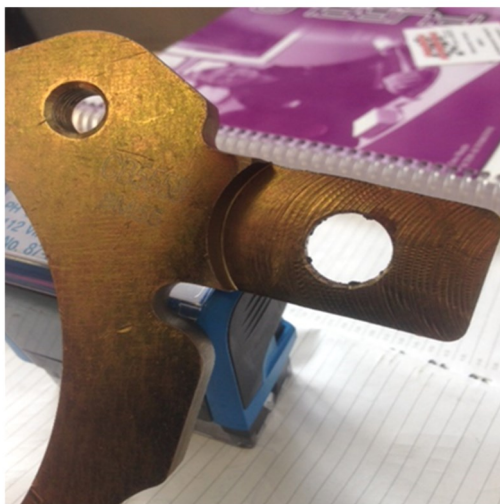
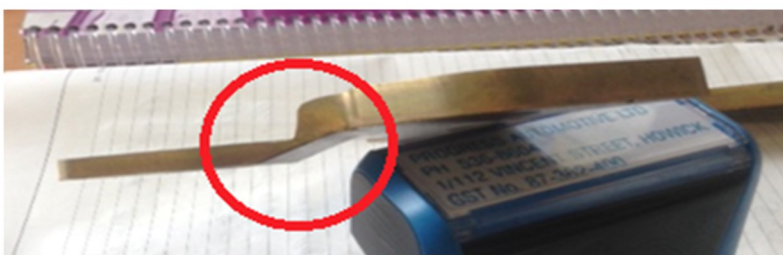
While at first glance the American-sourced kit looked good, upon closer inspection the caliper mounting bracket appeared to be dangerously thin. While approximately 10mm in thickness throughout most areas, the bracket has been machined to allow for clearance and tapers down to less than a 3mm cross-section in one area.

The LVVTA technical staff were concerned at the extent of the machining carried out by MBM to the caliper brackets, and have consulted the Technical Advisory Committee. The TAC have determined that the amount of material reduction is a poor engineering practice, rendering these brackets potentially unsafe and not fit for their intended purpose.

The area circled below shows where the 'MBM'-brand caliper bracket has been machined down such that less than 3mm of material remains, which is considered by the TAC to be a poor design and unsafe.

As such, LVV Certifiers should not approve any vehicles fitted with this kit, or any other kit machined this way and to this extent.

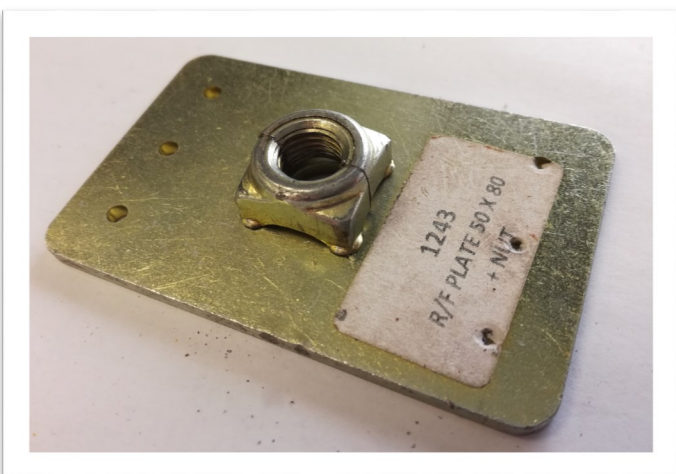
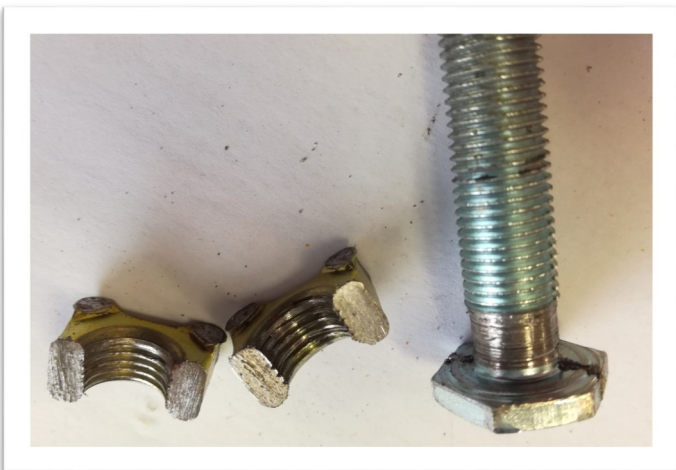
LVVTA have performed a bench test to check the thread strength when torqued up and found that the seatbelt bolt strips first, leaving the nut threads intact. The photos show the nut and doubler plate after testing the threads. The test also showed that the strength of the weld securing the nut to the plate was sufficient. Out of interest LVVTA staff then checked the level of torque required to break the welds and it was higher than expected.

As far as LVVTA is aware, this doubler plate is the only one to use this style of nut and welding, which makes the doubler plates in question readily identifiable to an LVV Certifier.

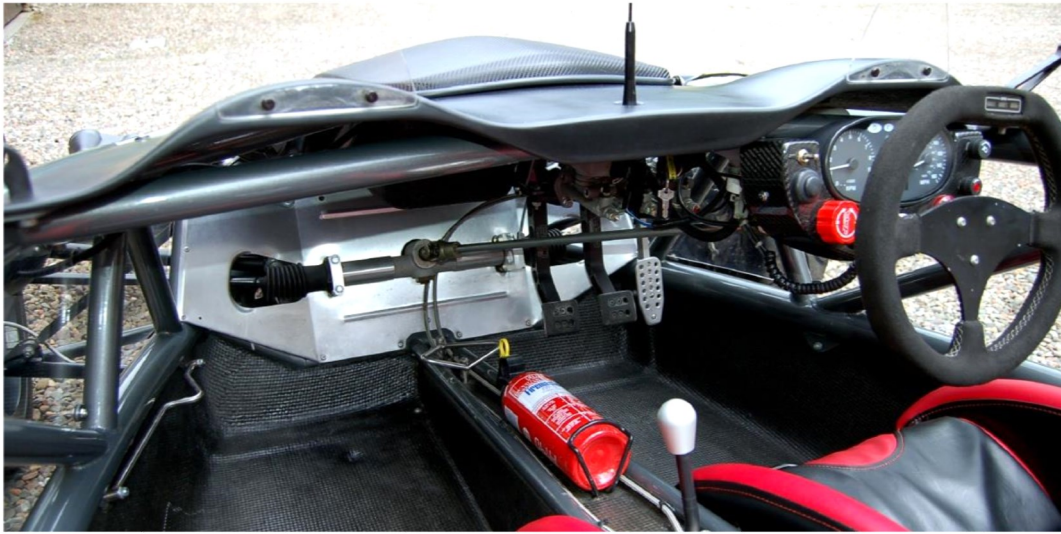
The Ariel Atom (a small-production English sports car which are certified as low volume vehicles) has a clever steering system design that enables the cars to be equipped for left-hand drive or right-hand drive markets; – a fire-wall-mounted centre-steer steering rack. The car's brake and accelerator lines run down the centre of the car's chassis and floor structure, and everything else like the dash is symmetrical. Convert to right-hand drive in a few minutes!

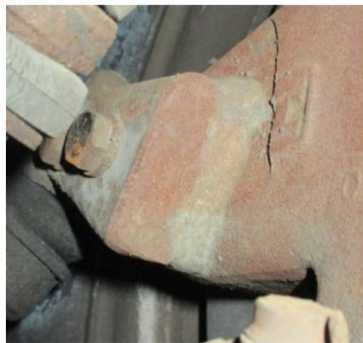
And some people say we don't need LVV certification or Warrants of Fitness! The dark line, by the way, is a casting mark, not a crack. Poor modification standards are still very prevalent in cars that have been modified in the USA.

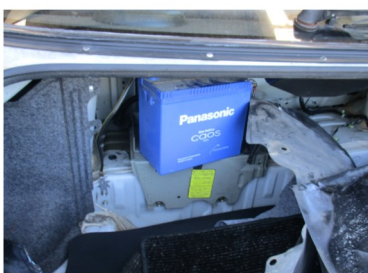
It might be LVV-101, but its surprising how many vehicle owners turn up for LVV certification with unsecured batteries, and the combination of wheel adaptors and wheel spacers.
