Unsafe Aftermarket Steering Columns

Introduction:

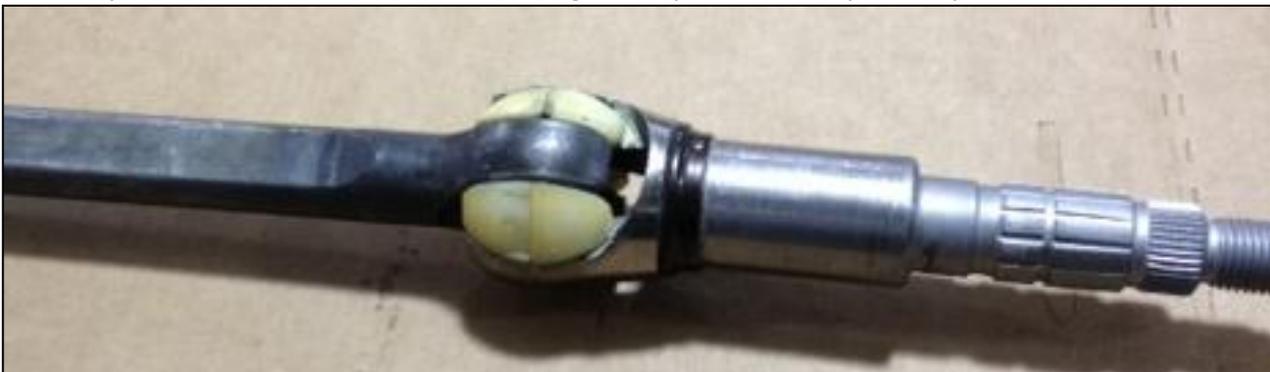
Figure 2: 'GM-style' tilt mechanism assembly, featuring upper and lower yoke shafts

Figure 2 shows a connection system which looks like a miniature constant velocity joint that is, or replicates, the OEM system used by General Motors in their tilt columns, which cannot disconnect within the column housing (the two sections have to be turned at 90 degrees to each other before they can be disconnected, which obviously cannot occur within the column housing). This system is used by most reputable brands.

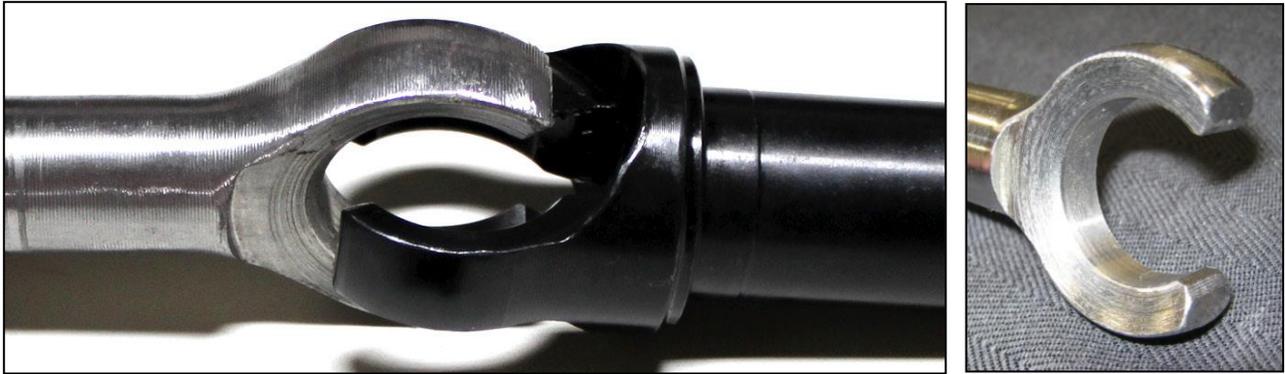
Figure 3: Two 'yokes' of the 'GM-style' tilt mechanism with bush removed, showing 'fail-safe' nature of system

As a general sound engineering principle associated with tilt steering columns, any tilt mechanism should be 'fail-safe', meaning that if any component within the tilt mechanism - such as the tilt ball, shaft, or pin - should for some reason fail, the two forks at each end of the shaft sections (in the case of the GM system) will still remain connected and 'drive'. Even with the plastic tilt-ball completely removed from the GM system, the two yokes will still remain engaged and drive, albeit with approximately 1/8th of a turn of free-play. See Figure 3.

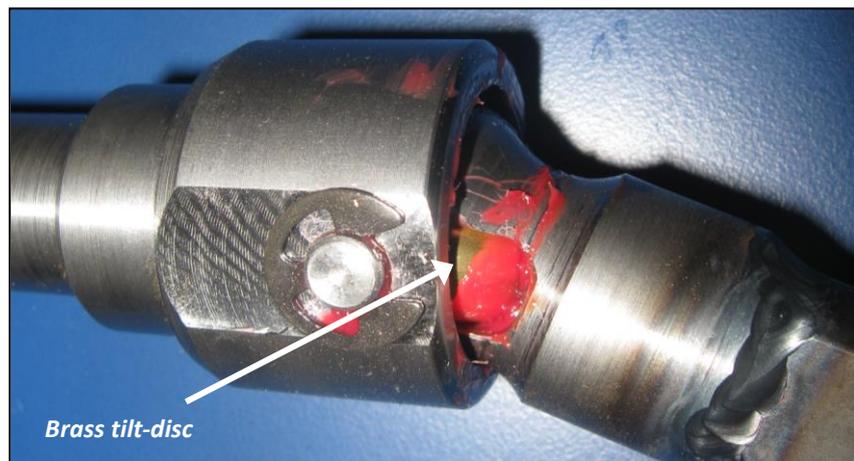
Figure 8: 'Flaming River' brand swivel-joint tilt mechanism assembly.

'Flaming River' uses a 'swivel-joint' tilt mechanism. Although not a proper automotive CV-like joint (as used by 'Ididit' and 'Billet Specialties') it nevertheless appears to be a robust system, and LVVTA has never heard of any problems with this system. An important part of this system is that it uses a proper brass disc-shaped bush as shown in Figure 8, as opposed to the inferior and cheaper plastic bush used by one of the cheap Asian copies.

'Flaming River' incorporates a welded connection at the upper end of the lower steering shaft as shown in Figure 8. 'Flaming River' has confirmed that it uses only TIG-welding, the welds have been tested by an external accredited laboratory, and an on-going quality control system is in place to ensure consistency and repeatability.

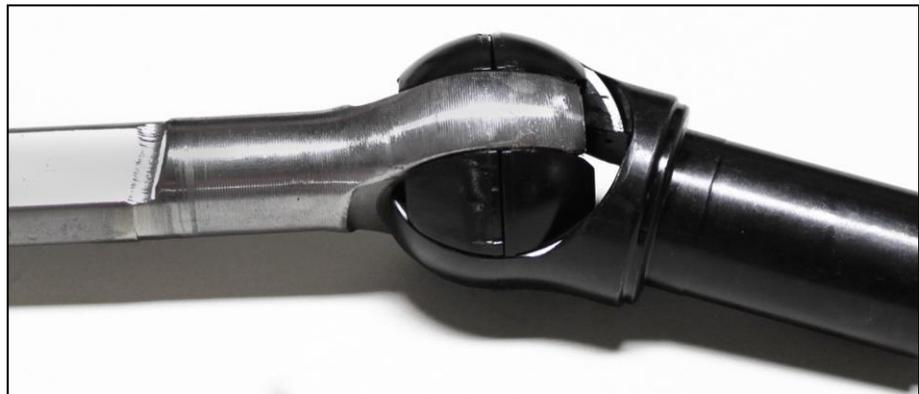
Figure 10: 'Ididit' remanufactured GM-style tilt mechanism & inertia-welded shaft

'Ididit' use a 'fail-safe' remanufactured GM-style tilt mechanism as shown in Figure 10. 'Ididit' have confirmed that all of the critical components used in the manufacture of their mechanisms are made by ISO-accredited facilities, and the captured tilt ball within the joint is a high-quality acetal copolymer, a material designed for high-load applications.

'Ididit' incorporates a weld connecting one 'yoke' to the lower shaft (as seen in Figure 10).

The welding process, which is carried out by an independently certified specialist, uses an inertia welding system which penetrates a controlled amount of depth and uses only the parent material.

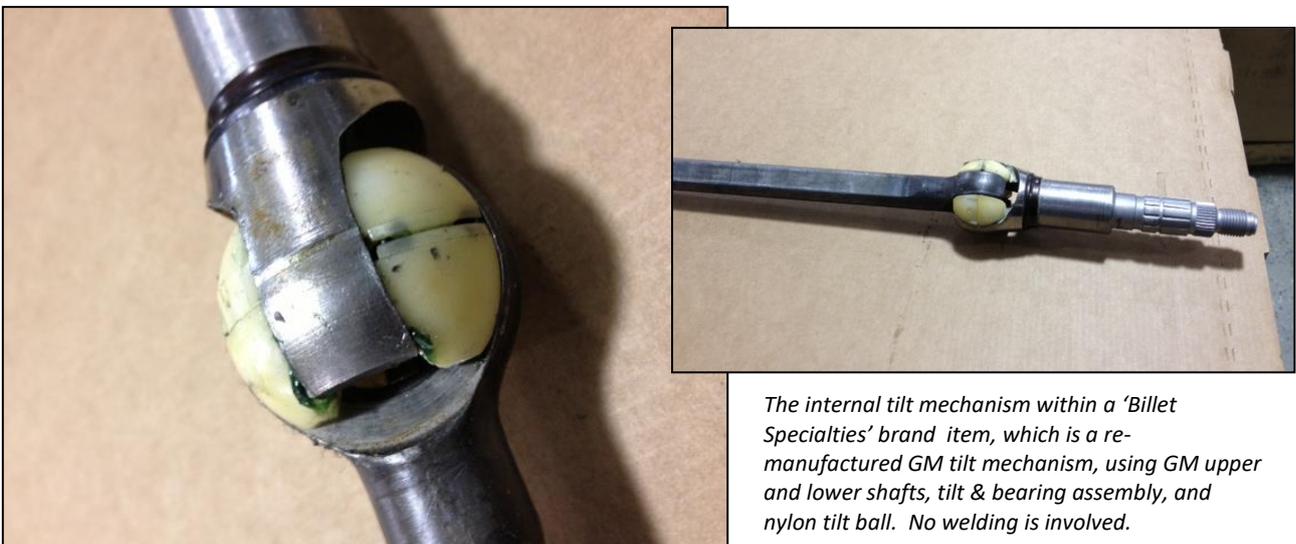
Figure 12: GM-style constant-velocity joint tilt mechanism assembly within 'Billet Specialties' column

From LVVTA's research to date, 'Billet Specialties' – as shown in Figure 12 - is the only aftermarket column manufacturer who uses all remanufactured GM components internally and are assembled without any welding.

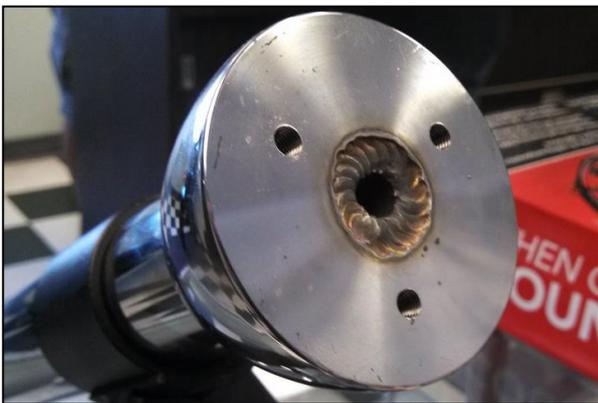
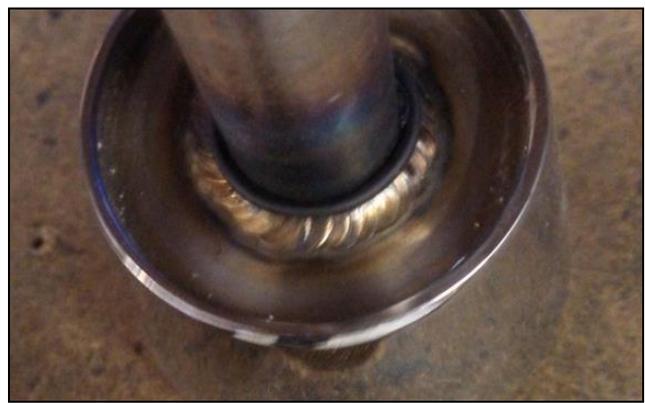
Figure 13: 'Limeworks' new-version 'Hot Rod'-style column at left, and old-version 'Hot Rod'-style column at right

'Limeworks' do not manufacture an aftermarket tilt steering column, so the only issue associated with this brand is their welding at the top end of the column. The 'Limeworks' traditional old Ford-style columns known as the 'Banjo' style and the 'Forty' style do not incorporate any welding anywhere, whereas their straight 'Hot rod' style columns (as shown in Figure 13) for use with three and four-spoke steering wheels are welded at the steering column head. 'Limeworks' old -version 'Hot Rod'-style column is welded on the underside of the steering wheel hub, and the new-version 'Hot Rod'-style column is welded on the top-side of the steering wheel hub.

'Limeworks' is a small California-based specialist fabrication shop, and all welding is carried out by one of two highly skilled welders on-site. The company has a long-standing and good reputation for high-quality products.

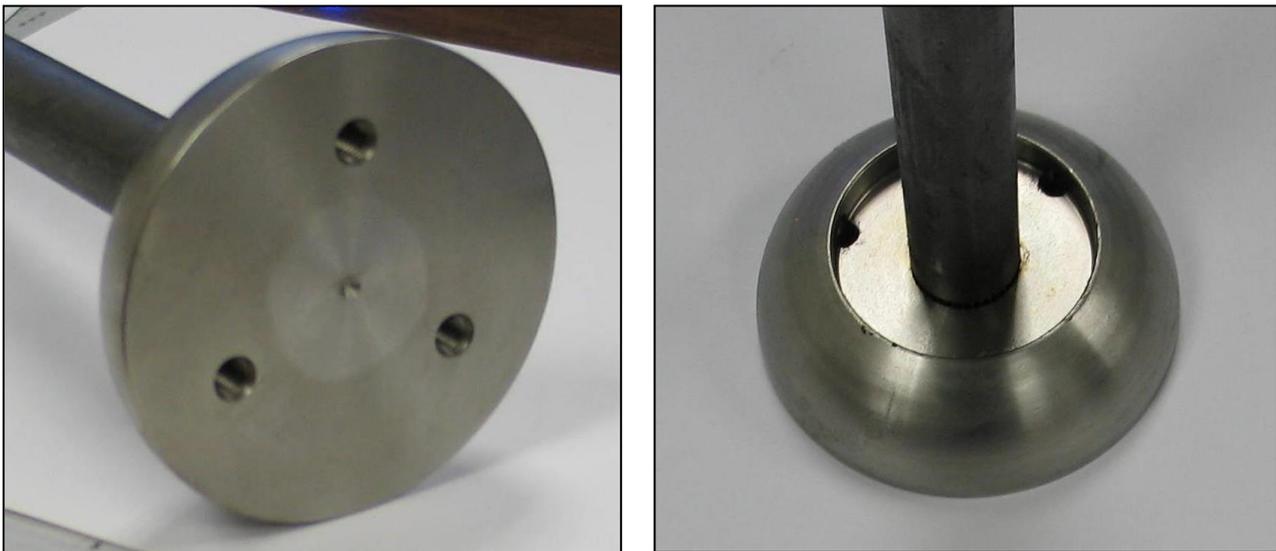
Figure 14: Welded and machined steering wheel hub face on left; back-side of steering wheel hub on right

While LVVTA holds the Borgeson company in high regard as a component manufacturer in general terms, LVVTA has a concern with this particular connection system, in that the welded steering wheel hub assembly is machined smooth (as shown in the photo to the left of Figure 14) removing most of the weld, and there is no welding on the back -side (as shown in the photo to the right of Figure 14) as a safeguard against the potential for the weld to be 'over-machined'. This is poor engineering practice. The position of the top bearing will prevent an un-machined weld from being carried out on the back-face of the hub.

In such a system, it is good practice to use a secondary securement method with the spline, so that the on-going rotational forces that the connection will be subjected to are not reliant entirely on a spline alone.

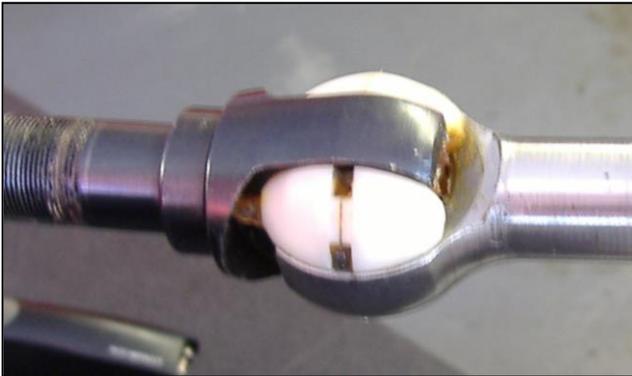
Figure 16: 'CPP' double-yoke tilt mechanism

The design of the tilt mechanism within the 'CPP' brand column is based on the GM-style double-yoke system (as shown in Figure 16), however the origin and quality of the 'CPP' mechanism is unknown, and therefore cannot be assured of being fit for use as a critical-function component such as a steering column. LVVTA believes that 'CPP' began manufacturing their own columns during 2012, and that the columns are manufactured in China.

The 'CPP' brand column incorporates a welded connection to join the lower yoke of the tilt mechanism to the main steering column shaft. Figure 17 shows a typical welded section from a 'CPP' brand tilt steering column, with a poor-quality weld. On other 'CPP' columns that LVVTA has inspected, this weld appears to simply butt-weld the two sections together (without the plug-weld that appears to exist in the example shown in Figure 16).

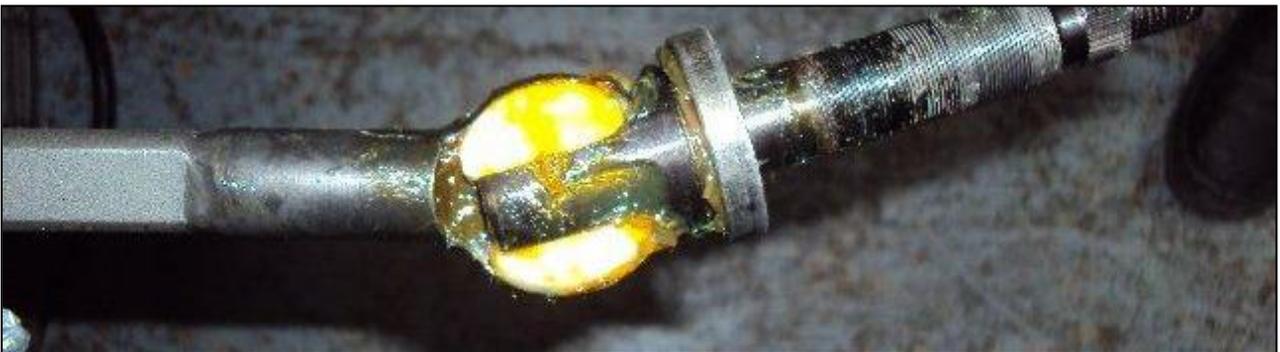
Figure 31: 'RPC' brand uses 'double-yoke' GM-style tilt mechanism

The design of the tilt mechanism within the 'RPC' brand column is based on the GM-style double-yoke system (as shown in Figure 31), however the origin and quality of the 'RPC' mechanism is unknown, and therefore cannot be assured of being fit for use as a critical-function component such as a steering column.

As can be seen in Figure 31 above, the 'RPC' brand column incorporates a welded connection to join the lower yoke of the tilt mechanism to the lower steering column shaft. Figure 32 shows a close-up image of the welded section from an 'RPC' brand tilt steering column, with an obvious defect visible within the photograph of the poor-quality weld. Despite the presence of a plug-weld, LVVTA cannot have any confidence in the quality controls of the welding, or the suitability in either the parent or filler materials used in the manufacturing and welding processes, particularly given that the entire directional control of the vehicle relies upon this weld.

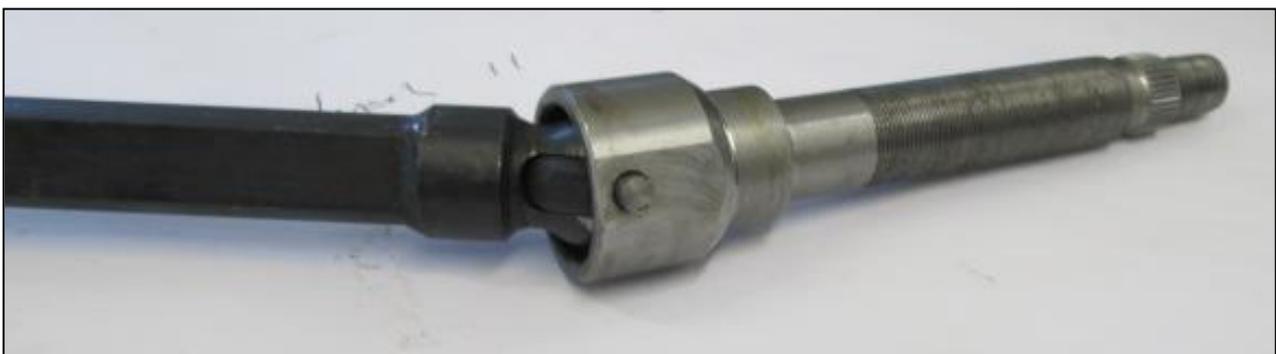
Figure 33: 'Wysco' column with a swivel-joint tilt mechanism

The column shown below in Figure 33 was sold to its owner by a New Zealand retailer as a 'Wysco' brand column. Because there is no visual brand identification anywhere on this column, LVVTA has tried to make contact with 'Wysco' in the USA to ensure that this is in fact correct. However, the California-based sales person that the website led us to had no technical knowledge, but confirmed that 'Wysco' columns are made in China, and stated that the only technical people within 'Wysco' are based in China - and that they cannot be contacted. This situation illustrates the difficulties associated with buying steering columns - or any products for that matter - from a website-based business that sits in front of a Chinese manufacturing plant, and for which no technical support exists. Even the New Zealand retailer wasn't really sure what the column is. Based on the information LVVTA has been able to find, this column is being treated as a 'Wysco' brand.
