Modified Kia Carnival LWB Safety Inspection Request

Purpose of this LVVTA Information Sheet:

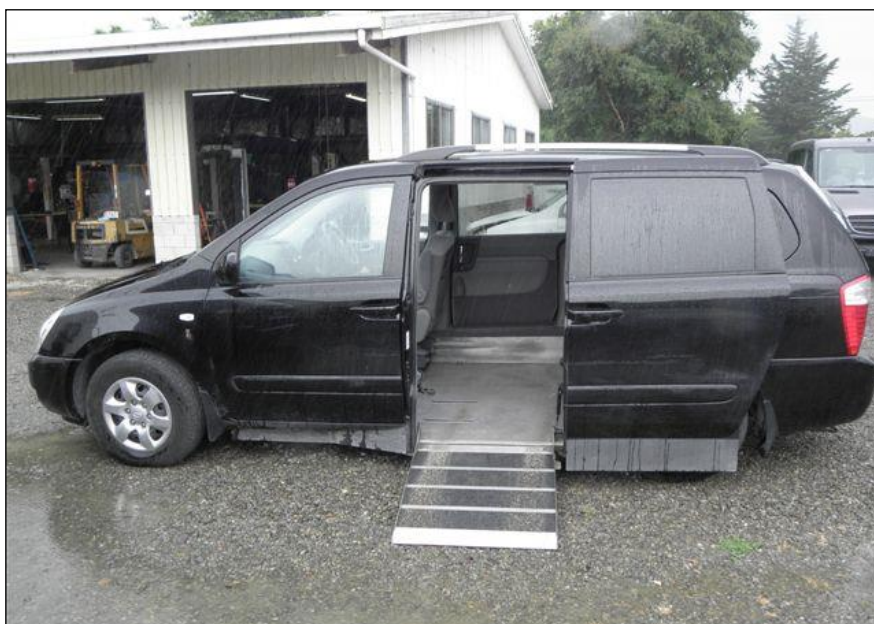
The left rear corner of the vehicle is lowered to aid wheelchair access by an electro-mechanically-actuated lever arm (see photo at right) which compresses the left rear coil spring. Approximately 50 of these vehicles have been imported into New Zealand by the ACC for their clients, who are highly-dependent on these vehicles for their continued mobility and independence.
