## Power Steering Torsion Bar Modification

### **Background:**

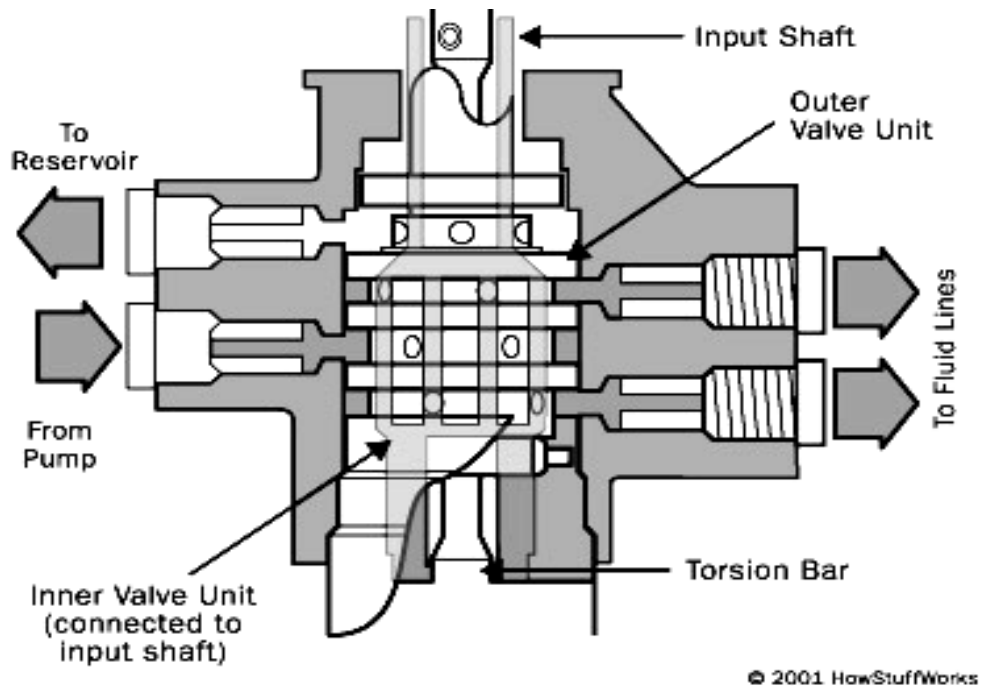
steering wheel), the amount of rotation between the inner and outer parts of the spool valve depends on how much torque the driver applies to the steering wheel.

When the steering wheel is not being turned, both hydraulic lines provide the same amount of pressure to the steering gear. However, if the spool valve is turned one way or the other, ports open up to provide high-pressure fluid to the appropriate line.

Most power steering assemblies are hydraulic/mechanical units. An internal rotary valve directs power steering fluid flow, and controls pressure to reduce the amount of steering effort required to turn the wheels.
