11 - 2005 (V1 November 2005)

Rear Shelf Speaker Aperture Modification

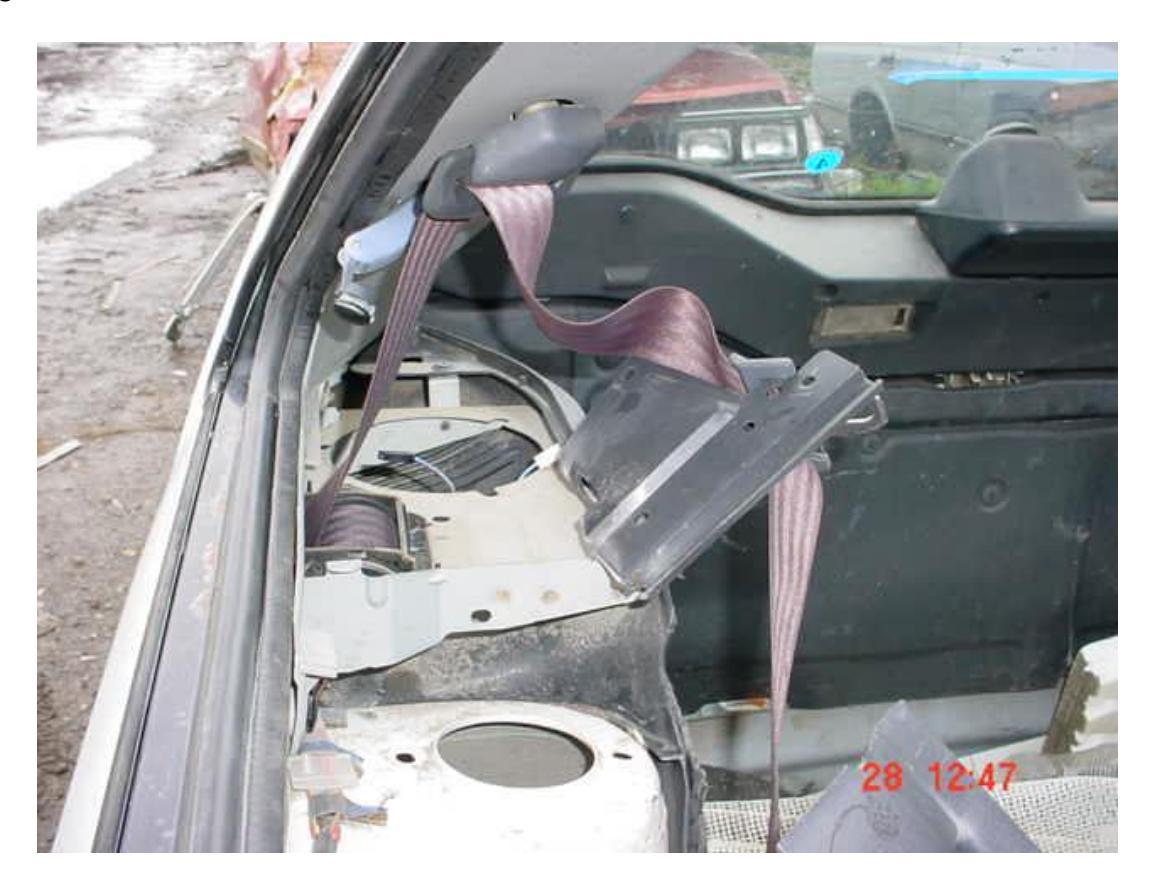
An example of a 3-door Ford Laser hatch (looking through the right side window aperture, rearward toward the tailgate) shows how the seatbelt anchorage is attached to the vehicle's C-pillar. The speaker structure around the seatbelt retractor is bolt-on, of flimsy construction, and plays no part of the seatbelt anchorage's strength.

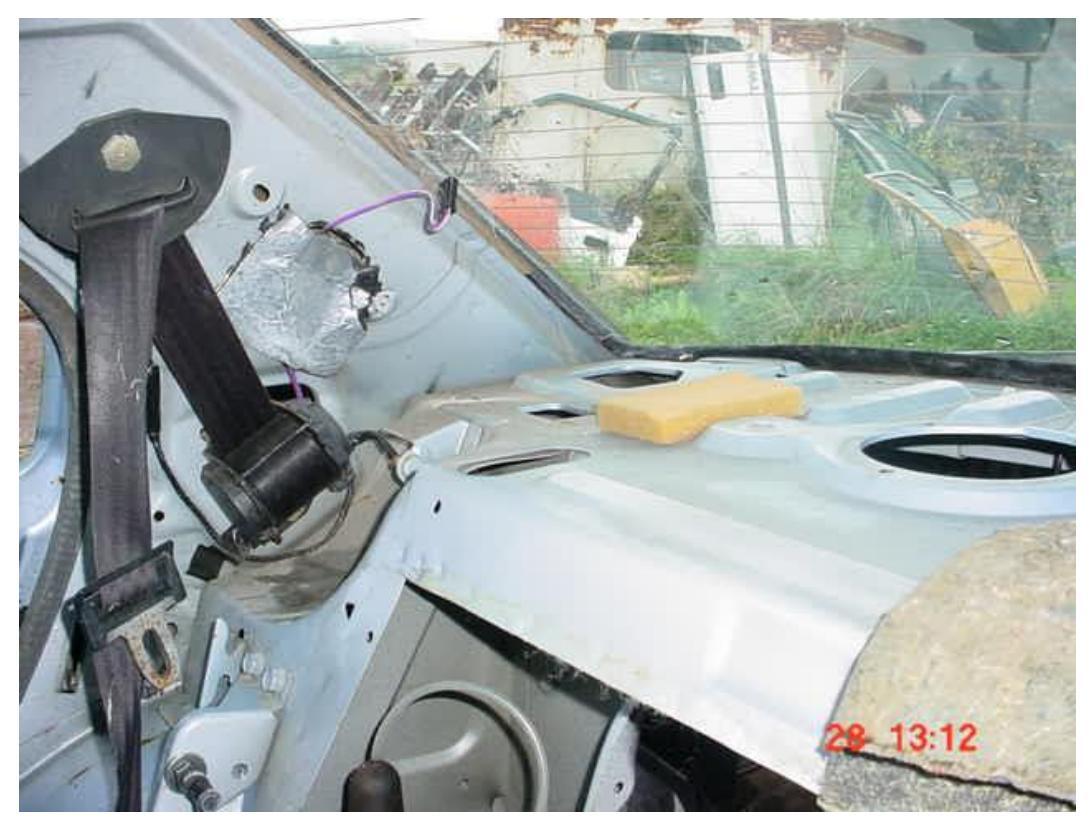
Ford Fairmont

To follow is an example of a seatbelt anchorage which is attached into the C-pillar of the vehicle, but which also has a substantial rear shelf.

This anchorage is from a Ford Fairmont, which has a strong rear shelf/rear of seat structure attached to the bodywork near the retractor anchorage. However, the relative positioning between the anchorage and the speaker aperture is such that a minor modification to the rear shelf would have no effect on the strength of the part of the vehicle structure to which the seatbelt retractor anchorage attaches, which is pulling upwards towards the running loop.

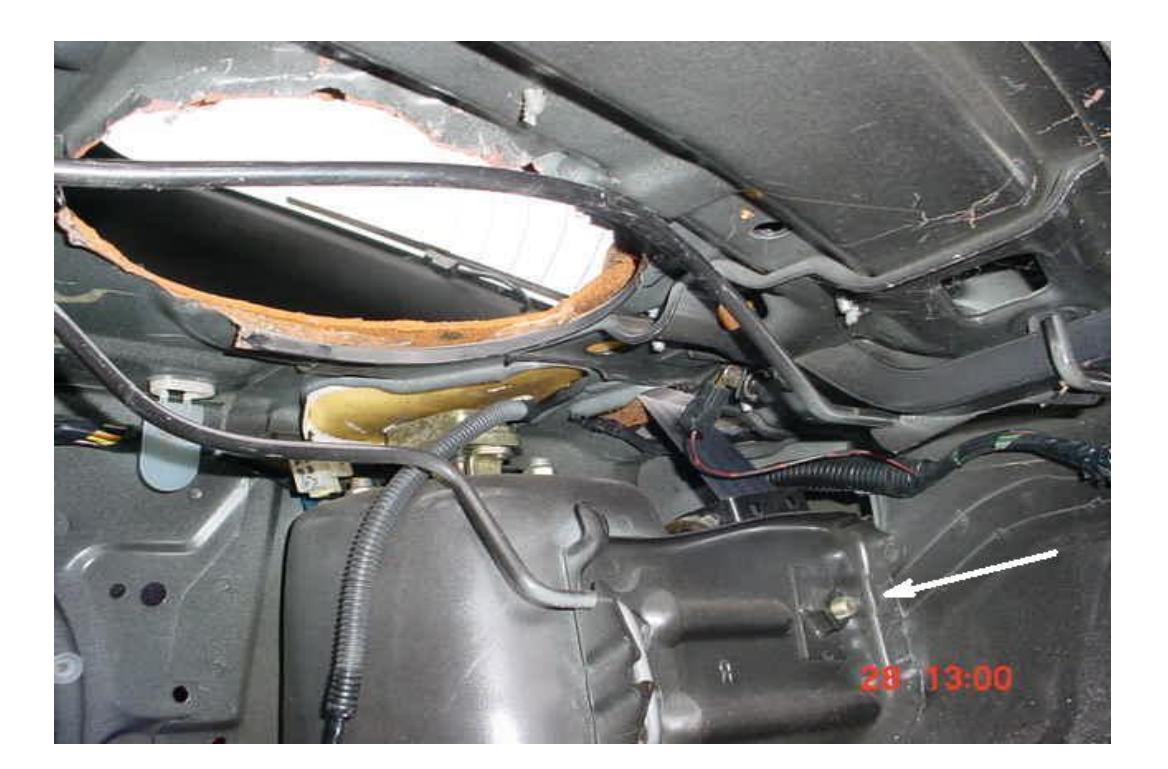
This 2-door sedan Nissan Skyline has an enlarged speaker aperture already, but as can be seen when viewed from within the boot looking forward, the retractor anchorage bolt (can be seen 'arrowed') is attached to a part of the rear structure, which is unrelated to the rear shelf. This speaker aperture modification would not affect the strength of the vehicle structure to which the seatbelt anchorage attaches.

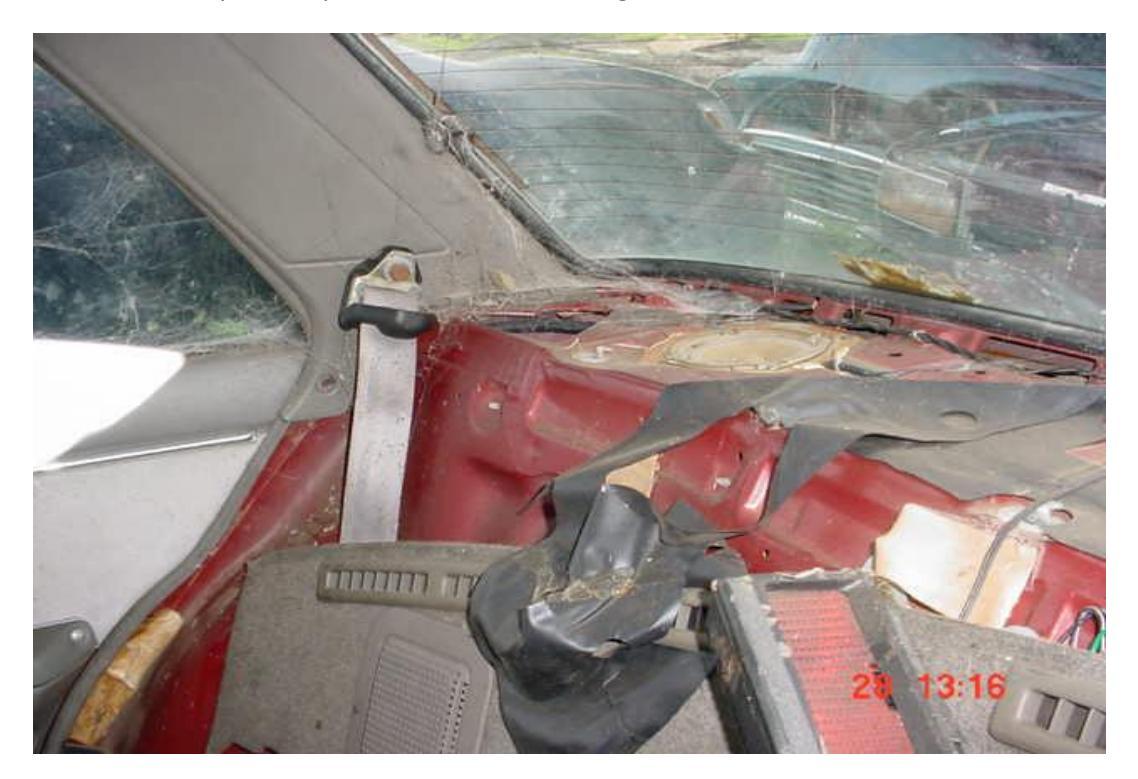
Early Nissan Bluebird

This Nissan Bluebird static anchorage would pull forwards on the C-pillar and inwards during an impact. The sheet metal structure forming the rear of the seat would still provide support to the C-pillar's inward loading, even if the rear shelf speaker aperture were to be enlarged.

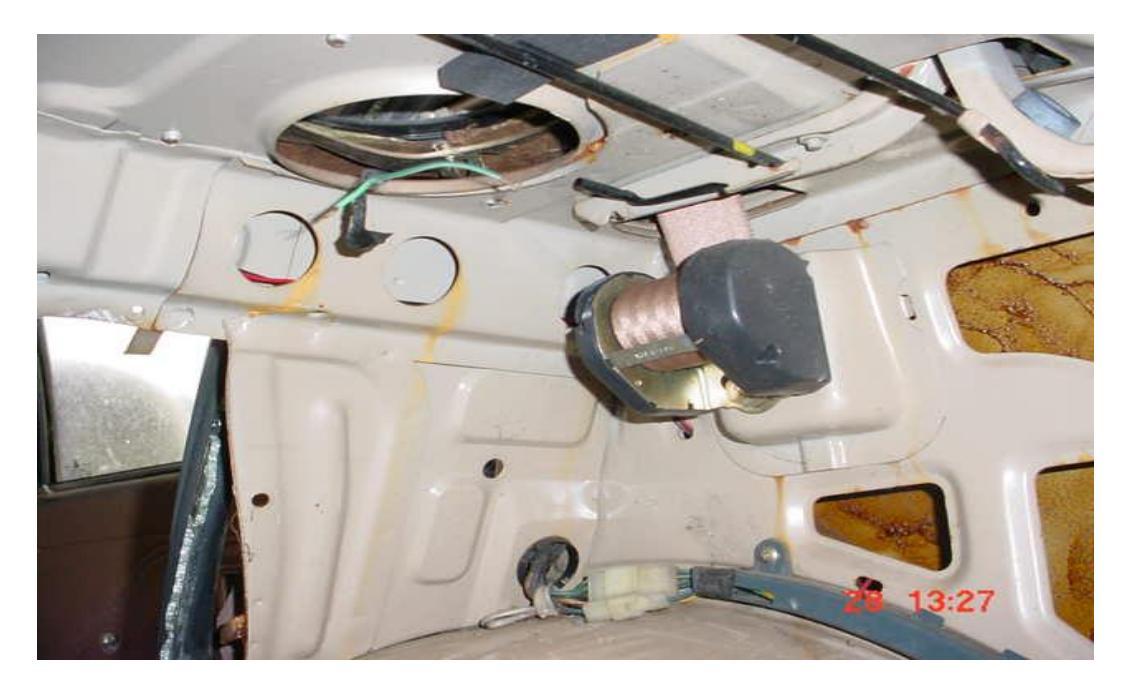
<u>Hyundai sedan</u>

This Hyundai 4-door sedan also has a running loop in the C-pillar. The pull on the retractor will be vertical, and the removal of some material on the rear shelf speaker aperture will not affect the strength of the vehicle structure supporting the seatbelt retractor mount or the running loop.

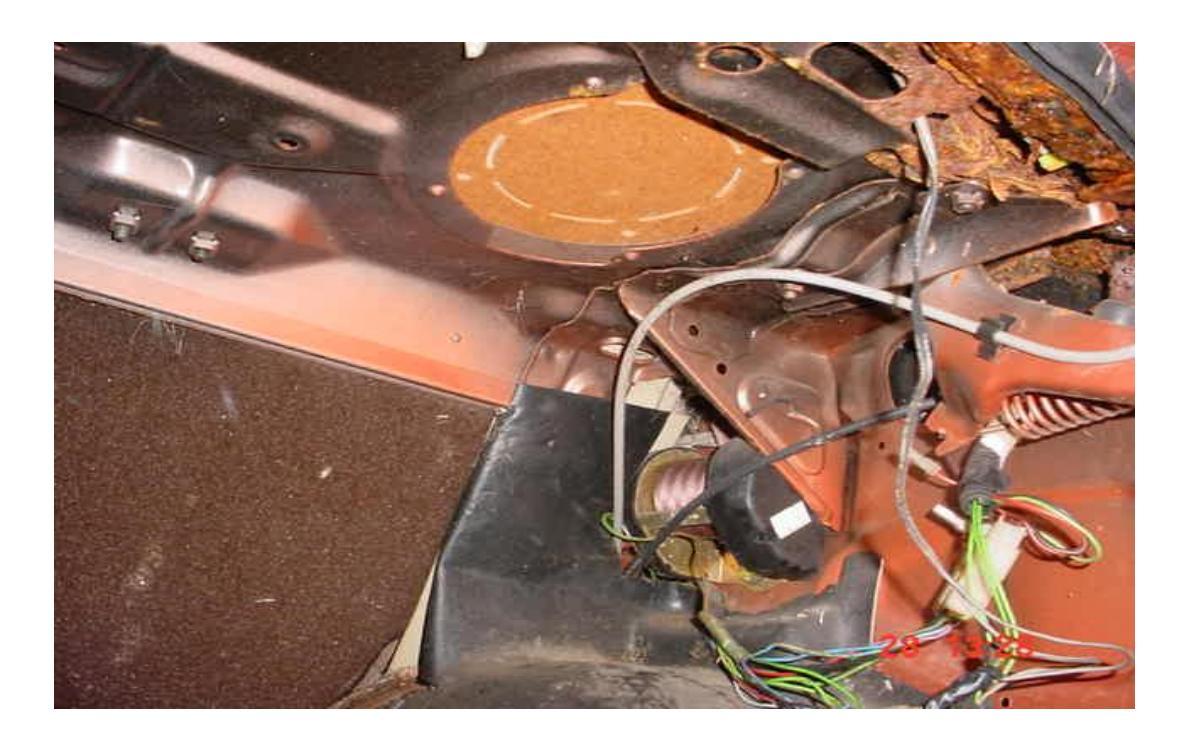
Mitsubishi Mirage Geneva

Again, the retractor and running loop are attached to the C-pillar, so the rear shelf is contributing little to the strength of the structure where the seatbelt anchorage attaches, provided the aperture was increased inwards toward the centre of the vehicle's longitudinal centreline, and the angled stiffener beside the retractor mount was not modified or removed.

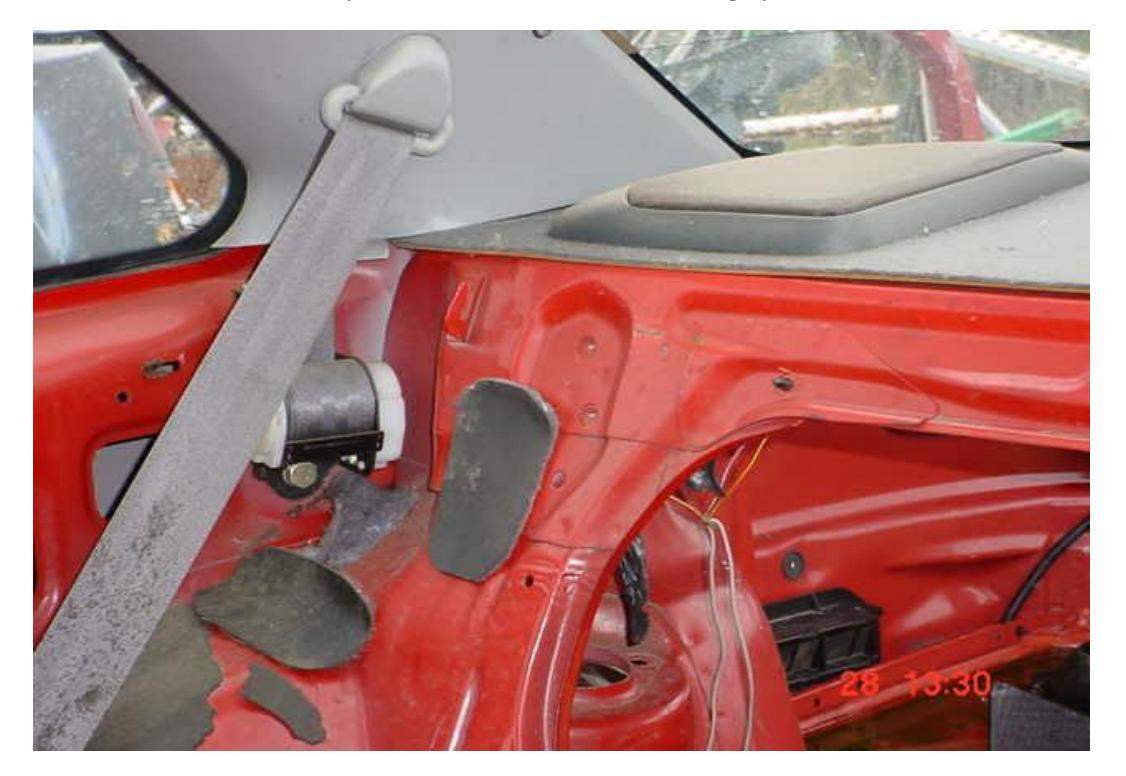
A Mitsubishi Mirage 2-door sedan: the retractor and the running loop both pull vertically against each other, with no inward load component at the retractor anchorage point.

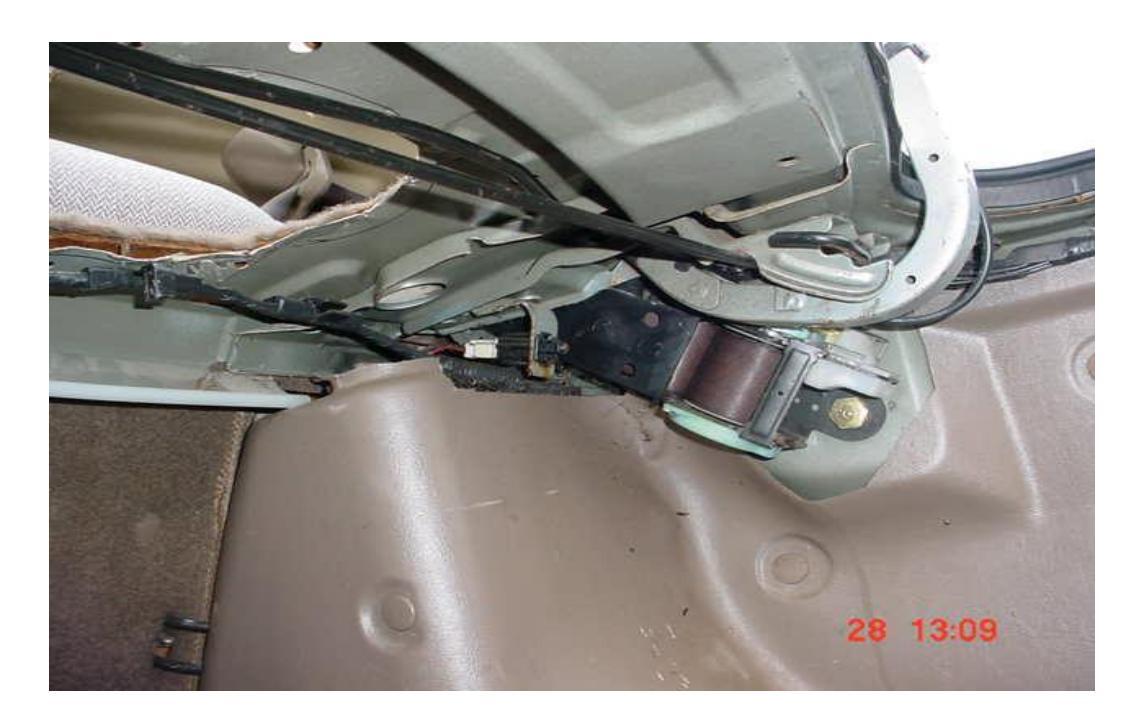
This Ford Telstar has a running loop in the C-pillar (as most of them have). In this vehicle, if the C-pillar were to be supported by anything, it would be from the much more robust section further back that supports the boot hinges, and not from the rear shelf where the speaker apertures are.

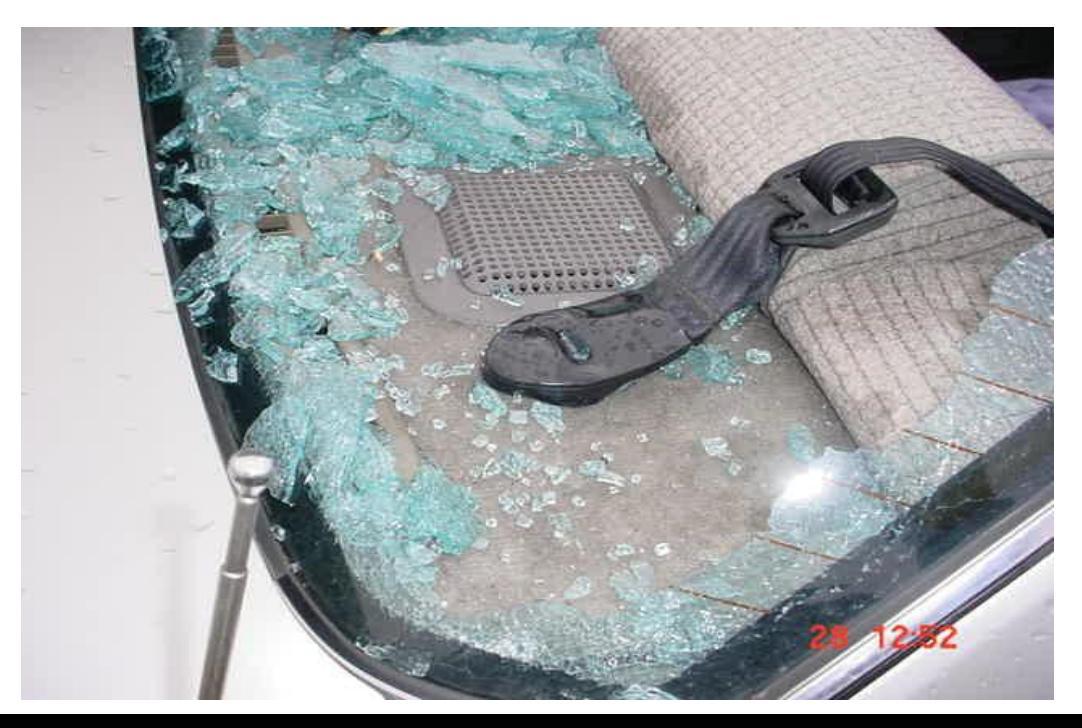
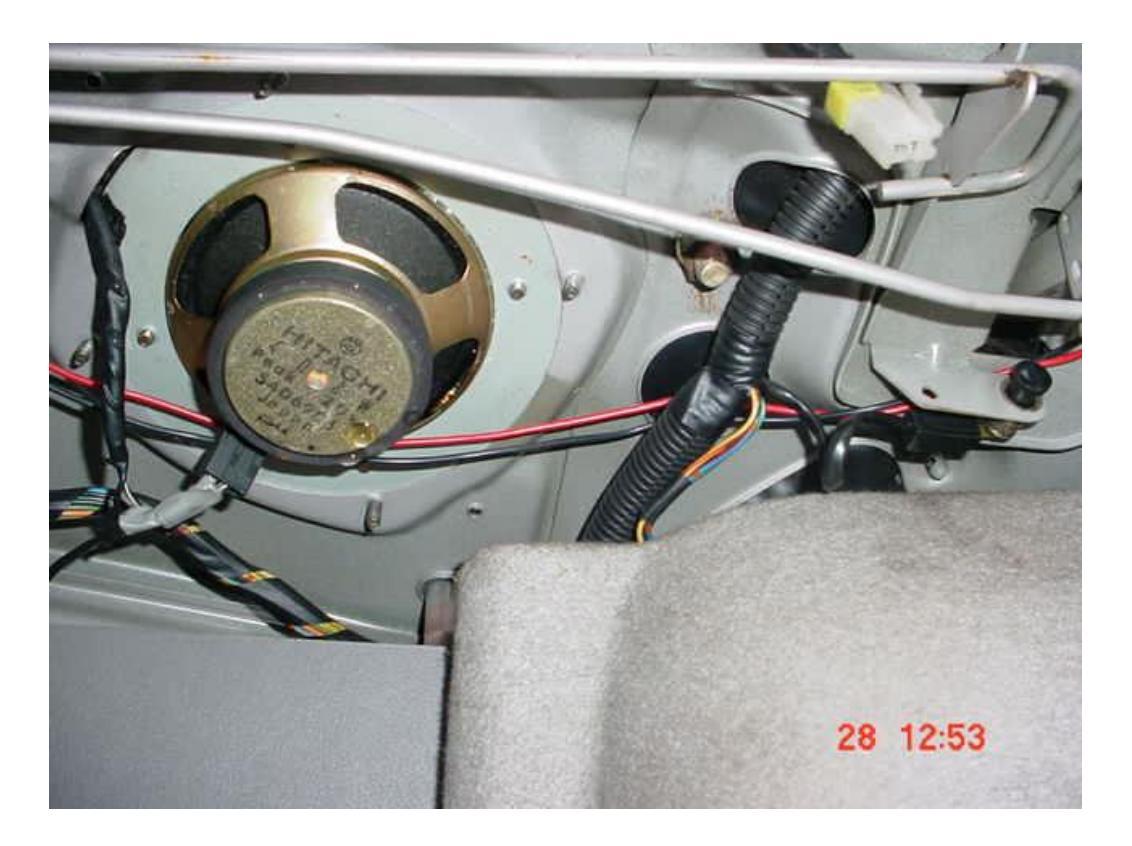
This Nissan Bluebird sedan (this photo and next page) has a static upper seatbelt anchorage attached directly to the rear shelf. This is typical of a rear shelf that should never have its speaker aperture increased in size without having the vehicle LVV certified.

A rear shelf which has an upper seatbelt anchorage attached directly into the shelf, and has an enlarged speaker aperture (or any other structural modification for that matter) must be referred to a LVV certifier, who will ensure that any strength lost to the shelf as a result of the modification will be reinstated by some suitable method.
