Rear Suspension Radius Rod Geometry

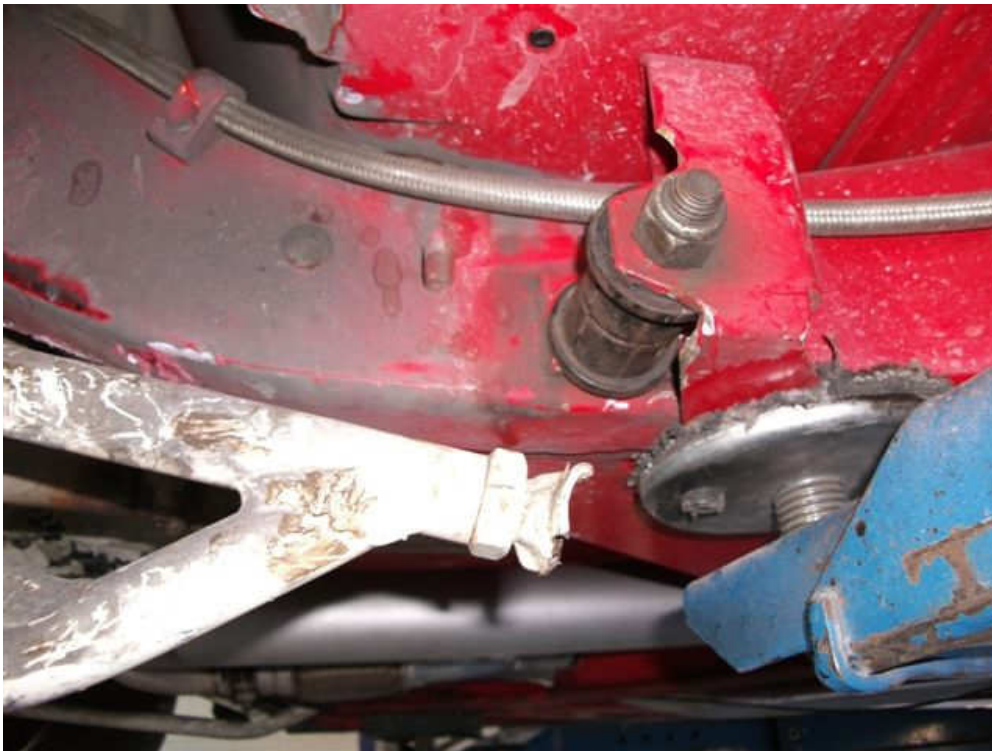
Pictured to the left is the remains of a failed rod end, still attached to the ladder bar. The vehicle in question is a 'worst-case scenario', in that it had everything going against it; - heavy vehicle, a lot of suspension travel (due to airbags), short ladder bars, and minimal bush compliance. The most likely reason that the bars were so short is that the builder decided to use the front OE leaf spring hanger mounts on the chassis as forward attachment points for the ladder bars. The bar's failure caused a (non-injury) accident.

Types of failure that LVVTA people have seen first-hand over the years are radius rod brackets fracturing (or even being torn completely off the diff housing), fracturing of the diff housing (sometimes the first signs of this has been diff oil leaking from axle housings), and failure of the rod end at the chassis.
