Helping New Zealanders Build & Modify Safe Vehicles

## SUPERFORMANCE-BRAND LOWER CONTROL ARM

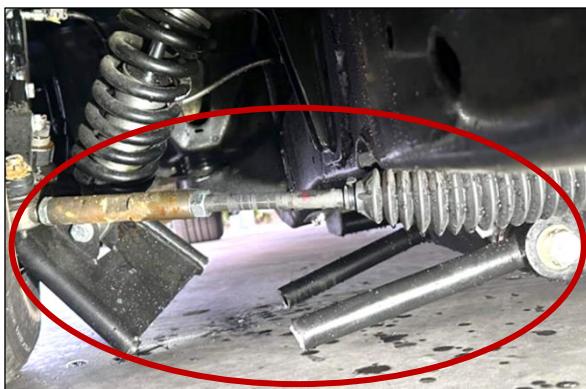
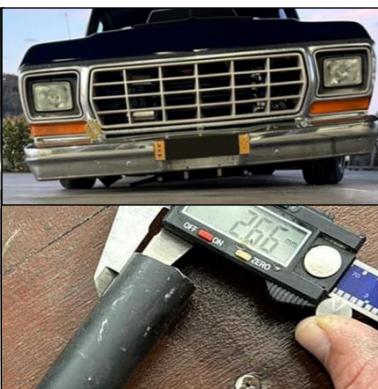
LVVTA has recently become aware of the catastrophic failure of a 'Superformance'-brand suspension arm in Australia. The lower control arm (also referred to as a lower A-arm) was part of a complete custom independent front suspension (IFS) assembly, which was purchased on the basis of it having an Australian engineering report. The tube material has failed, and the arm has sheared through the middle of both tubular sections.

The arm (far left) was measured at the failure site (below right), and the tubing was found to be well below the LVVTA minimum wall thickness specification.

Based on the information provided, it appears that the manufacturer (Superformance) has erroneously used tubing with a significantly reduced wall thickness - which when measured, was just 2.6mm. It is not known whether the upper control arms are similarly undersized, how many lower control arms are affected, or whether there are any other non-LVV-compliant aspects to the IFS design or construction.

Based on some simple calculations, these lower control arms provide only 70% of the minimum required strength. As evidenced, these control arms are at risk of catastrophic failure, and owners of any vehicles fitted with this type of IFS should cease using the vehicle immediately. Owners should contact an LVV Certifier to have the control arm tubing sizes measured accurately, and if these are found to be undersize, for suitable rectifications to be made.
